## Walkover Assessment

## River Fane

5th-7th/08/2019

Undertaken by the Wild Trout Trust

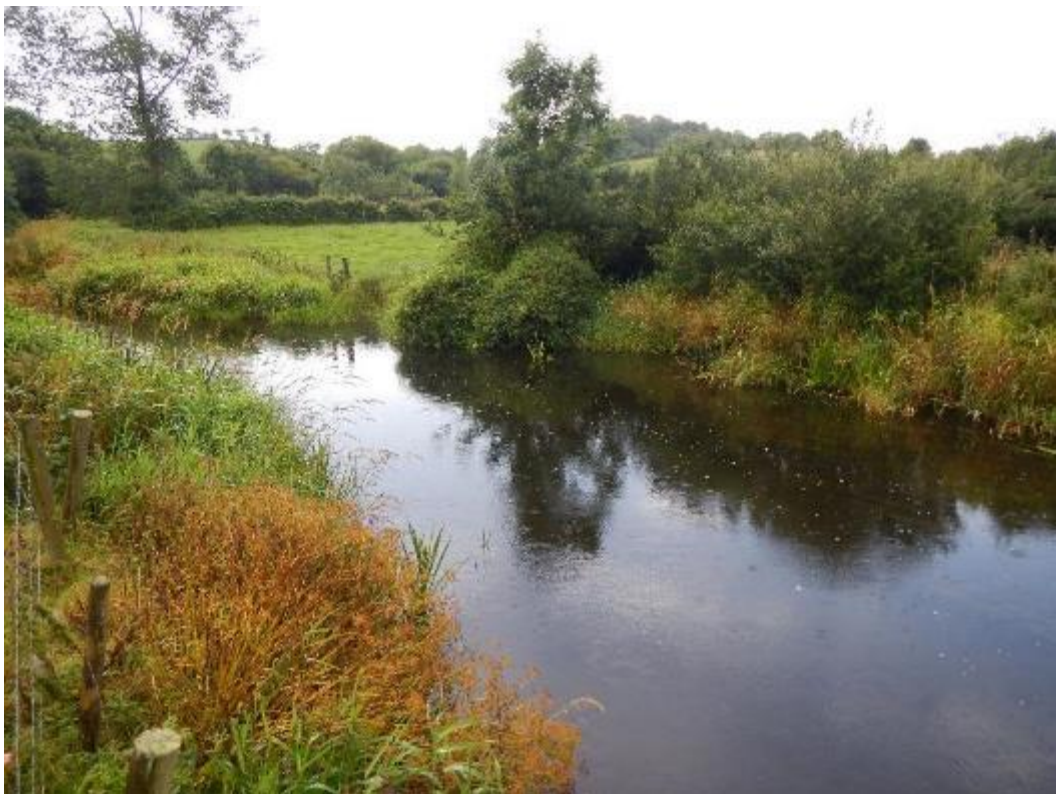
**Photo 5.** A deeper pool d/s of the bend provides high quality habitat for adult salmonids. This feature is created and maintained by bed scour associated with the bend which naturally increases the water depth over that found in the straighter sections.

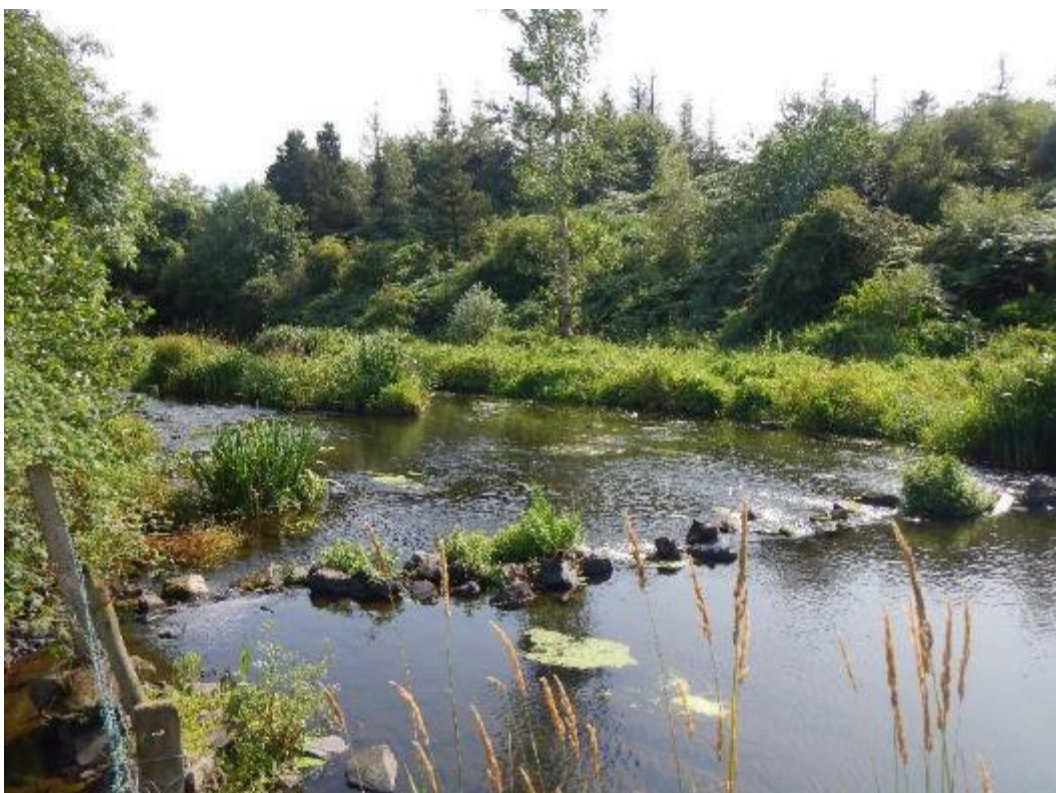
**Photo 12.** A weir at (54.0339750, -6.6217200) impounds flow u/s and degrades local habitat. Unlike natural pools, the additional depth created upstream of the weir is at the expense of flow diversity, leading to a reduction in habitat quality for flow-loving salmonids. Weirs also trap sediment, resulting in the reach u/s becoming much shallower over time. Ideally, this weir would be removed, or a portion notched down to bed level on the RB side, to remove the impoundment, allow free sediment transport and encourage bed scour. Prioritising flow down the RB channel d/s would encourage the reinstatement of a bend. A pasture pump or other alternative watering option is likely to be required.

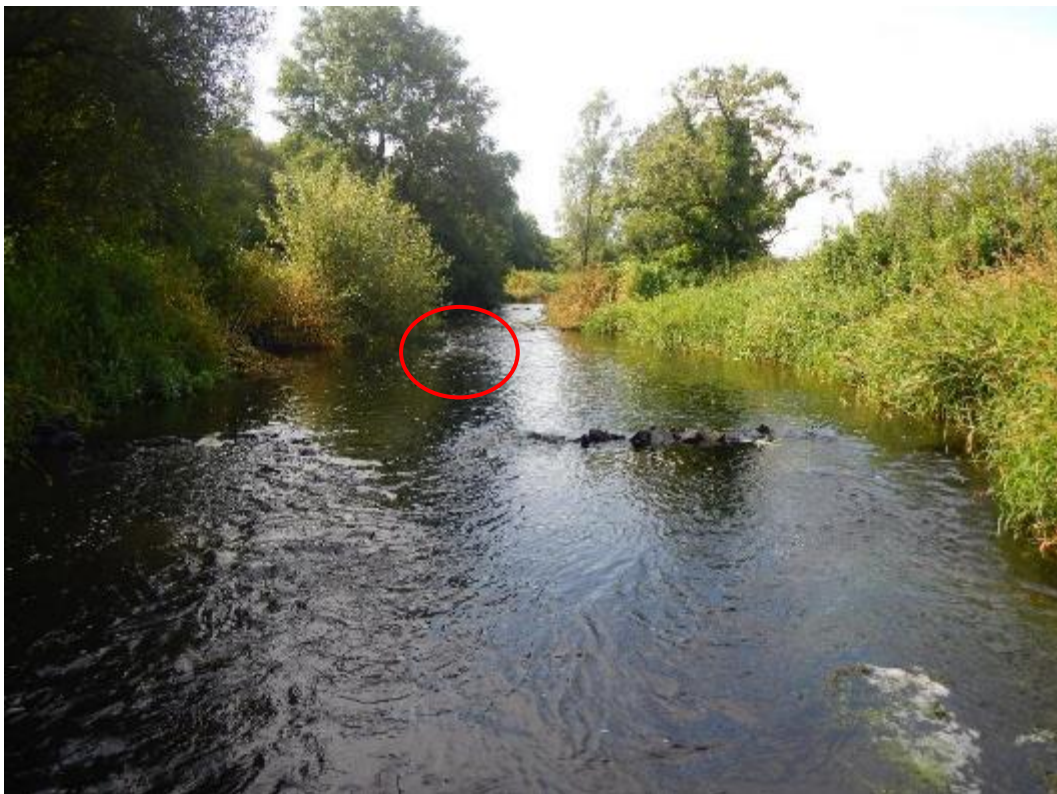
**Photo 14.** Small, deflectors in the channel create flow diversity, but it is generally better to employ habitat techniques such as planting and woody material (54.0322583, -6.6199483). Note that the rock placed in the channel is inhibiting flow in an area that would otherwise be a valuable food-lane adjacent to the overhanging bush. A better course of action would be to lay that bush down into the wetted channel (see Recommendations).

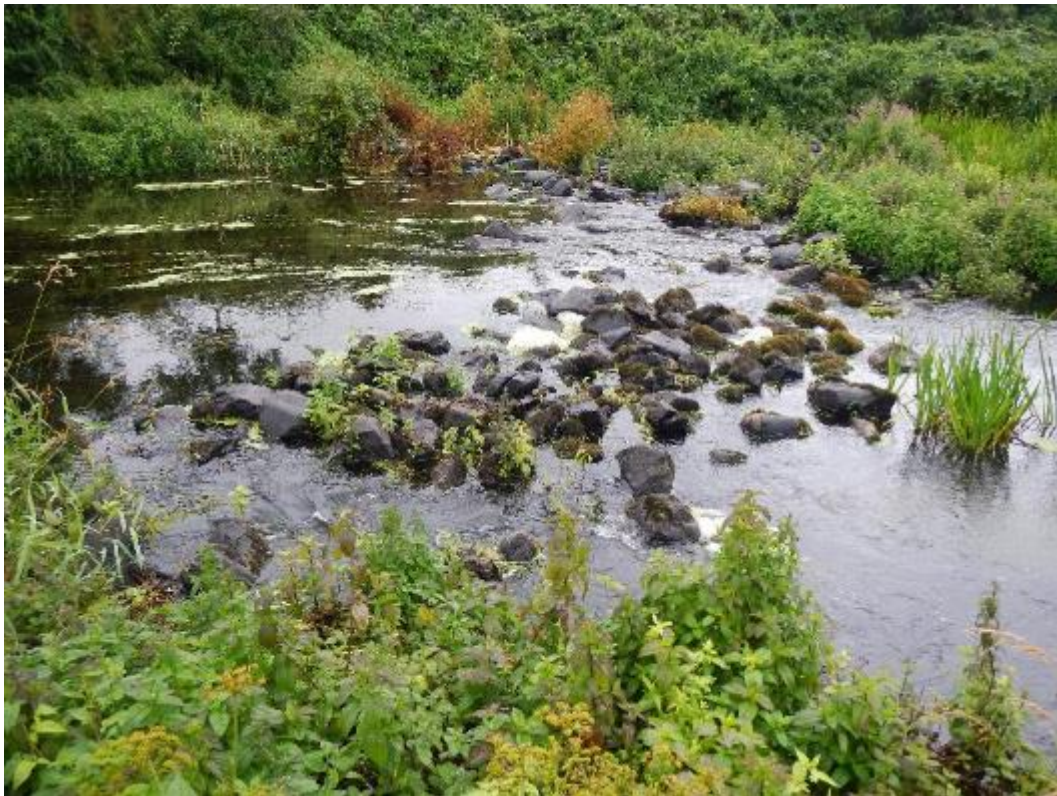
**Photo 31.** A more formal weir backs up flow and creates similar but greater issues as those found u/s (54.020598, -6.60211). Removing stones from the RB side would accentuate the existing left-hand bend and help consolidate flow and habitat alongside the island downstream. Otter spraint were observed at this point.

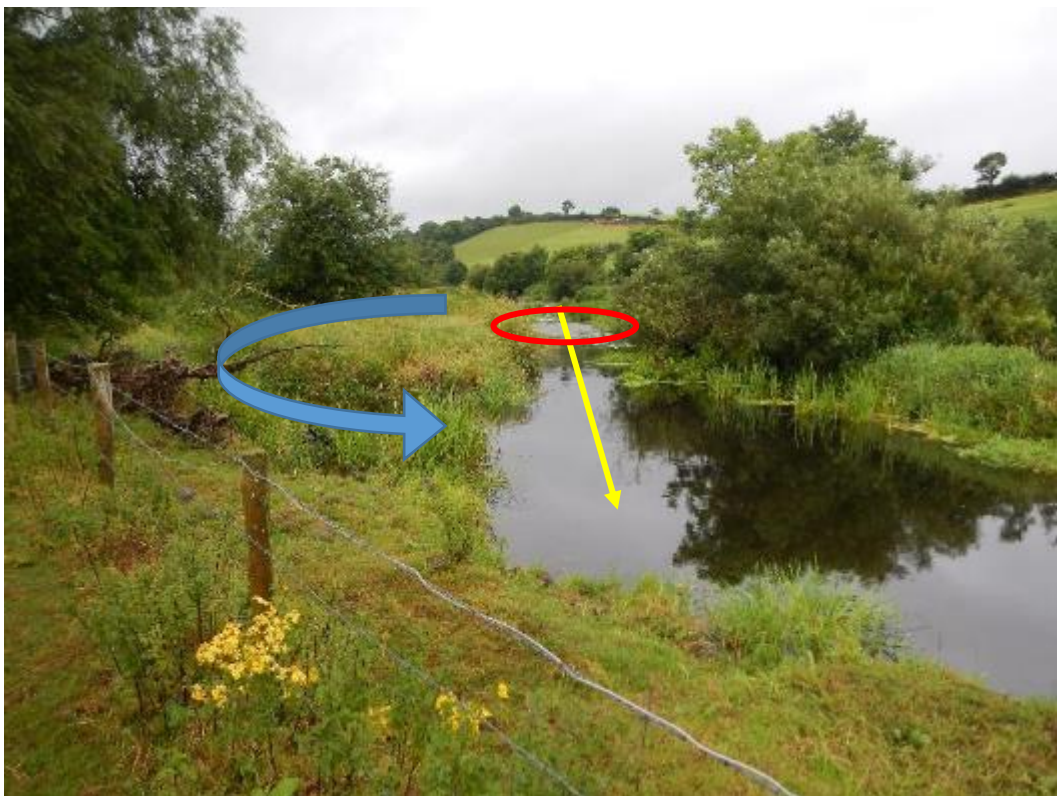
**Photo 33.** Looking u/s at the weir (red ellipse) and island. Encouraging flow down the RB channel could reintroduce a much-needed meander (blue arrow) to the long, straightened channel (yellow arrow).

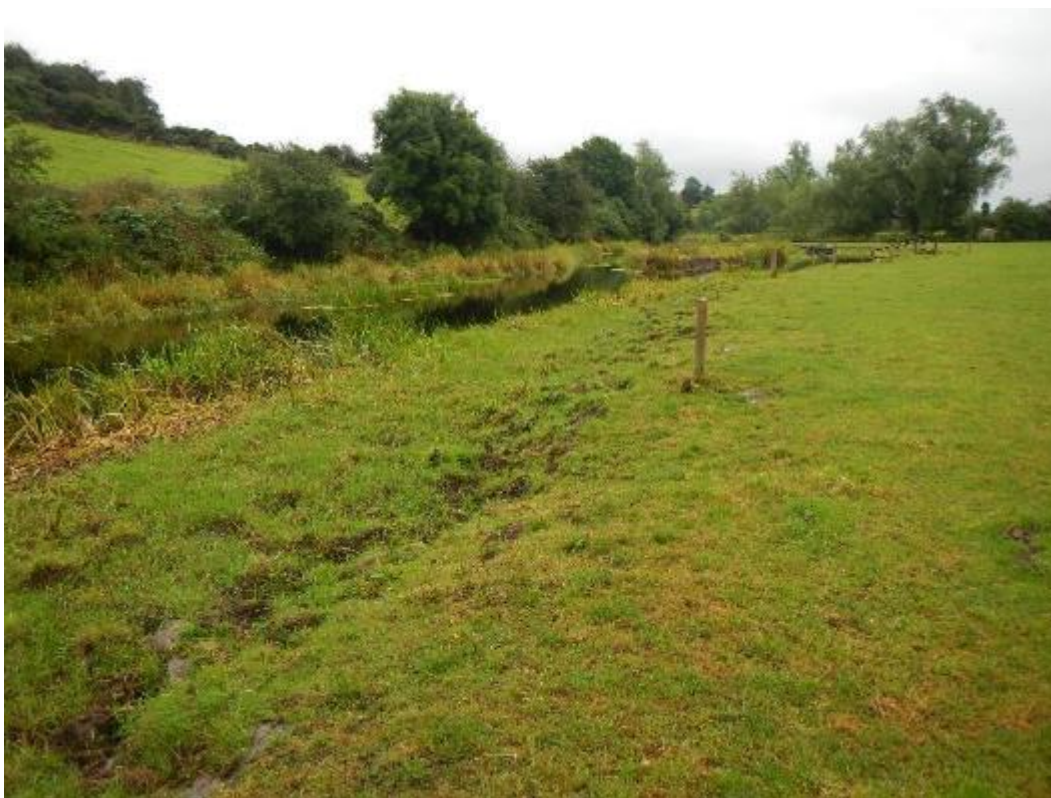
**Photo 34.** The field on the RB is heavily grazed and the buffer fence has failed, leading to poaching and habitat degradation (54.019797, -6.601495).

<p><b>Photo 34</b></p>	1/2	54.019797, -6.601495	Reinstate the buffer fence.
Island / split channel

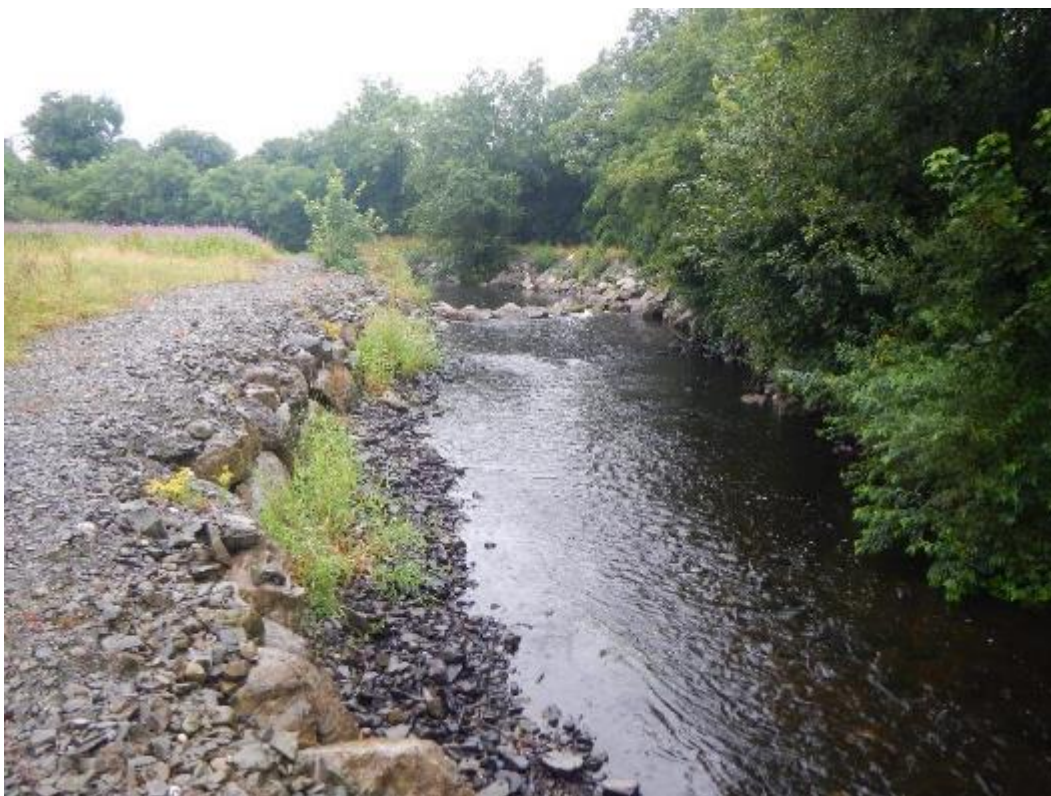
**Photo 42.** Spot checks were then undertaken around Inniskeen to look at some inappropriate in-channel work where weirs have been installed (54.004066, -6.582740). Dredging has also destabilised the bed and banks, leading to yet more bank work. It is not known what the purpose of the work was but it has certainly degraded the in-channel habitat for fish and interrupts vital sediment transport.

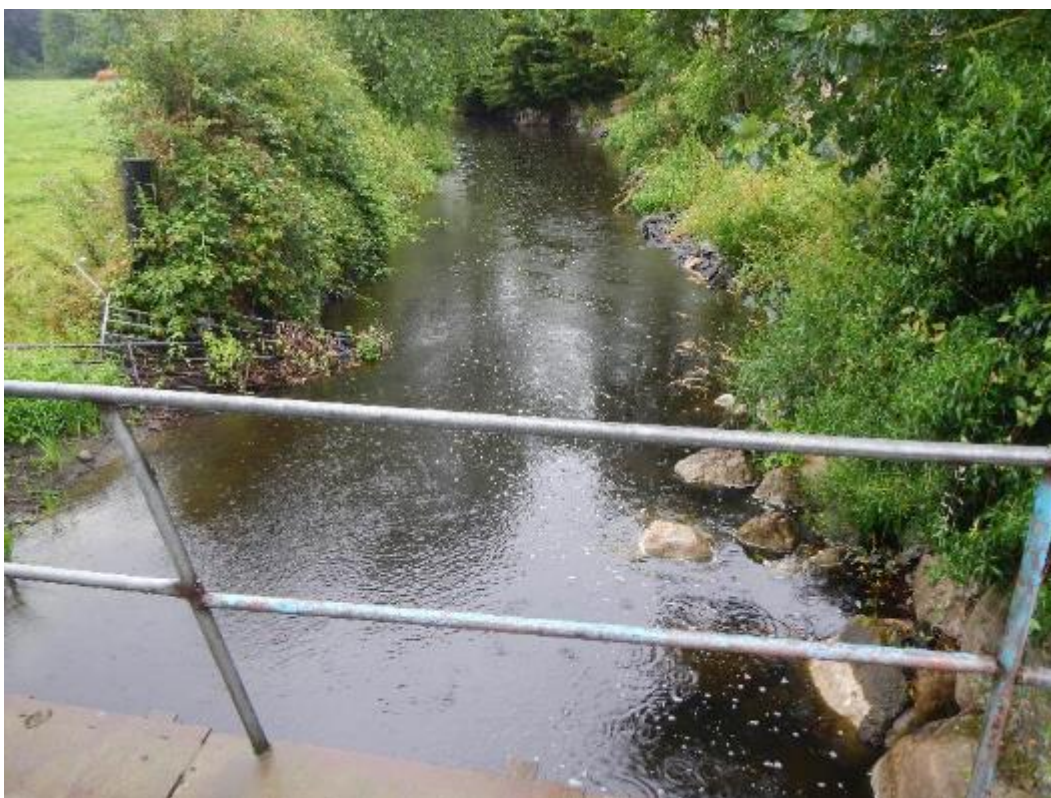
**Photo 43.** Another area dredged d/s of the weir. The issue of dredging and lowering of the bed is compounded by the interruption in the supply of sediment created by the weirs u/s. This is likely to result in further bank destabilisation and erosion in the nearby sections d/s.

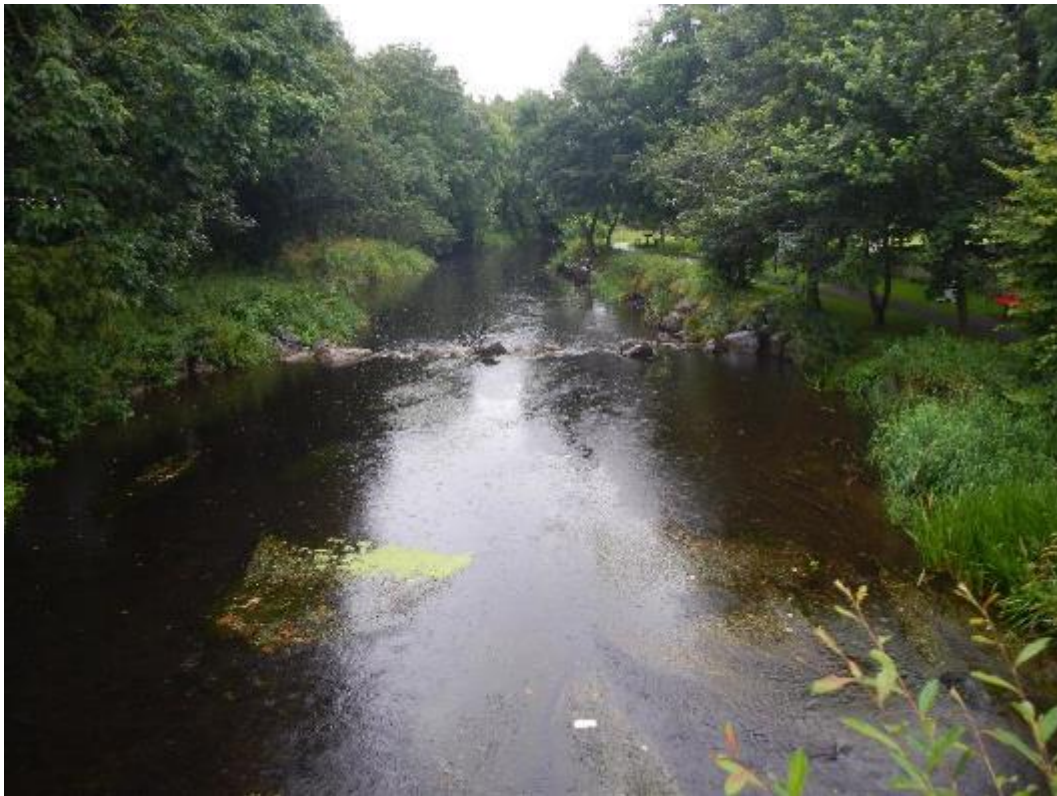
**Photo 44.** The larger weirs in Inniskeen not only degrade the habitat u/s and d/s, they create an impediment to the u/s and d/s migration of fish, particularly in low flows. Juvenile fish dropping down the river are often deterred by such structures, delaying their progress d/s and making them an easy target for predators.

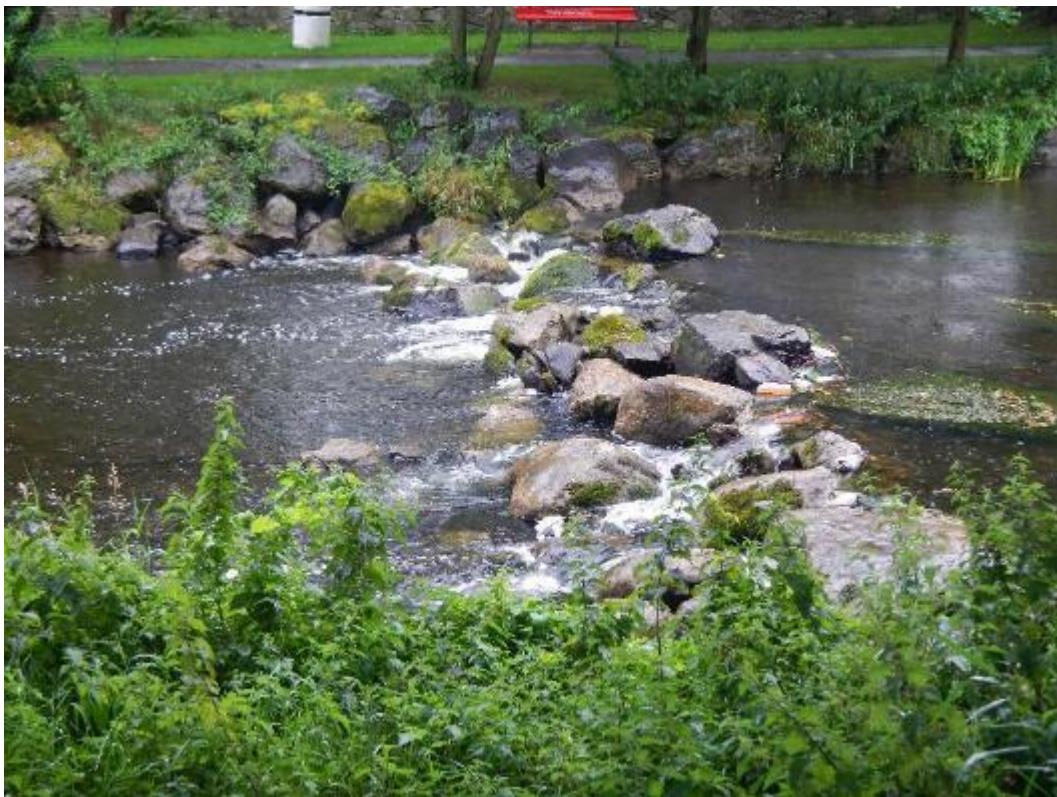
**Photo 45.** The weirs are also an unnecessary obstacle to u/s fish migration (54.004334, -6.578381). Contrary to common belief, migration doesn't just occur at high water. In the absence of obstacles, most fish (particularly sea trout) will move as and when they need to, on little or no increase in water. Creating unnecessary barriers can therefore greatly impact upon the distribution of fish through a system, delaying them from reaching their spawning areas and negatively impacting their populations.

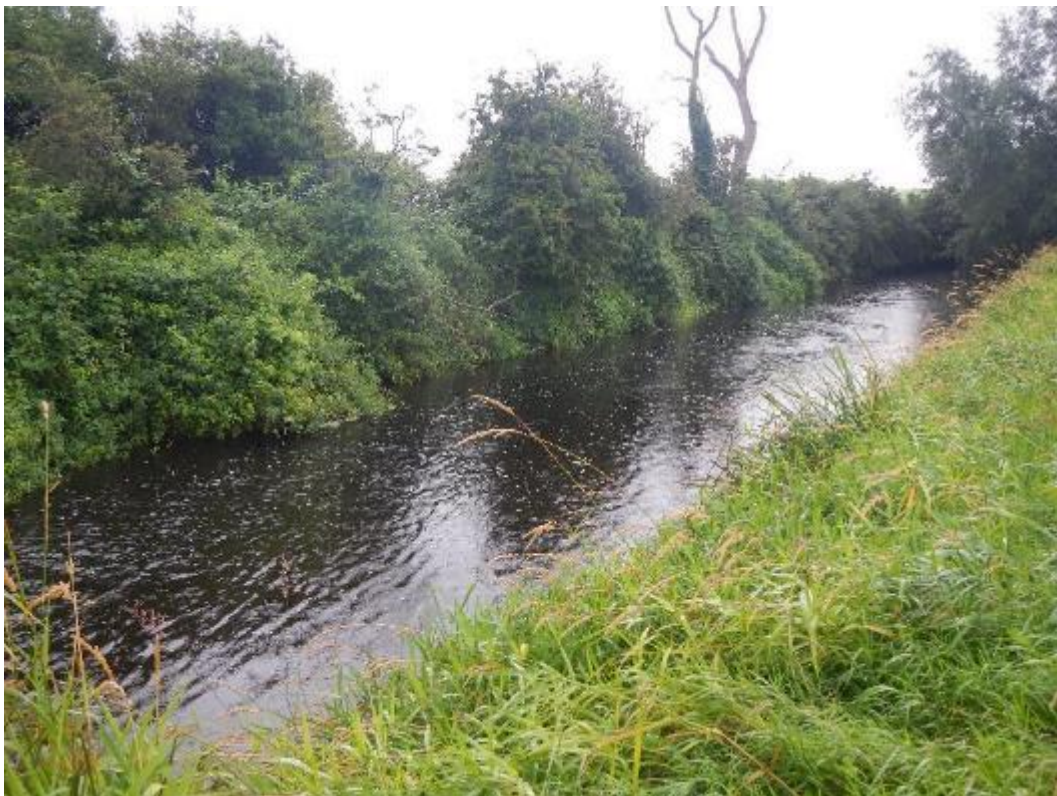
**Photo 53.** Sections of channel d/s appear to have also been straightened (possibly for agricultural purposes). Fortunately, in-channel habitat quality remains relatively good, with healthy bankside vegetation and trees. However, alder disease (*Phytophthora alni*) becomes increasingly apparent with progression d/s. This issue should be monitored, with dead trees being replaced with alternative species if areas suffer badly.

<b>Photo 53</b>	1	Throughout the river.	Monitor trees on the river and replace dying alders by planting with other species.  Winter coppice selected trees if the disease is identified early.
Track crossing and run-off

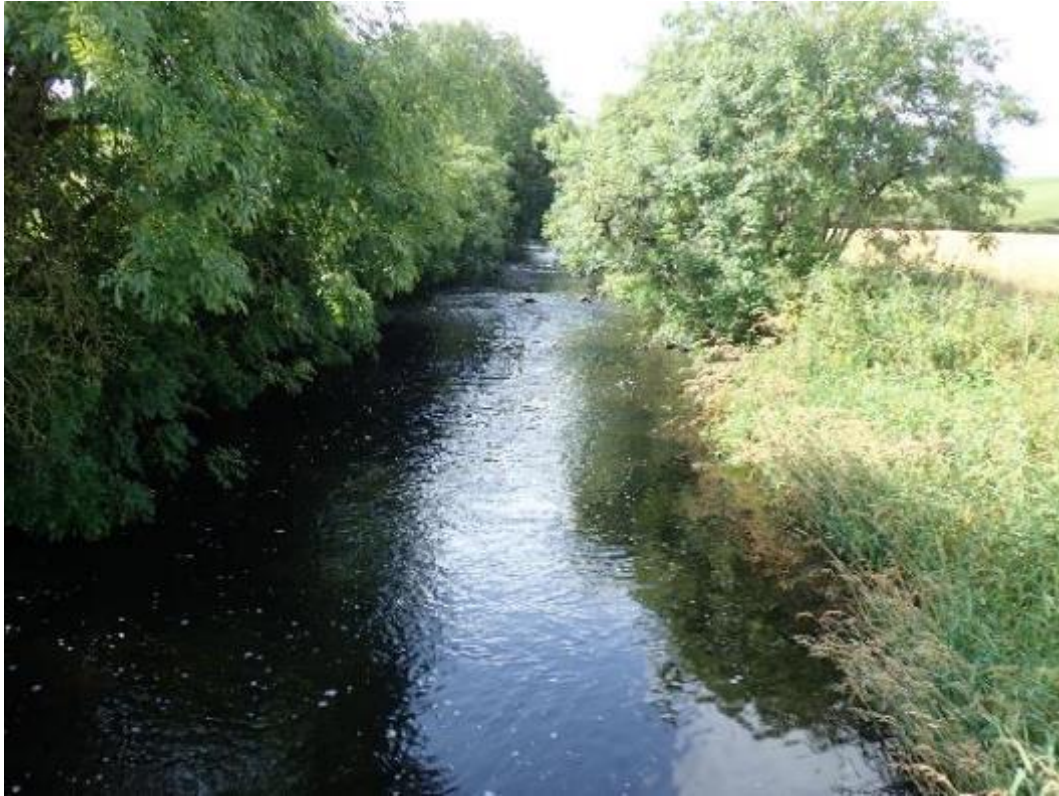
**Photo 60.** A long, straight section of channel (53.983335, -6551503) lacking any significant pool habitat. Previous channel straightening, fallen tree removal and bank protection are usually the reasons why pool habitats fail to develop. Opportunities exist for tree hinging to promote a meandering thalweg at the very least.

<b>Photo 60</b>	2	53.983335, -6551503	Undertake selective tree-hinging or lodged woody material installation.
Inadequately buffered maize field

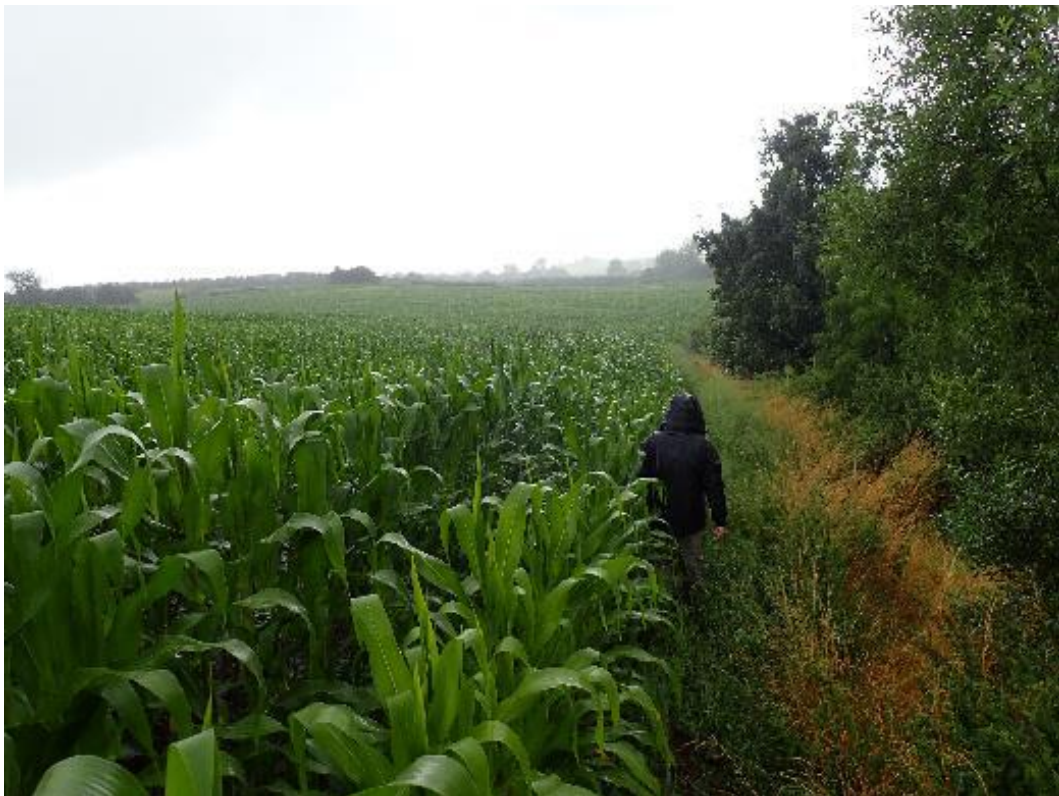
**Photo 69.** A large maize field located on a sloping meadow with a wholly inadequate buffer strip adjacent to RB just upstream of Castlering bridge (53.974340, -6.629830). Unless a cover crop is quickly planted post-harvest, this meadow will lose significant quantities of nutrient rich soil to the river over the winter period.

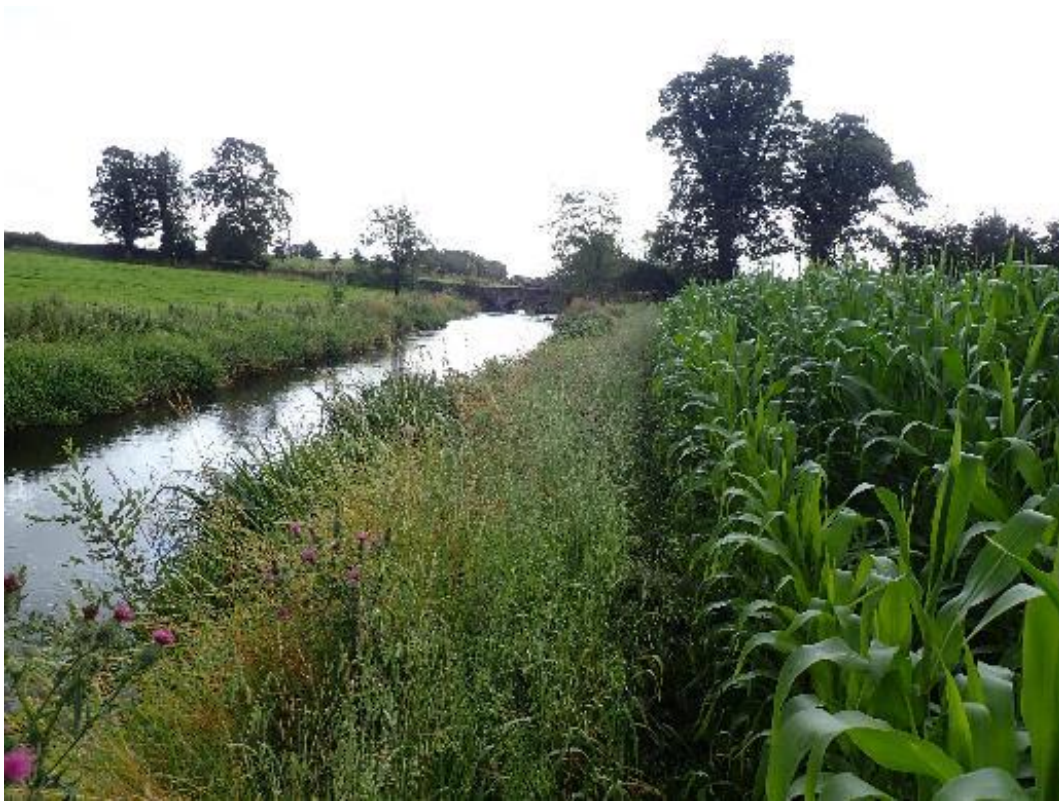
**Photo 70.** The same maize field a short distance above Castlering bridge, clearly showing the proximity of this crop to the river. An urgent dialogue is needed to encourage the farmer to give adequate protection to the river by leaving a much wider un-cultivated field margin.

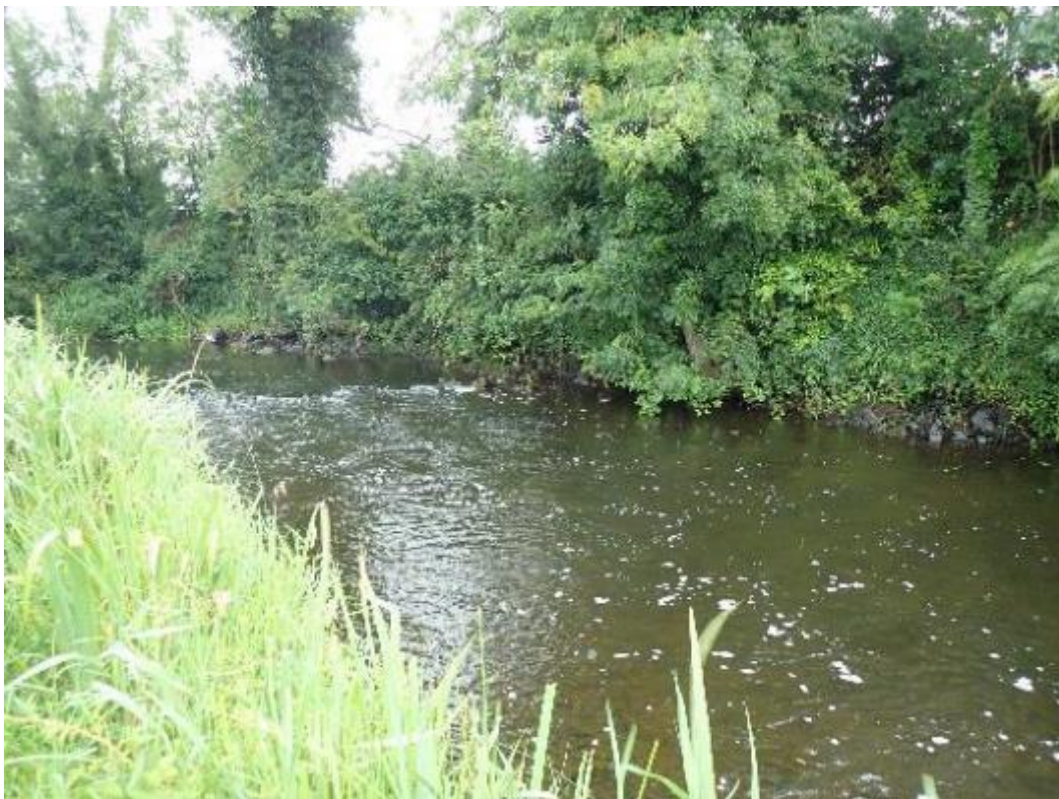
**Photo 78.** Another low stone weir should be notched adjacent to the far LB to create an attractive run down under the far bank cover.

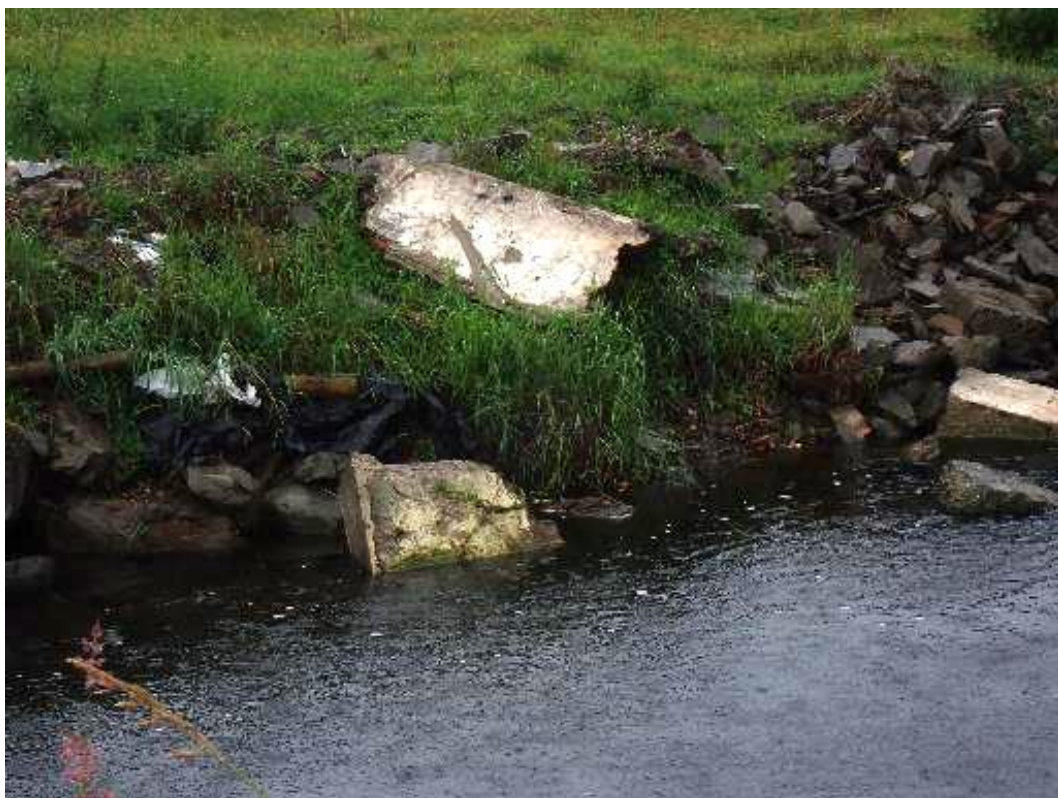
**Photo 83.** Discarded waste, stone and building materials presumably dumped in an ill-conceived attempt to reduce bank erosion pressures, initially caused by a lack of fencing and livestock access to the banks.

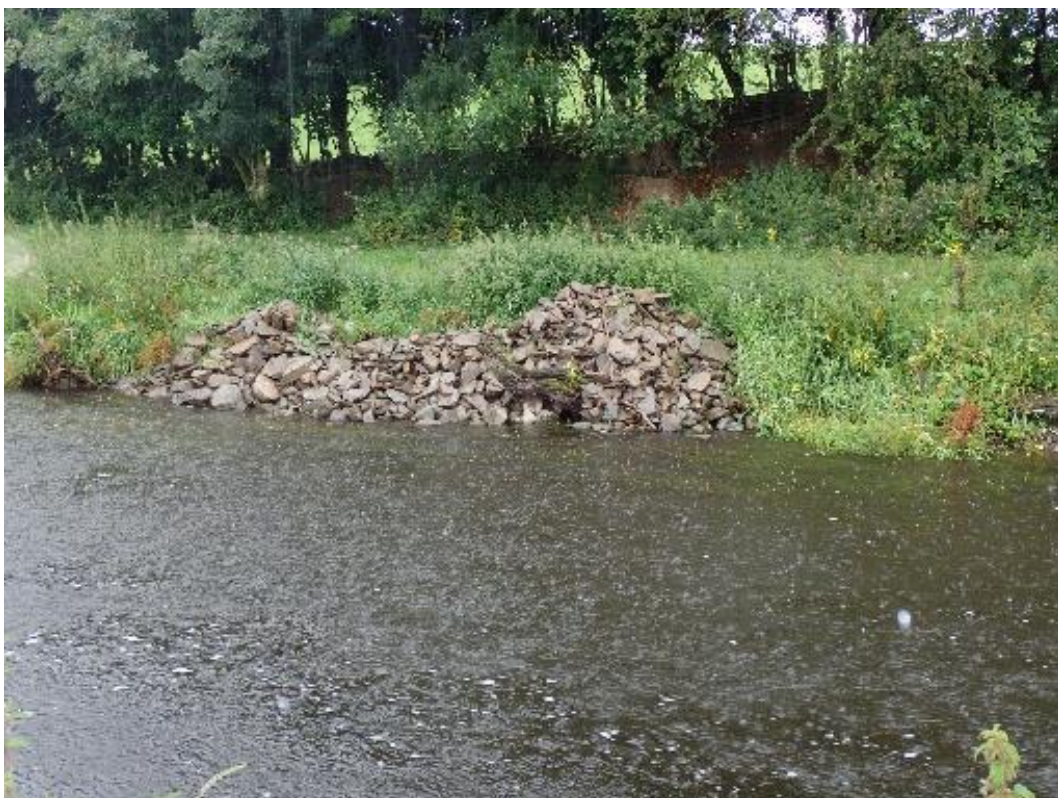
**Photo 84.** Further examples of inappropriate dumping of stone, presumably for ad hoc bank protection on a bank that doesn't really need protecting. It is possible these stones were removed from the riverbed.

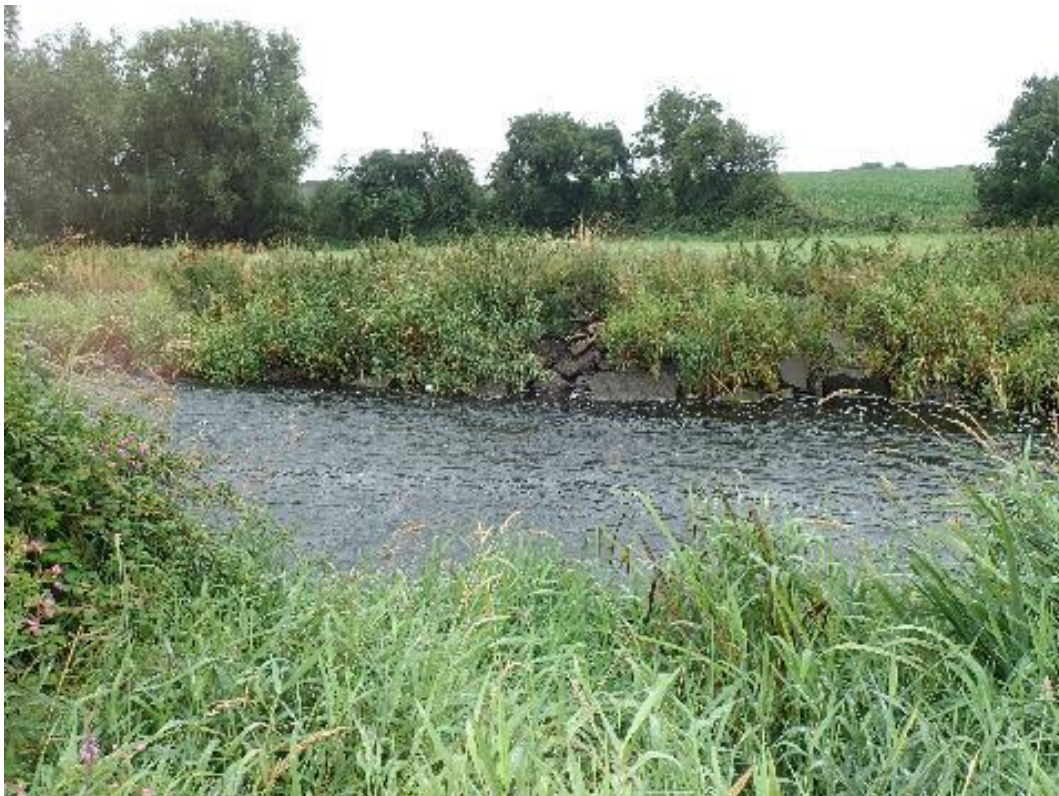
**Photo 97.** Yet more inappropriate bank protection, this time using waste concrete adjacent to the LB. It appears that the small meadow beyond has been raised and drained. Unfortunately, bank work like this will interfere with natural river processes. The reluctance to allow any lateral movement in this channel over the years has greatly degraded the river's natural morphological features, particularly deeper pool habitat, which are at a premium in this reach. This is a problem when the section is specially preserved for salmon fishing, where deeper fish-holding water is required.

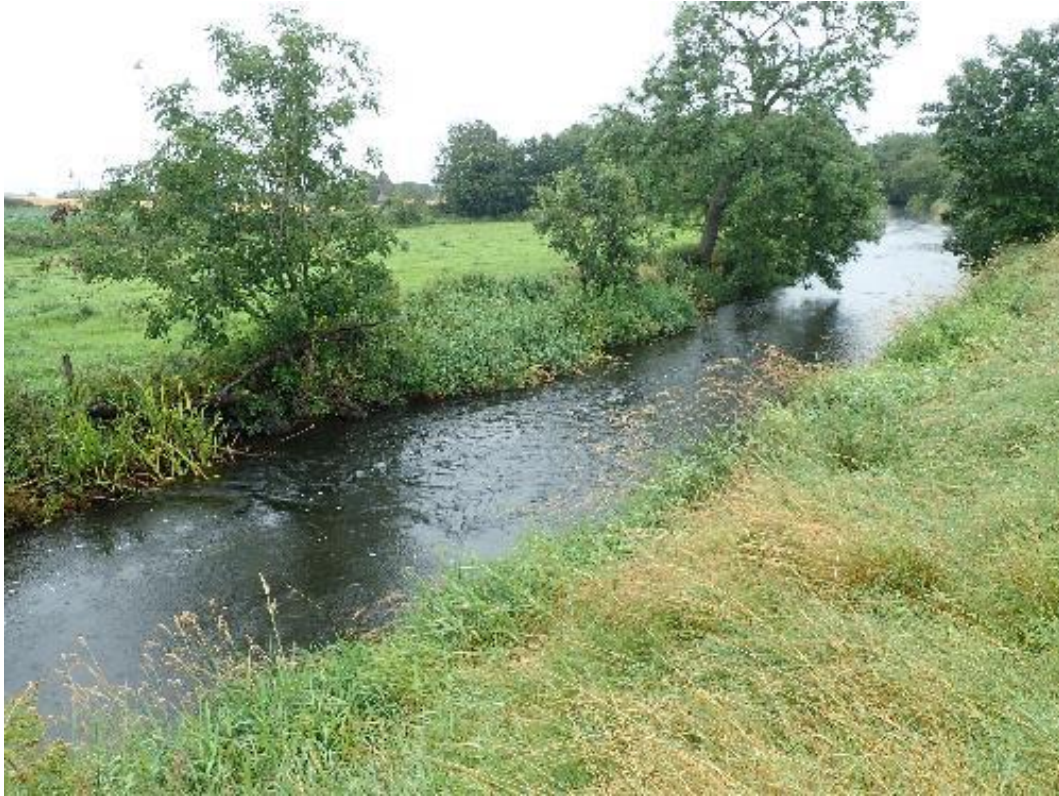
**Photo 98.** Long sections of this lower river are remarkably straight. This is un-natural for the mature phase of a river where the bed gradient has reduced. The lack of a twisting, meandering planform has left the channel remarkably bereft of deeper pool habitat. Local information suggests the river has not been dredged or modified in recent memory, although it is highly likely that the river is artificially modified, perhaps back in the 1800s or earlier.

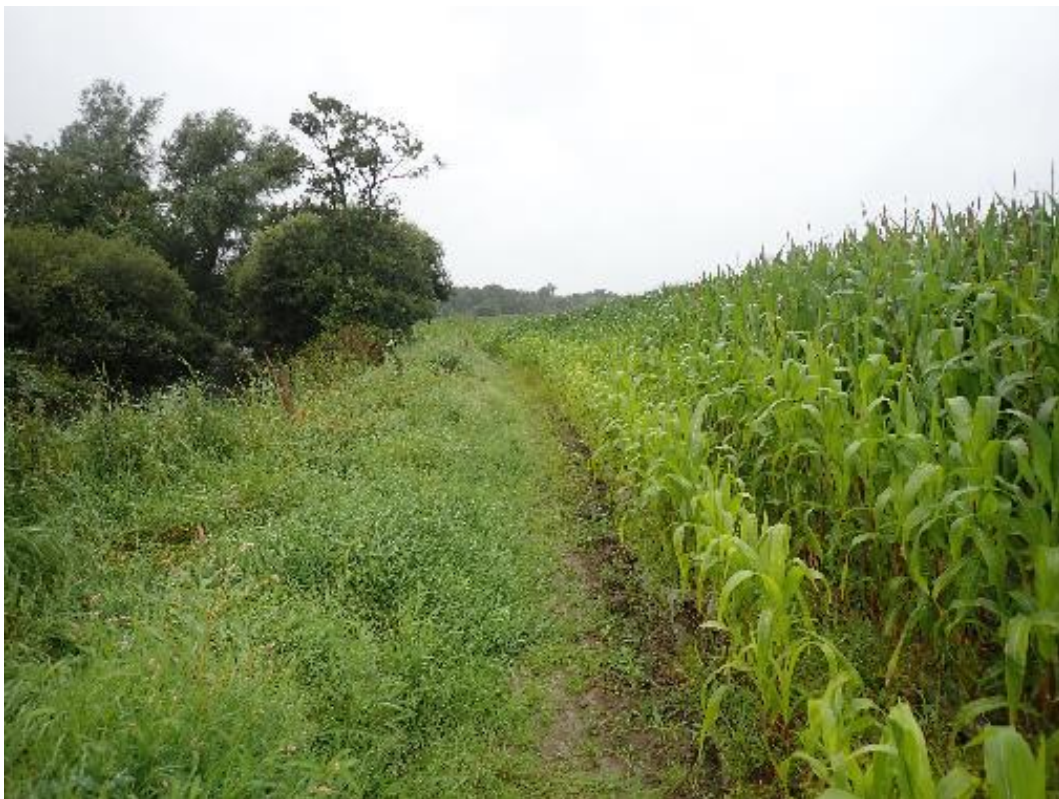
**Photo 103.** Again, in some areas, essential buffer zones between sloping arable fields and the river were completely missing (53.958030, -6.470700). In this case, a large field running down below the derelict manor house.

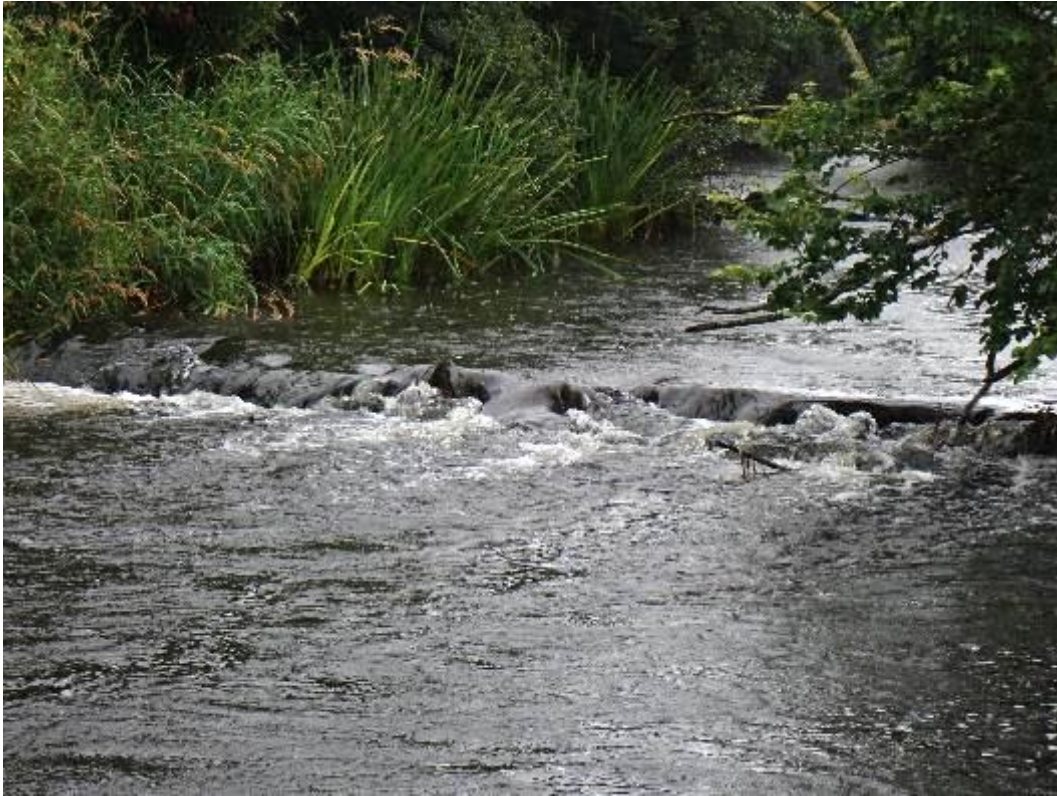
**Photo 104.** Yet another low stone weir is present on this reach (53.957936, -6.467749). Creating a 2m wide notch to be level is recommended.

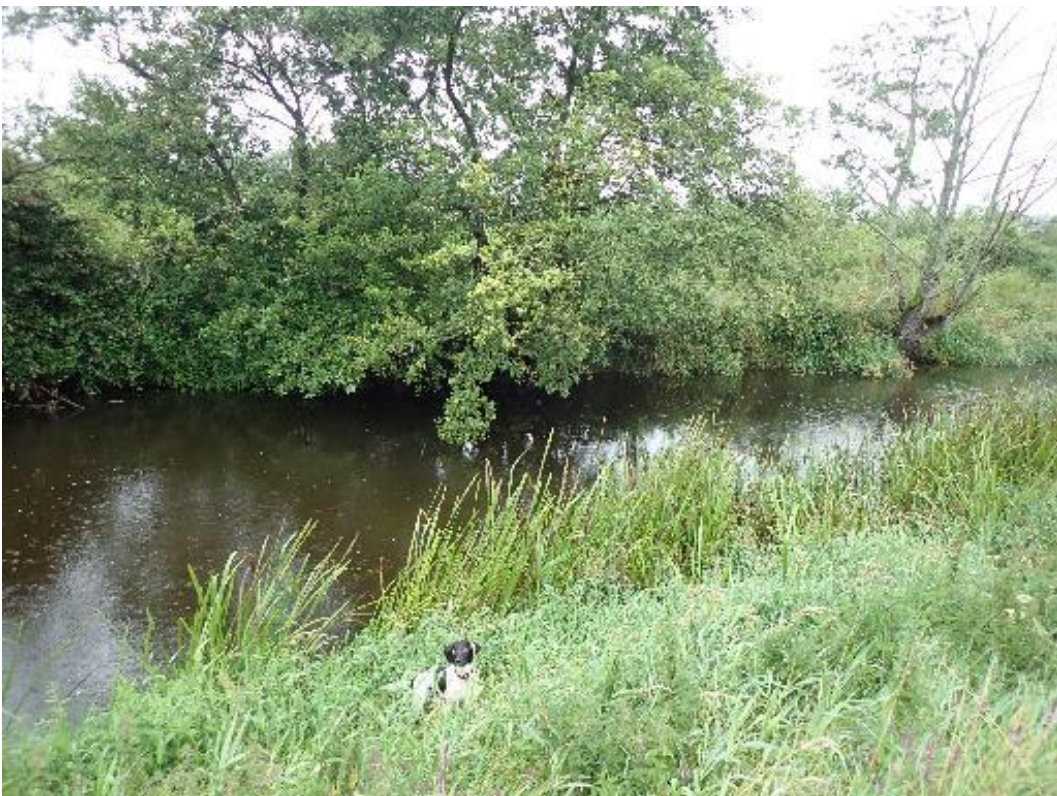
**Photo 105.** It was noted on this reach that alder trees in particular were suffering from disease (far right of picture). Consider coppicing trees with any early signs of *Phytophthora* (sooty marks on the bark) which is a fungal disease and particularly impacts river-side alders. Early coppicing can sometimes save the tree and its valuable root system.

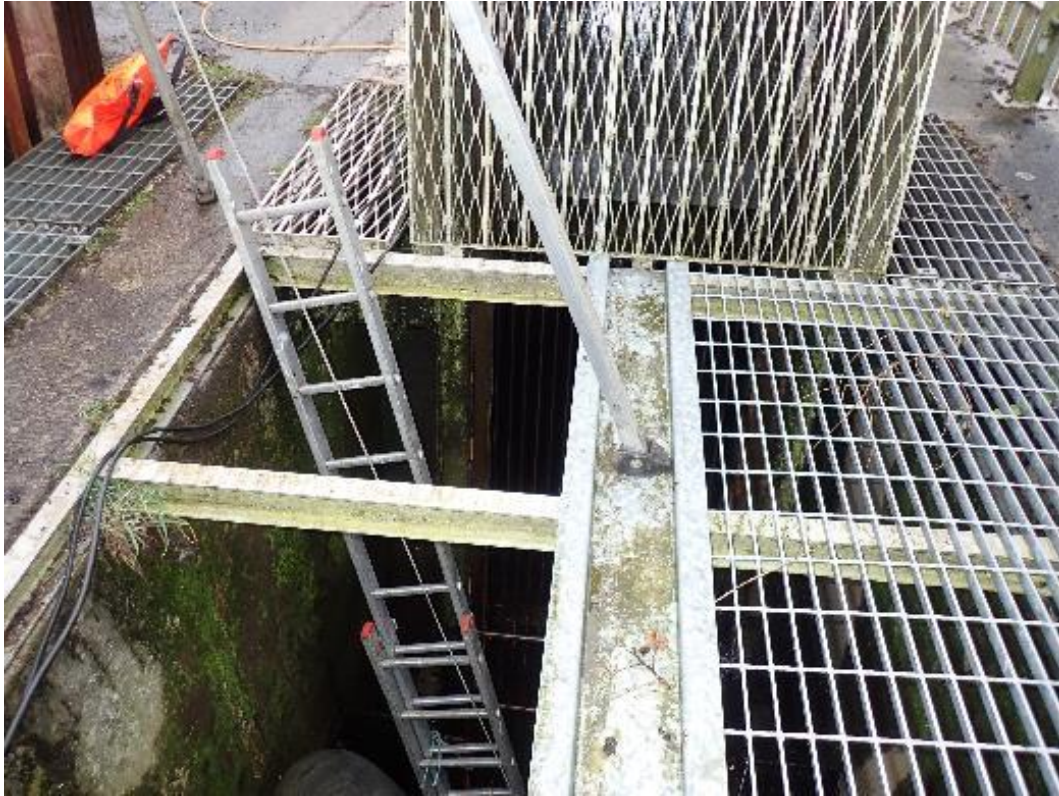
**Photo 106.** The chamber to the public water supply abstraction near the bottom of the beat (53.954030, -6.460303). The author was surprised to find that there were only trash screens and appeared to be no fish barriers or behavioural screens installed. It is highly likely that this intake will be entraining smolts and eels on migration. Dialogue is required to establish if screens are fitted and if not, lobby for urgent mitigation.

impact on this sensitive stretch of the river. The provision of secondary screening of the structure, in addition to simple trash screens, is essential and likely to be required by law. There is a chance that these screens are in place, or are planned; however, they were not evident during this walk-over survey. Rotating drum-style wedge-wire screens are the industry standard for abstraction points on rivers that support migratory salmonids and eels. It is therefore recommended that all angling clubs call for urgent improvements to screening.
