## Walkover Assessment

## River Fane

5th-7th/08/2019

Undertaken by the Wild Trout Trust

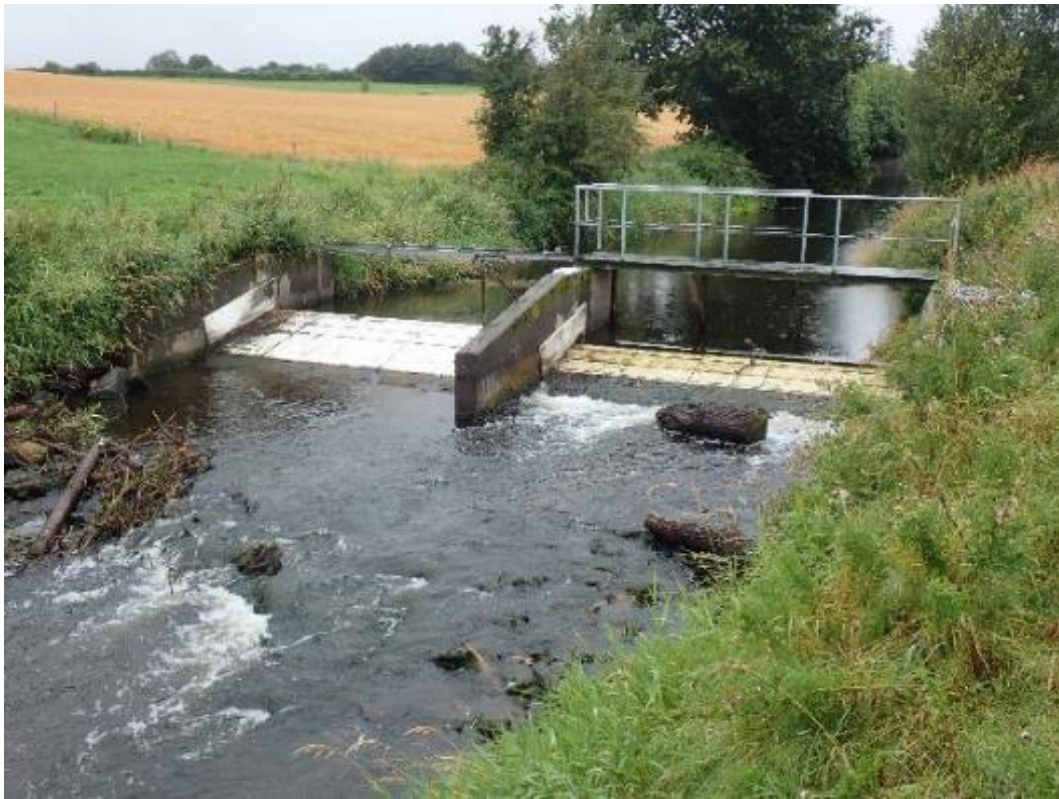
**Photo 109.** The crump weir/fish counter located a short distance downstream of the abstraction point (53.9536604, -6.4580669) raises a number of questions:

Larger migratory salmonids will be able to negotiate the fish counter during higher flow conditions, when the water depth over the weir increases and elevated tail-water heights reduce the step over the weir. But prolonged periods of even normal flows from say mid-April through to September, will render this structure a massive challenge to fish passage, upstream migrating fish deterred and forced to simply drop back downstream. Any such delays potentially put migratory fish at increased risk from stress and predation and may prevent them from reaching their destination within the vital timing window. The high potential for increased predation on downstream migrating juvenile salmonids delayed upstream of the weir, within the long, impounded reach must also be considered.

Good quality data gathered from fish counters can be of enormous value to regulators and clubs. On the Fane, it is not apparent if such data are available and shared or, indeed, if the counter is fully functional. It is recommended that the clubs open a dialogue with the regulators to explore options for gathering fish population data and improving information sharing. Furthermore, the weir at the counter is a significant barrier to free fish migration and will significantly impact downstream sediment transport, over time creating siltation problems for the u/s reach. We suggest that the regulators be encouraged to consider alternative fish population monitoring options that do not require a significant step in the bed height and obstruction of the river.

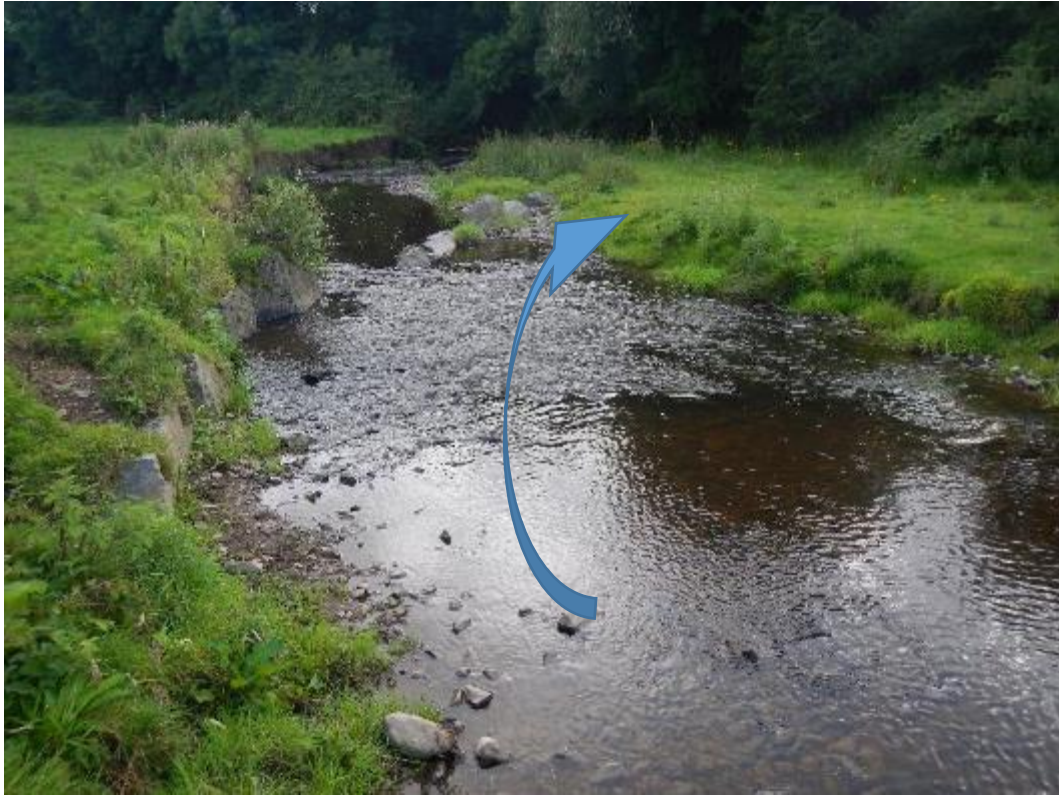
**Photo 123.** Around 54.139052, -6.640593, what appears to be a weir is actually the remains of failed bank protection, where the river has broken through from its previous course (blue arrow). Flow is now being directed into the bank by the failed revetment which acts as a flow deflector, which will be a particular issue at high flows. Consequently, the bank d/s is eroding at an accelerated rate.

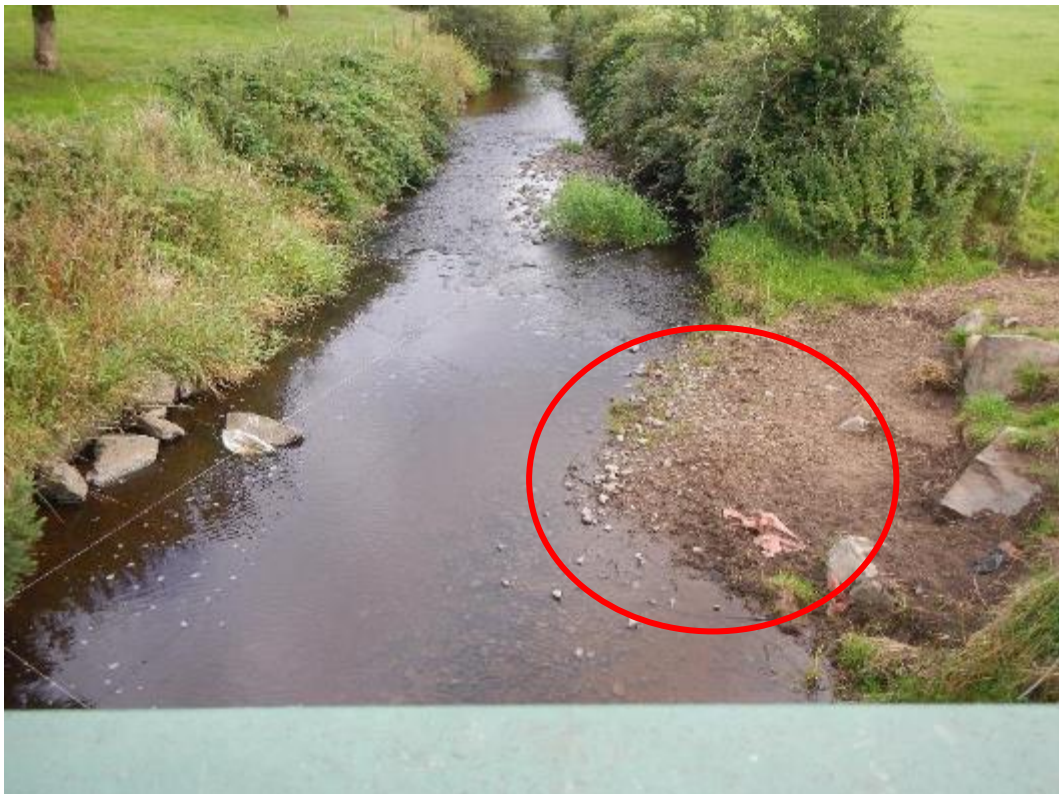
**Photo 124.** D/s of the road bridge (54.13813, -6.639995), a drinking bay creates typical bank erosion issues. Interestingly, the erosion and widening at that point has subsequently led to deposition of fine material supplied from u/s (red circle), highlighting the over-supply of fine material resulting from erosion from u/s too. Note the very silty bed and smothered gravel.

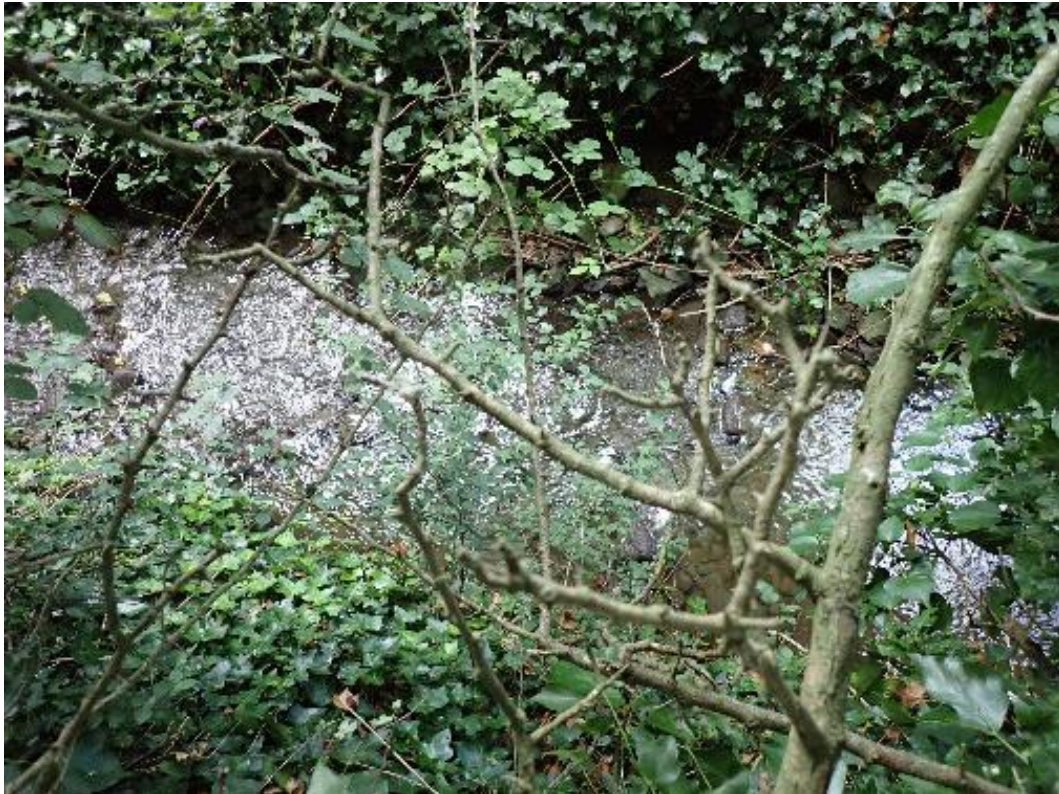
**Photo 136.** The Halftate was inspected at various locations in the meadows rising up above the Fane confluence at 53.972776, -6.500684. The stream has been dredged and straightened and is set well down in a deeply-incised channel, making inspection and assessment of habitat quality difficult.

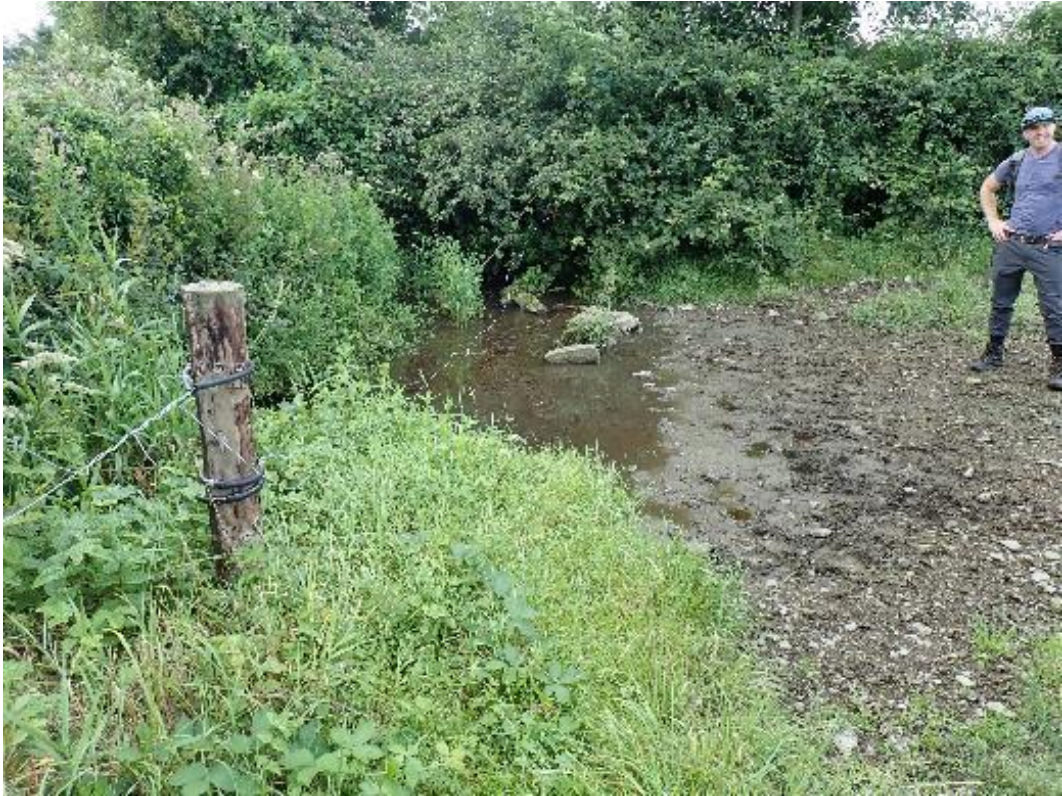
**Photo 138.** Another example where cattle have access to the stream, a short distance from the Fane confluence. Large densities of shrimp *Gammarus pulex* were found here, which often indicates enrichment, potentially even significant eutrophication.
