## Walkover Assessment

## River Fane

5th-7th/08/2019

Undertaken by the Wild Trout Trust

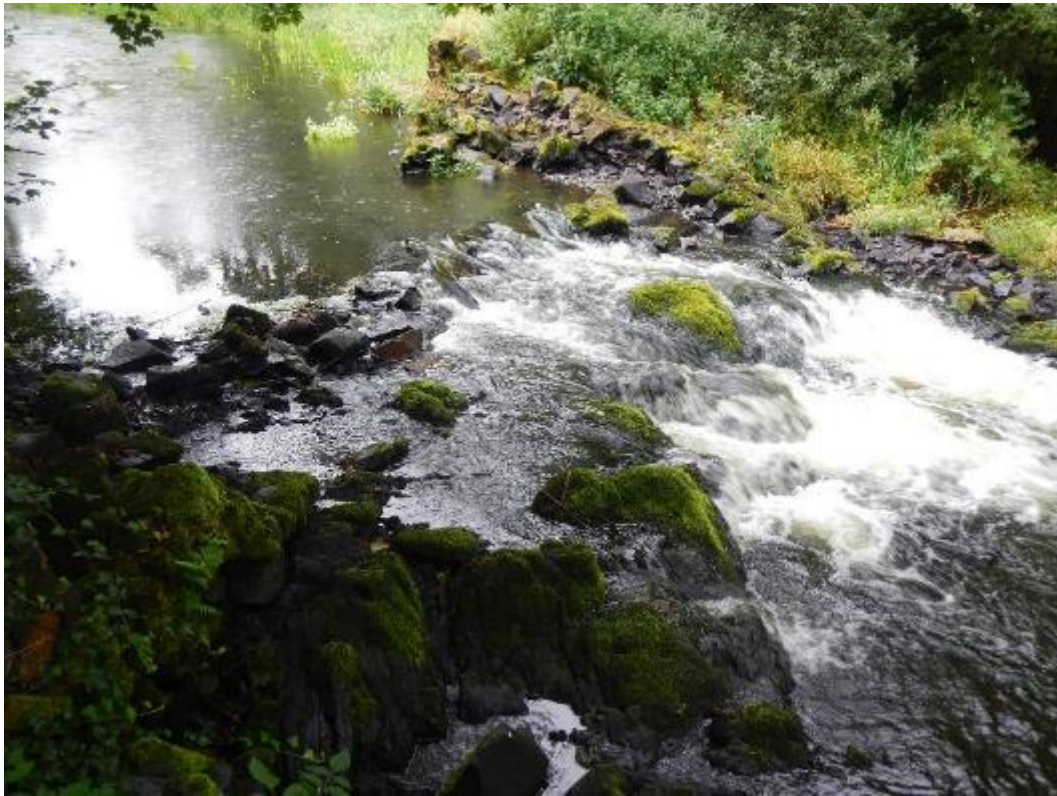
**Photo 1.** A spot-check was undertaken on the upper River Fane, visiting a collapsed weir (54.059055, -6.647277). The underlying bedrock creates a small natural obstruction but passability is made worse by the weir, and subsequent attempts to rebuild it. Ideally, the manmade part of this structure should be removed or allowed to fully disintegrate.

Photo 1	1/2	54.059055, -6.647277	Ensure that the obstruction is not rebuilt.
Straight, uniform channel

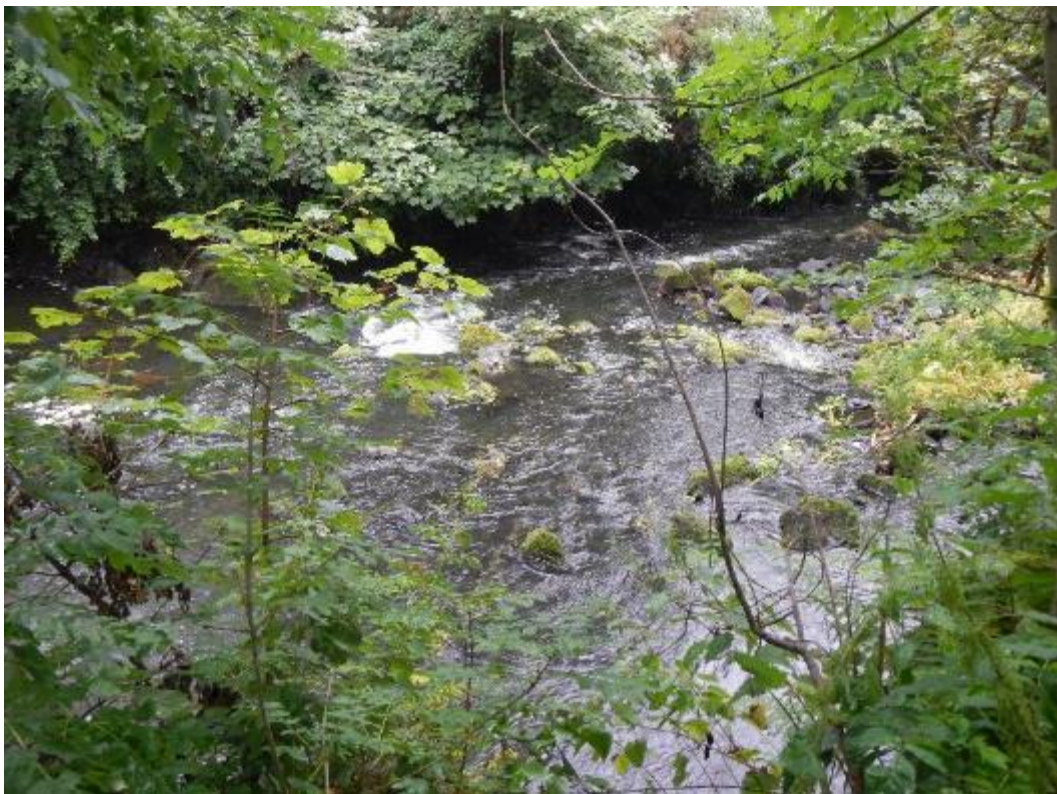
**Photo 2.** The section immediately u/s of the Corrasmore Road bridge at Cullaville is bedrock with good habitat for fry and parr and potential deeper pocket water for occasional larger adult fish. The deciduous tree-lined banks provide good shade and cover.

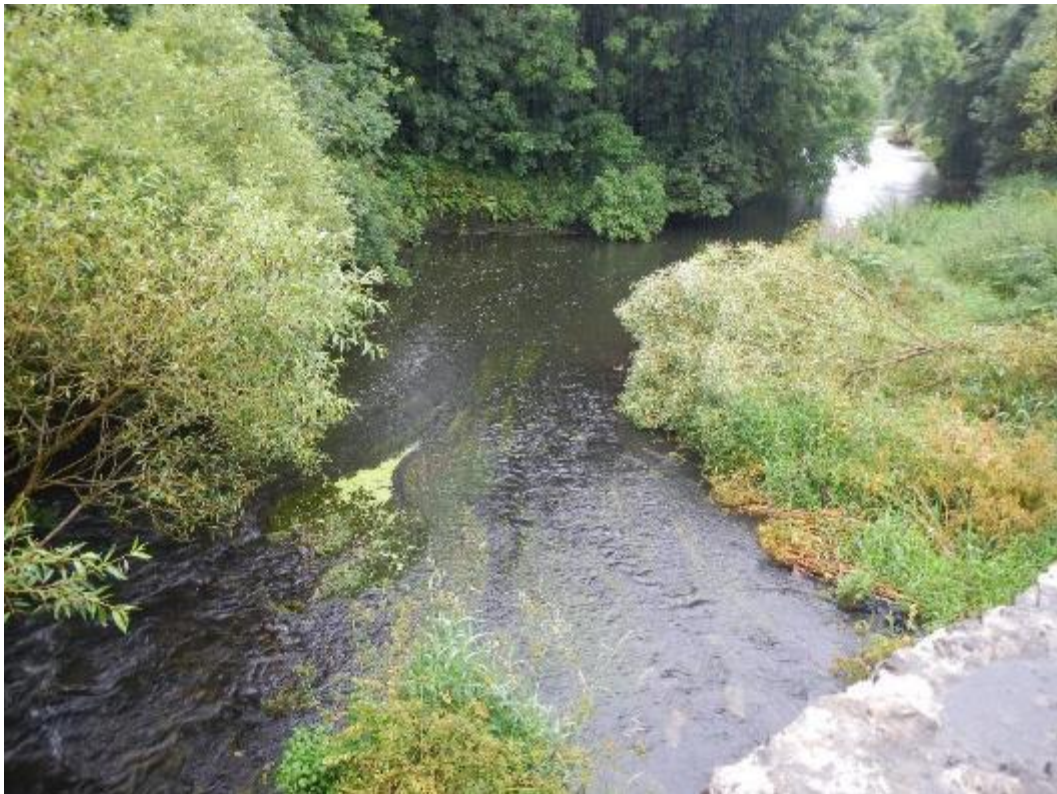
**Photo 3.** D/s of the bridge, the gravel bed facilitates a pool and riffle sequence with deeper adult fish holding water; again, complemented by low-level and trailing cover.

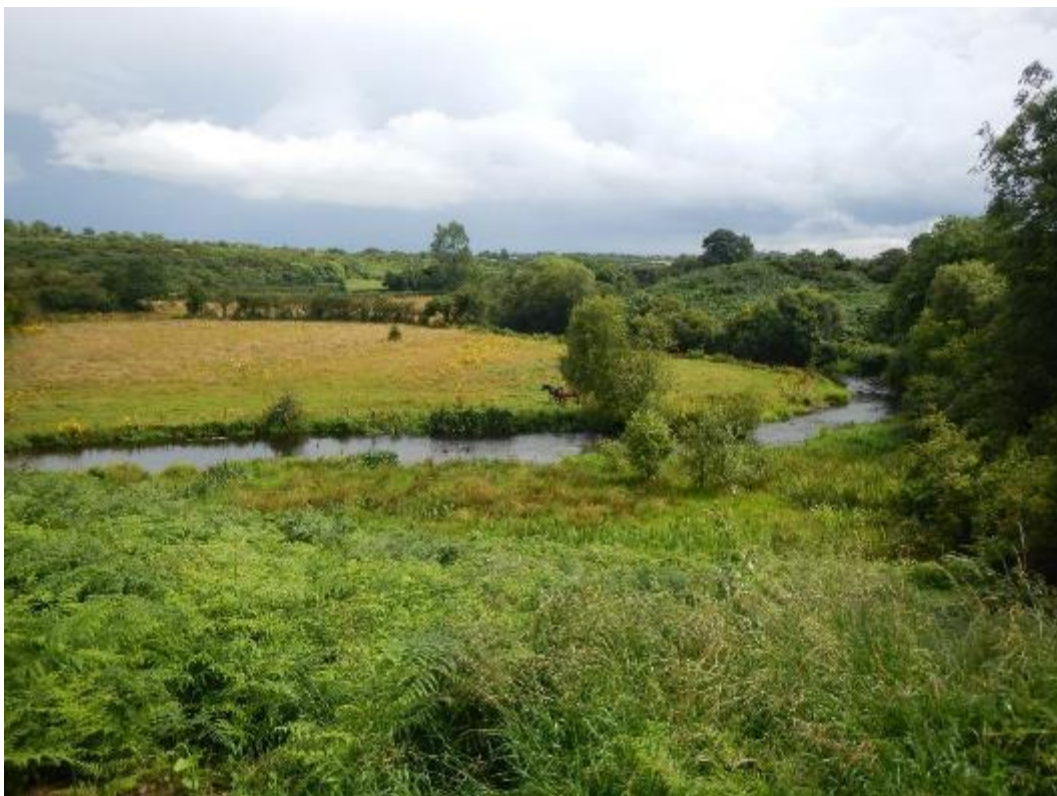
**Photo 4.** The next section visited (54.0444867, -6.6368217) consists of a short sinuous section of channel, where the increased flow diversity creates varied bed scour and the bends provide good, deeper adult fish-holding water; something that is scarce in many areas of the Fane.

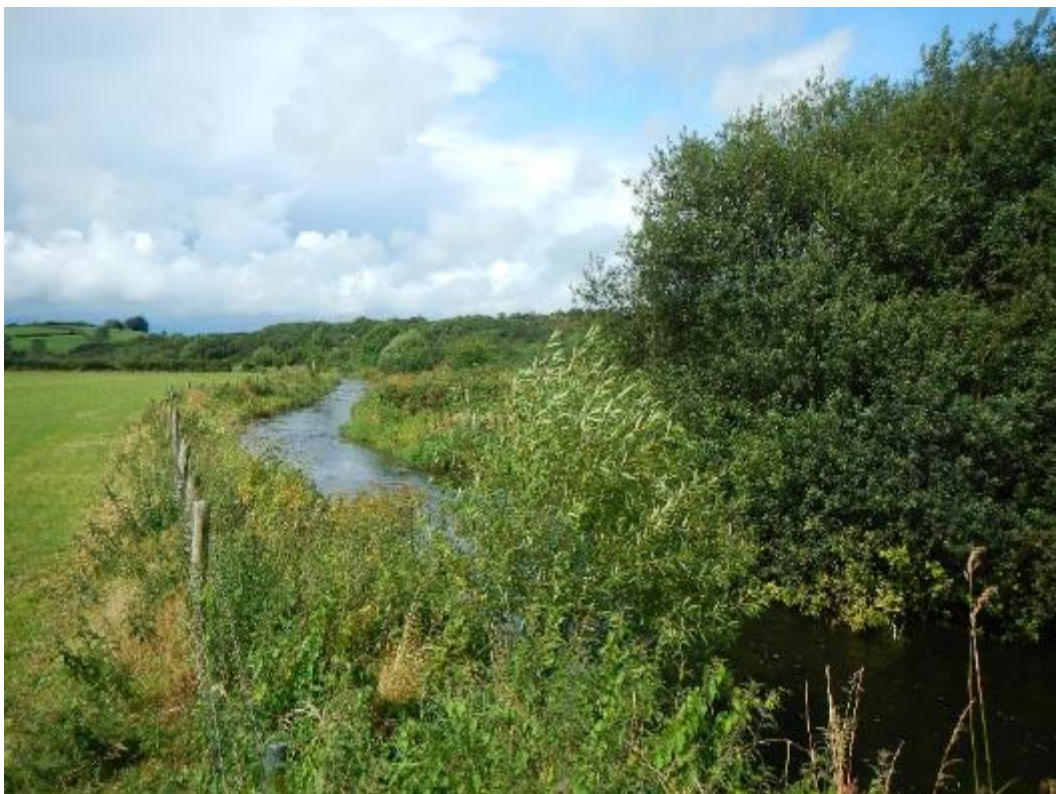
**Photo 6.** Although straight (suspected to have been straightened), the well vegetated channel margins provide good cover for salmonids, particularly fry and parr. The value of bankside buffer fencing in achieving this should not be overlooked and it is in the interest of anglers to report any breaches of the fence to the owner and/or tenant if they occur.

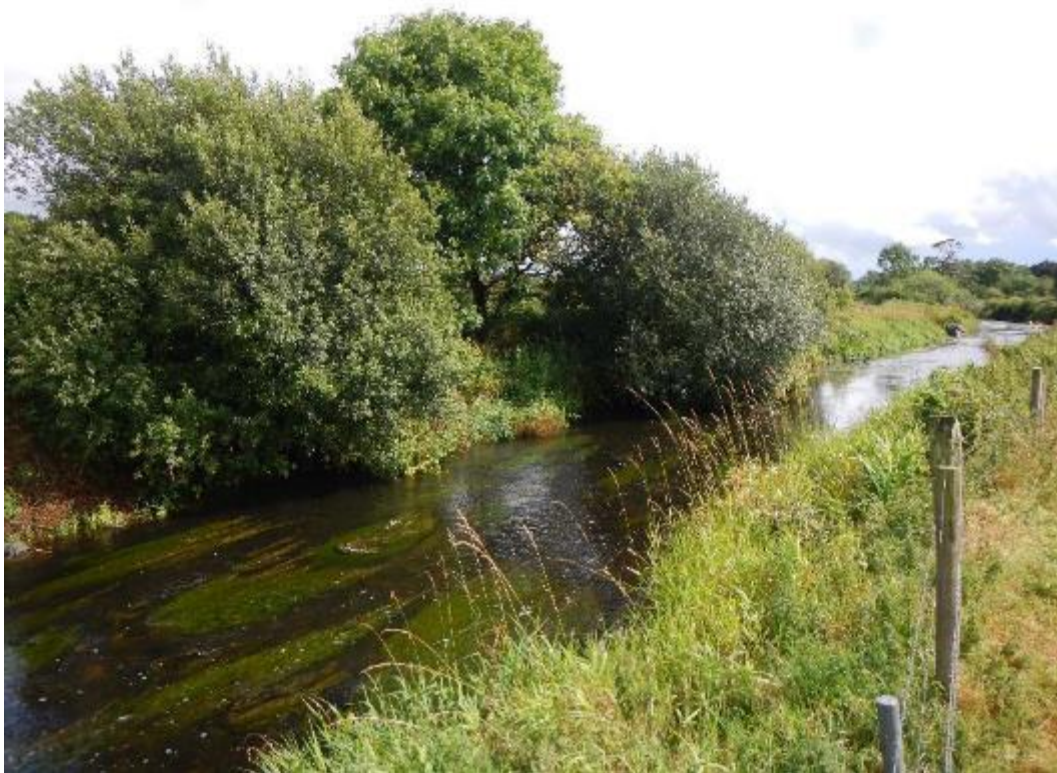
**Photo 7.** Bushy willows encroaching into the channel help focus flows and create bed scour that will help to develop valuable deeper areas.

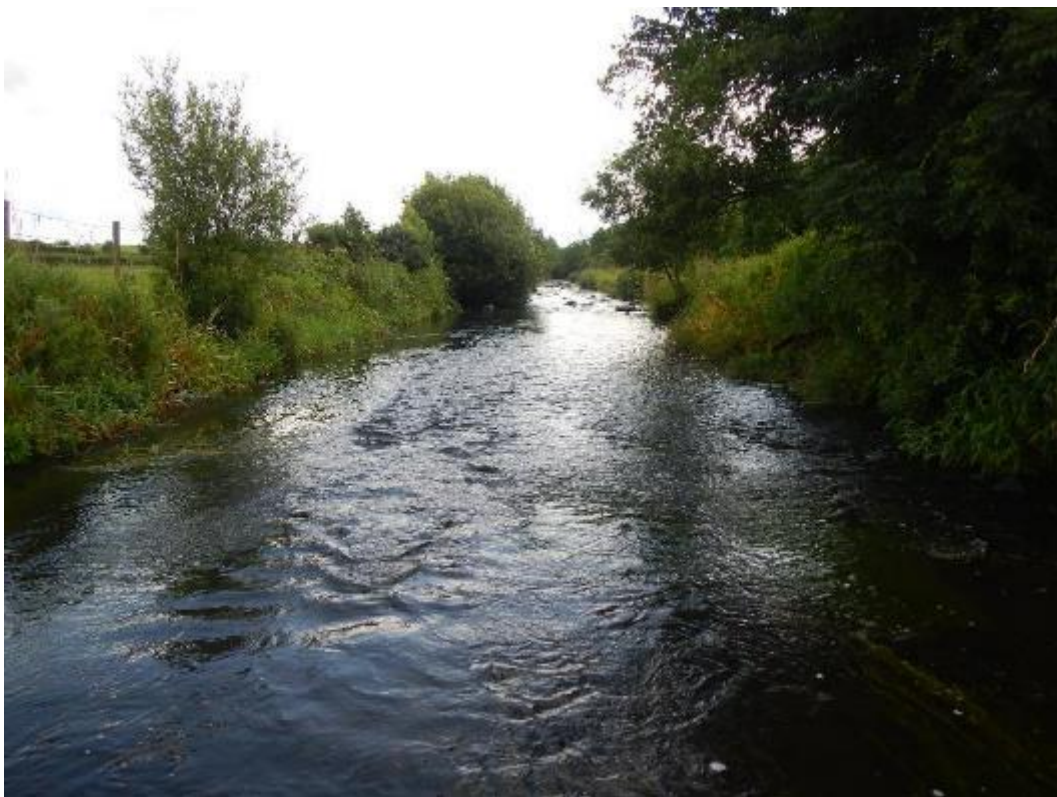
**Photo 8.** Particularly in the more open, straighter sections, laying the occasional willow into the channel, or planting additional shrub willow species (goat willow or grey willow) on alternating banks to encourage the flow to kick from one bankside to the other would be beneficial (around 54.039103, -6.626745 to 54.0352583, -6.6224367). From around this point, there is also potential for a more aspirational restoration scheme to reinstate a meandering form to the channel using the rough land adjacent to the RB.

Photo 8	2	54.039103, -6.626745 to 54.0352583, -6.6224367	Planting and laying the occasional willow shrub.  <b>From around this point, there is also potential for a more aspirational channel restoration scheme to reinstate some of the lacking meanders to the channel in the rough land to the RB.</b>
Poaching of a tributary (LB)

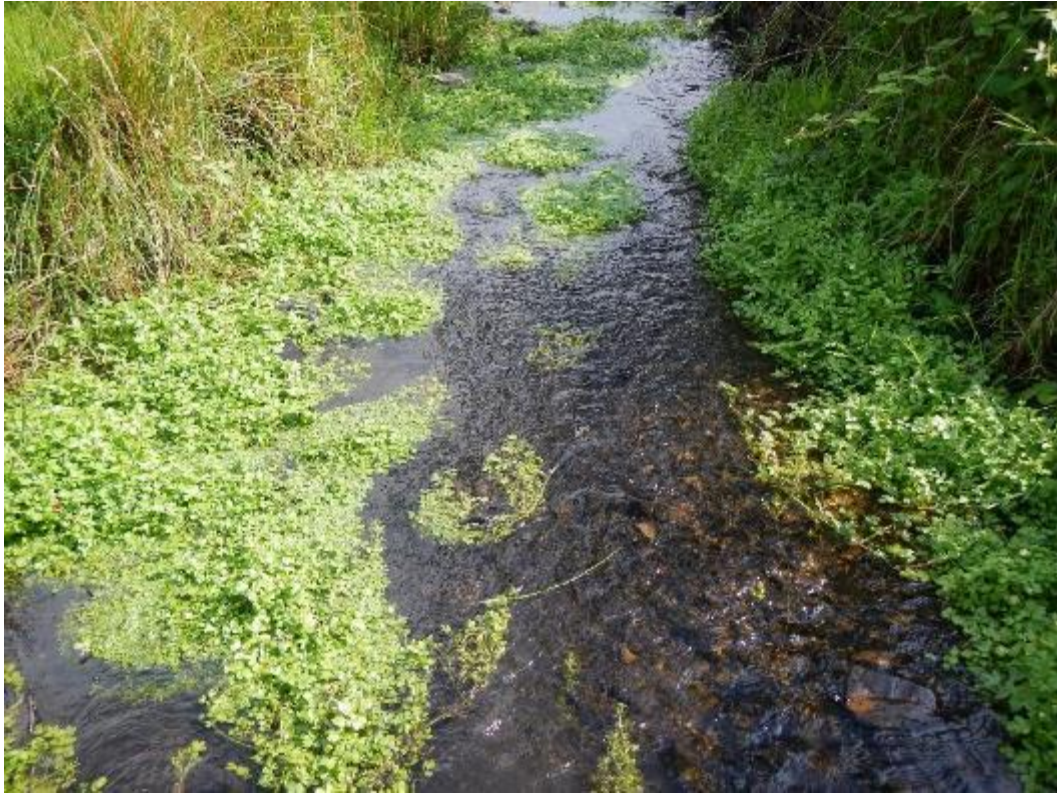
**Photo 9.** A small LB tributary provides good potential salmonid spawning and juvenile habitat and should be regularly monitored to ensure protection from the impacts of livestock/agriculture (54.03651, -6.623628).

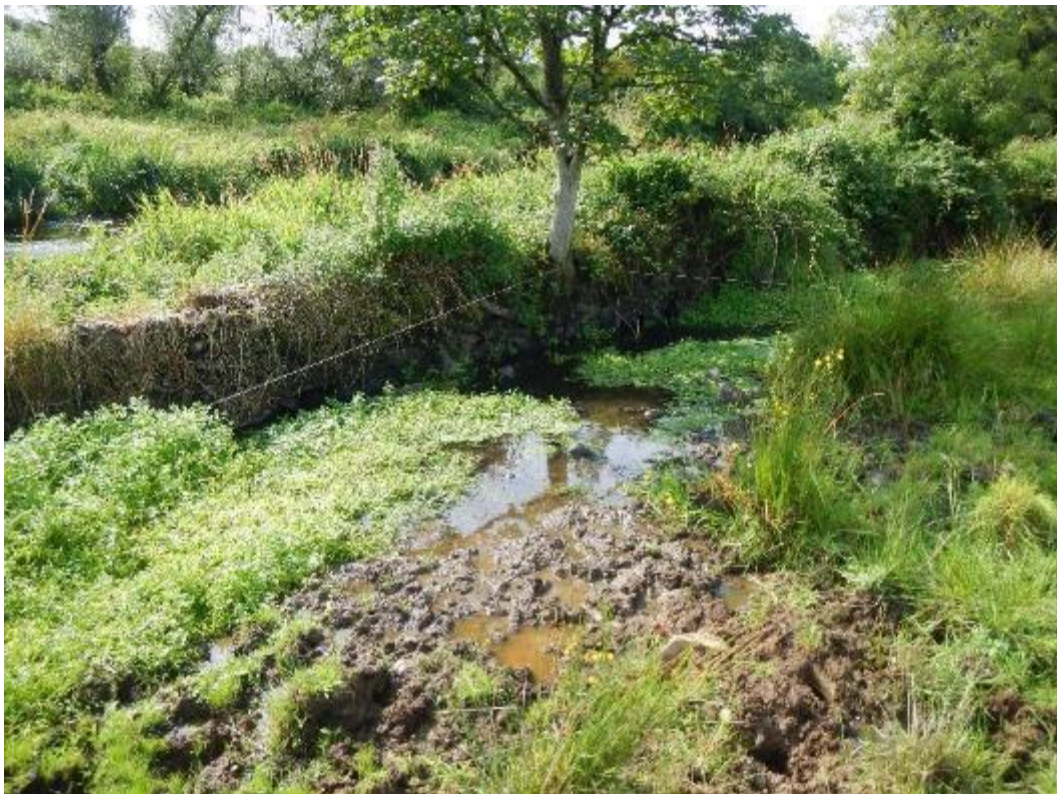
**Photo 10.** Use of the tributary for livestock watering is creating issues from poaching and siltation (54.0364133, -6.6234633). Excluding livestock and employing alternative watering options such as pasture pumps would be highly beneficial.

Photo 10	1/2	54.0364133, -6.6234633	Replace the drinking bay with an alternative watering source (pasture pump, solar pump, ram pump etc).

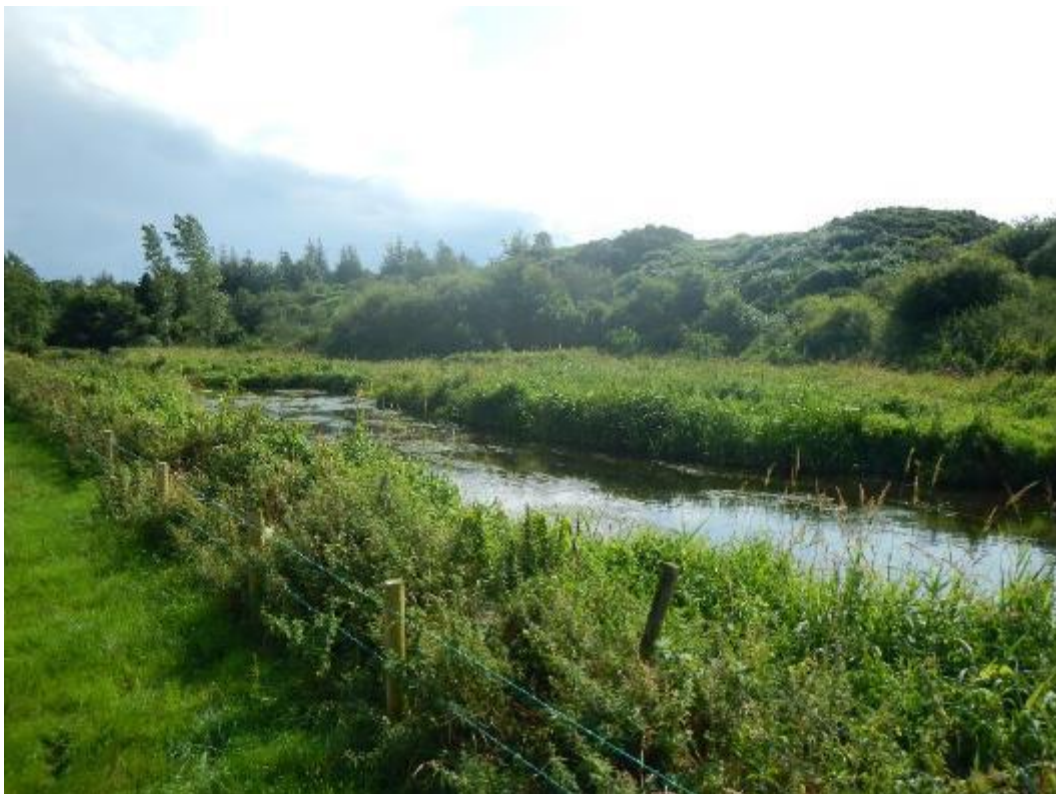
**Photo 11.** The generous buffer on the RB (right of shot) could be utilised for river restoration to re-meander the channel (54.0352583, -6.6224367).

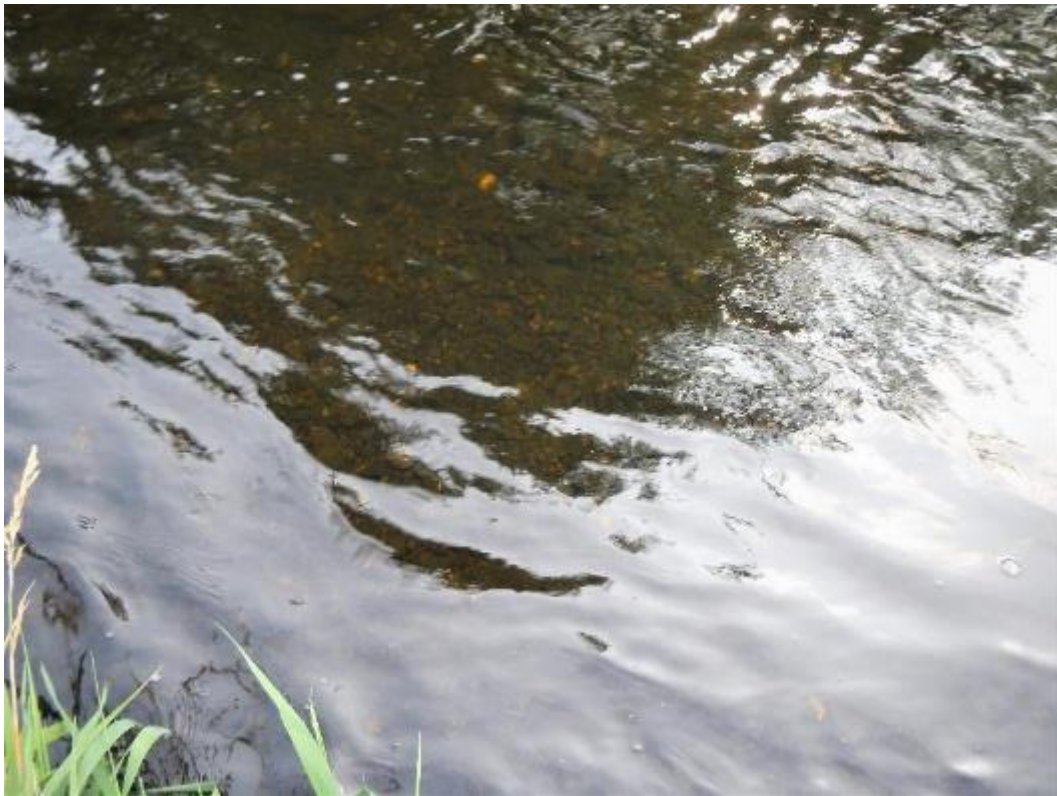
**Photo 13.** Potential salmonid spawning substrate (c. 5-40mm for trout c. 40-60mm for migratory salmonids) was observed d/s in areas with more natural sediment transport. For gravels to be of value for spawning they must be able to move within the channel during flood events, sorting the material and allowing fine sediment to be flushed away. This ensures that flow is able to percolate through the gravel to oxygenate incubating eggs.

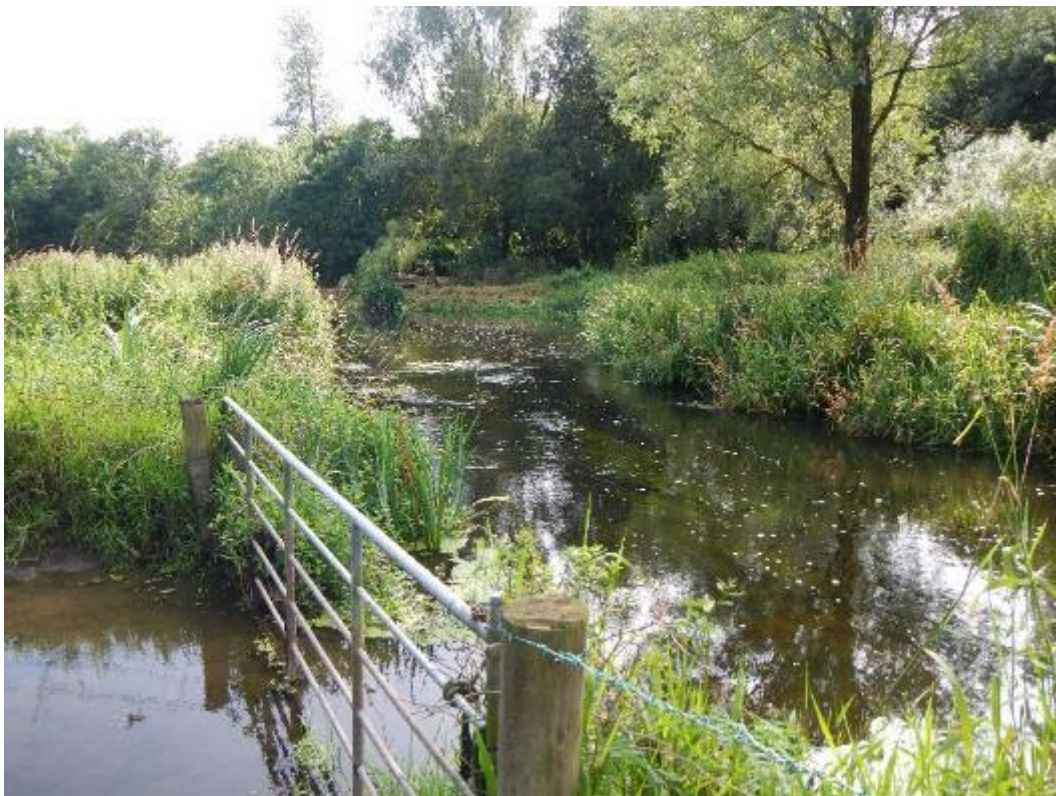
**Photo 15.** Again, wherever the river's natural bends remain, valuable pools and deeper water habitat is usually available, providing adult trout holding areas. Larger fish will not spend all of their time in the deeper water but generally require a deeper bolthole not too far from their shallow water lies.

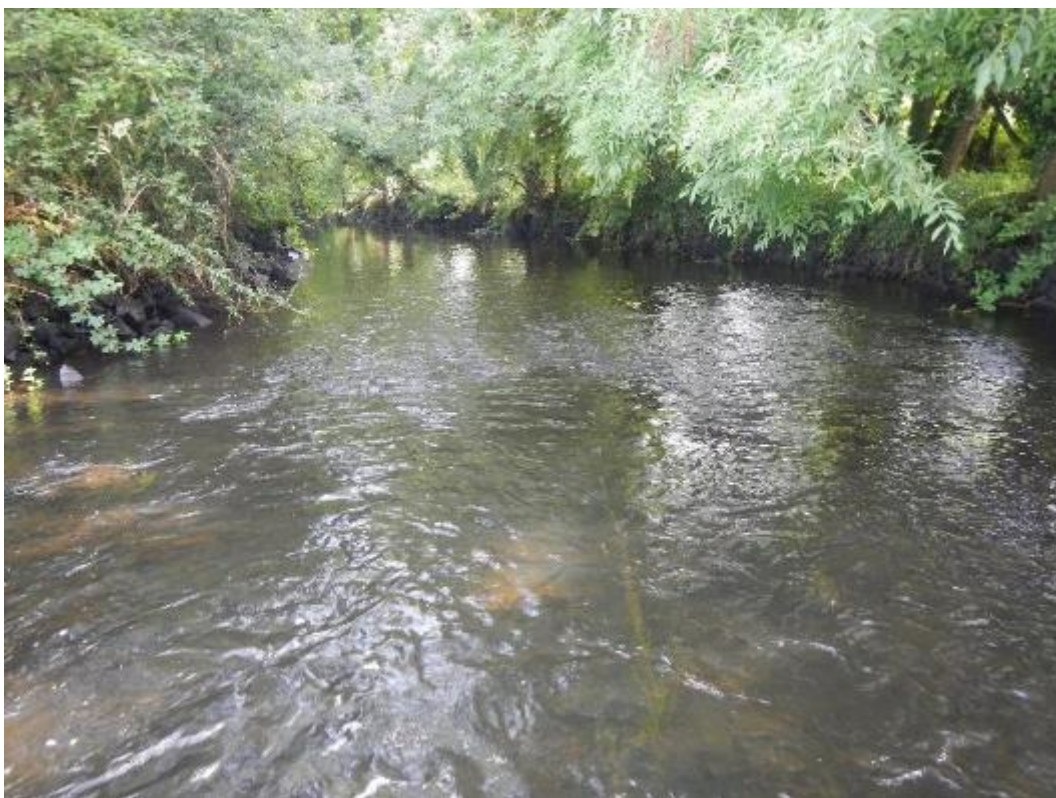
**Photo 16.** D/s the channel splits in two, with the main flow passing down what is suspected to be an artificially straightened section. Trees consolidate the RB and deflect scour downwards into the bed to create depth. The low cover they provide also improves the habitat. However, a more naturally sinuous channel would provide greater flow, depth and habitat diversity, and therefore improve the overall habitat quality.

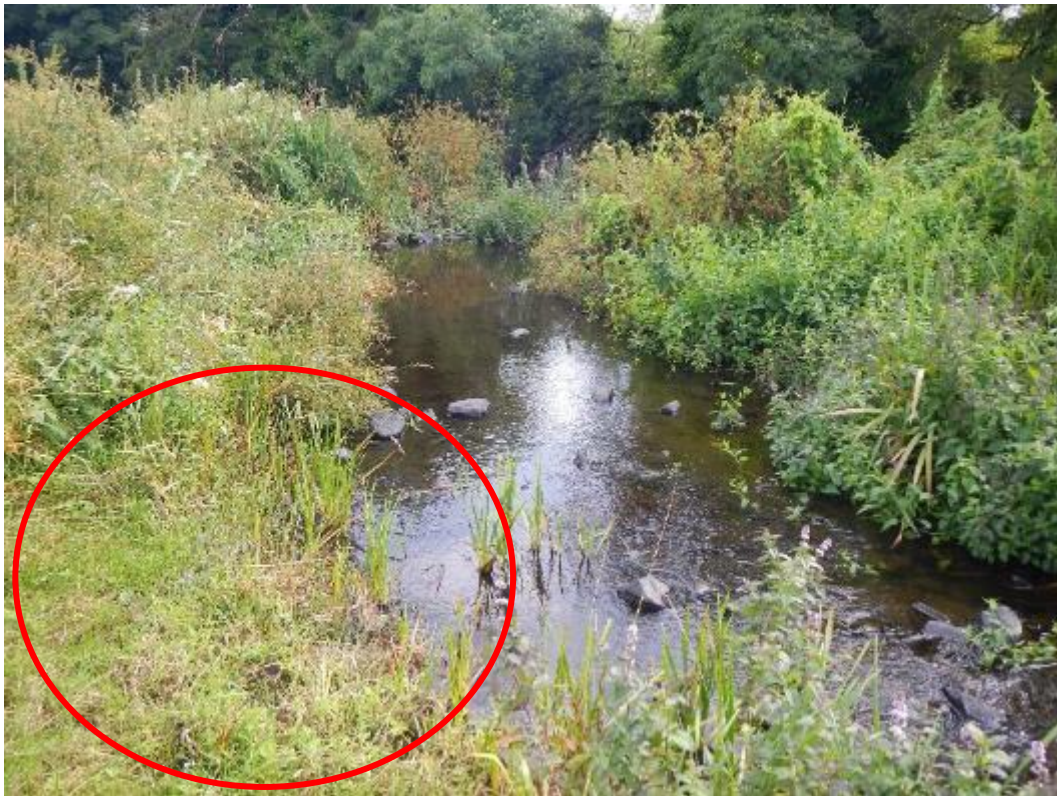
**Photo 17.** At 54.0310733, -6.6191033, attempts have been made to block a more sinuous side-channel and it now only carries a small percentage of the flow. It would be better to encourage more flow through the side-channel to reinstate bends and increase channel sinuosity. As a minimum, the stones blocking the side channel could be removed to encourage more flow through and improve it as juvenile habitat. Livestock access along the side-channel impacts on the bankside vegetation (red circle).

<p><b>Photo 17</b></p>	2/3	54.0310733, -6.6191033	<p>The obstructions at the u/s and d/s end of the side-channel could be reinstated, with flow prioritised there to create a more sinuous channel.</p> <p>As a bare minimum, excluding livestock from the side-channel would be beneficial.</p>
Open section could be improved by increasing in-channel structure

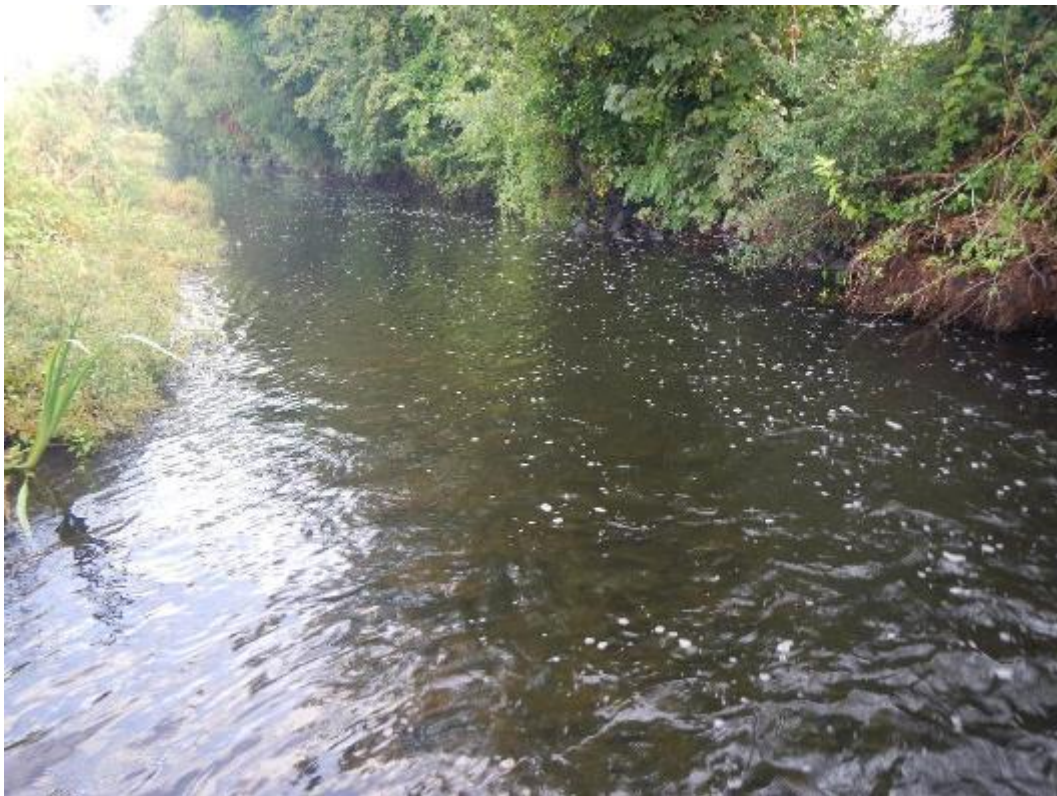
**Photo 18.** The straight d/s to the next split/side-channel provides some reasonable habitat but could be improved with increased sinuosity/bends and a more varied bed profile. Laying a tree or creating a lodged flow deflector here would be beneficial in breaking up the long open stretch (see Recommendations).

<p><b>Photo 18</b></p>	3	54.0310733, -6.6191033 to 54.029942, -6.616602	<p>Following guidelines set in the habitat techniques section, identify suitable trees for hinging or coppicing to provide material for a lodged flow deflector.</p>

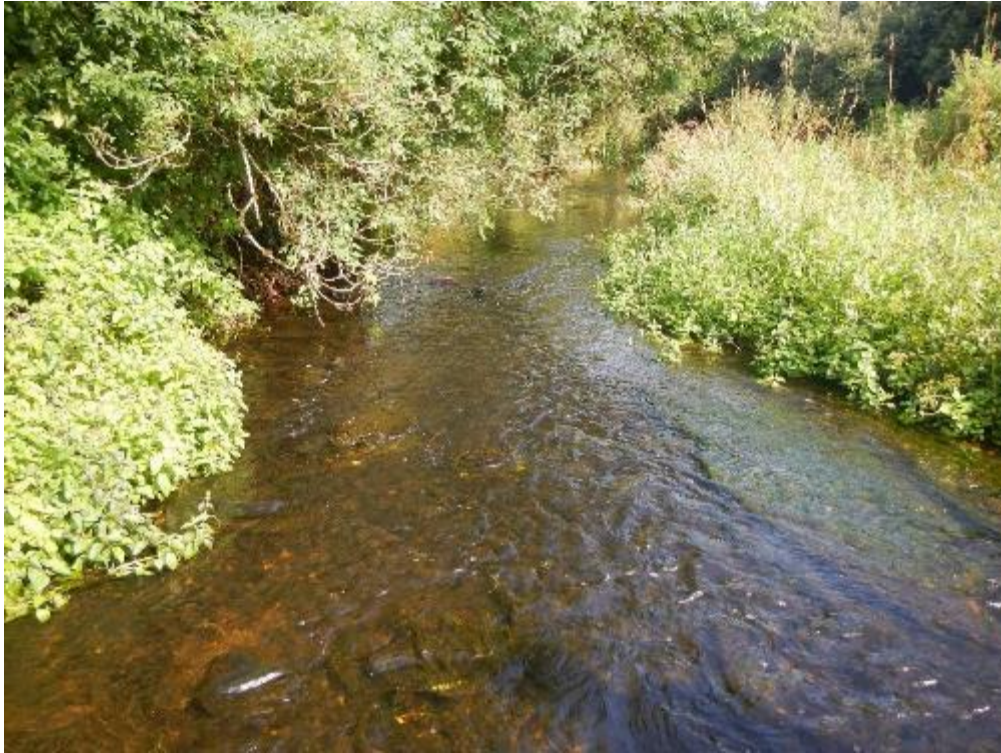
**Photo 19.** Another side-channel d/s (54.0352583, -6.6224367) carries more flow and consequently supports better quality habitat. Again, there is potential to encourage more flow down this channel to reinstate bends to the river. This could be achieved over time by removing the stone that partially blocks the u/s and d/s end of the side-channel and installing more features within the current, straight main flow channel to divert flow into the side-channel.

<p><b>Photo 19</b></p>	2	54.0352583, -6.6224367	The obstructions at the u/s and d/s end of the side-channel could be reinstated, with flow prioritised there to create a more sinuous channel.
Small weir

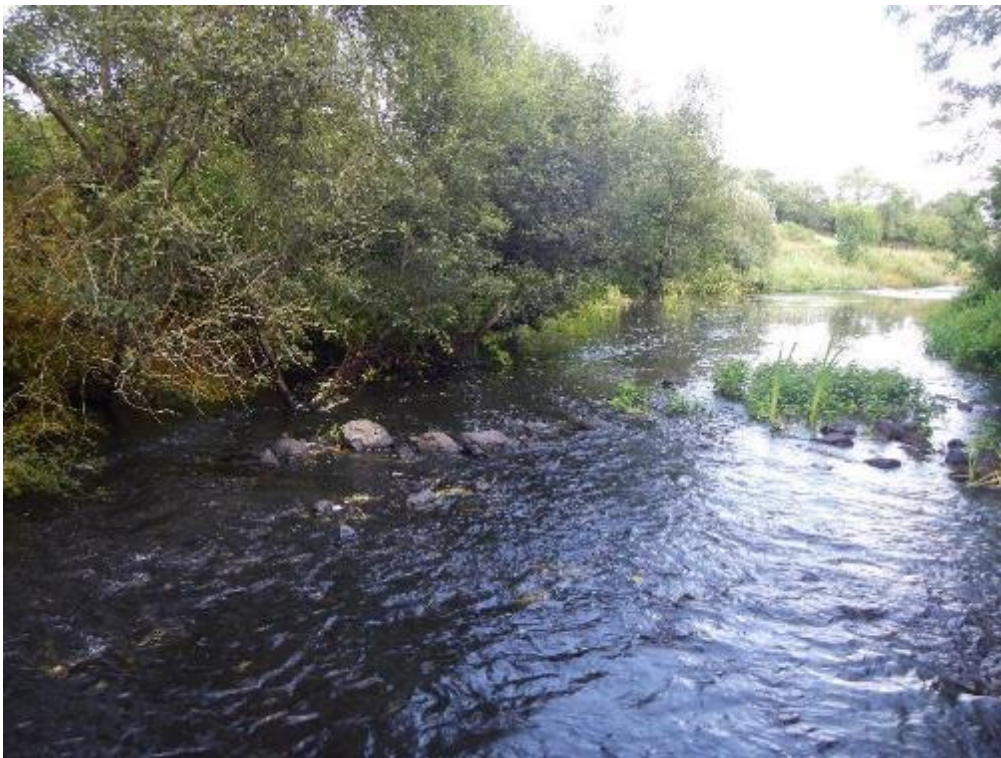
**Photo 20.** There is good quality habitat in the current main channel (alongside the side-channel), but the overall habitat of the area would be improved by prioritising flow down the more varied, side-channel and reinstating a much-needed bend to the river.

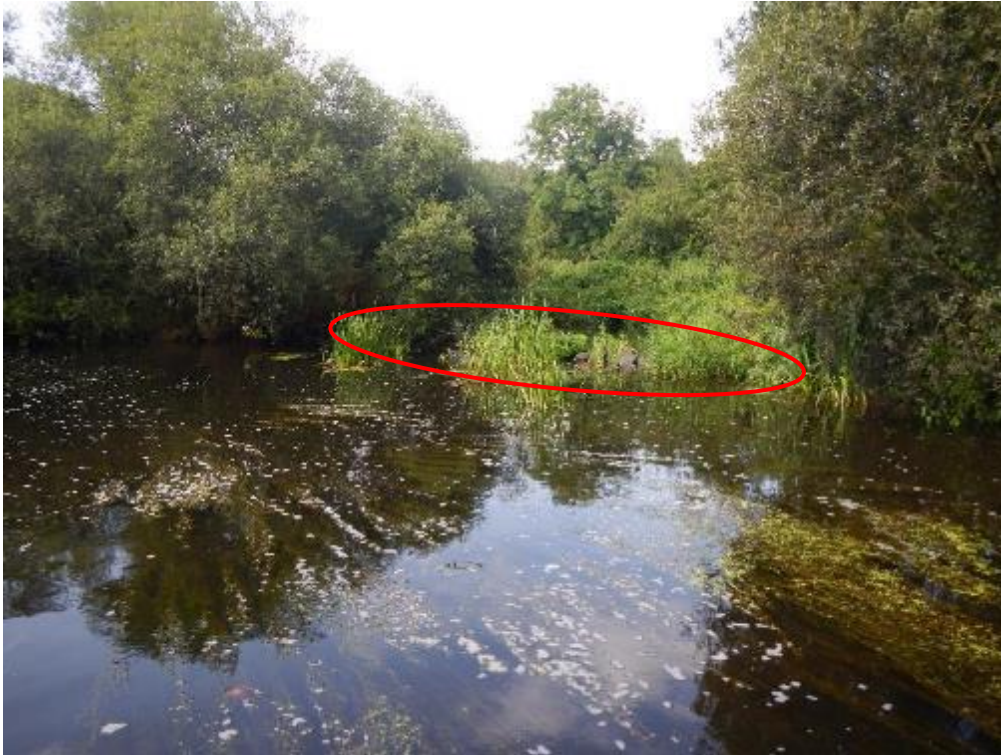
**Photo 21.** Rocks have been used to reduce the flow passing down the side channel (red ellipse). The pool at the d/s (foreground) would change if the predominant flow came down the side-channel, but the overall habitat diversity and quality would be increased.

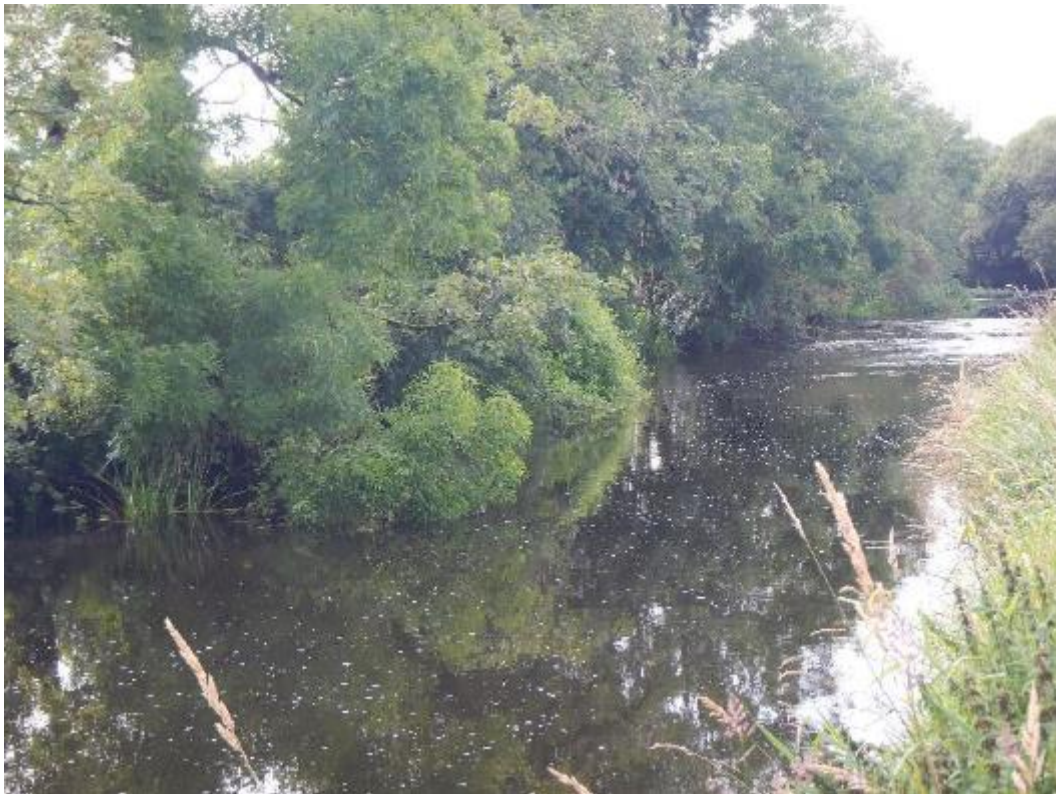
**Photo 22.** Habitat in the pool u/s of Magoney Bridge (54.028318, -6.614318) is greatly enhanced by the trailing ash branches. While these may prevent an angler from covering every area of the pool, the habitat improvement and increased fish-holding potential is a major benefit to angling.

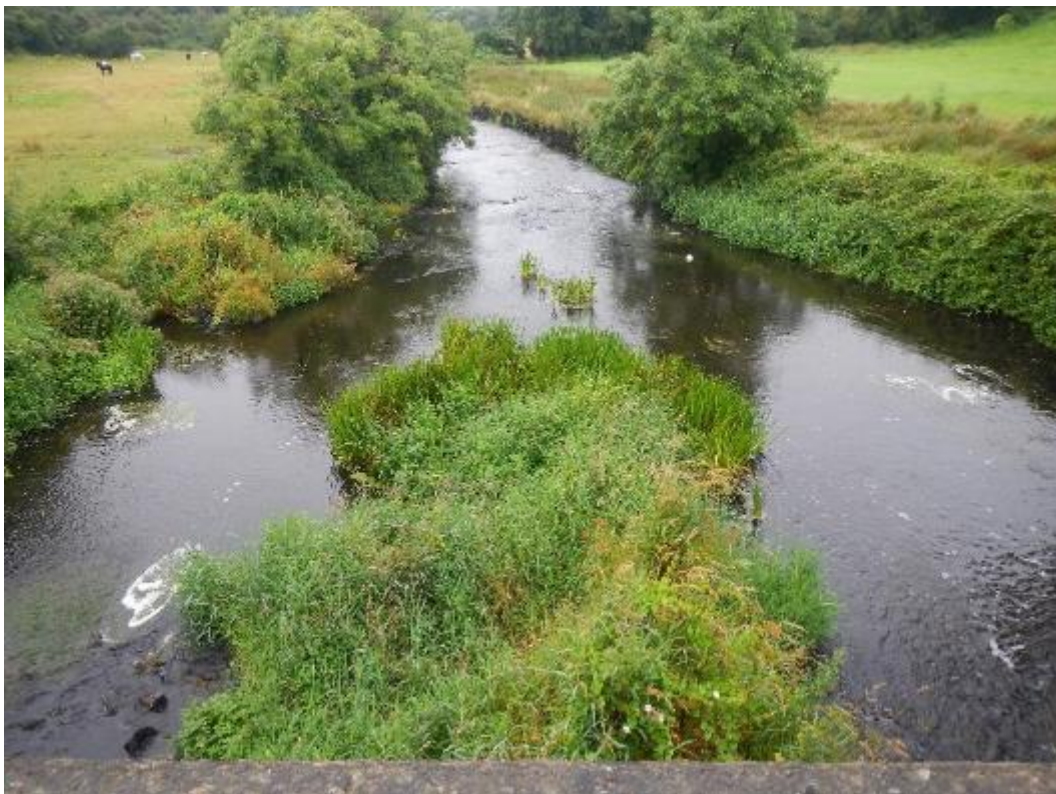
**Photo 23.** D/s of Magoney Bridge (54.0283183, -6.6143183), the channel remains straight, with artificially armoured sections of bank. There may be more opportunities here to encourage the channel to move laterally into the low-grade agricultural land on the RB by removing the armouring, or even to undertake a more formal river restoration project.

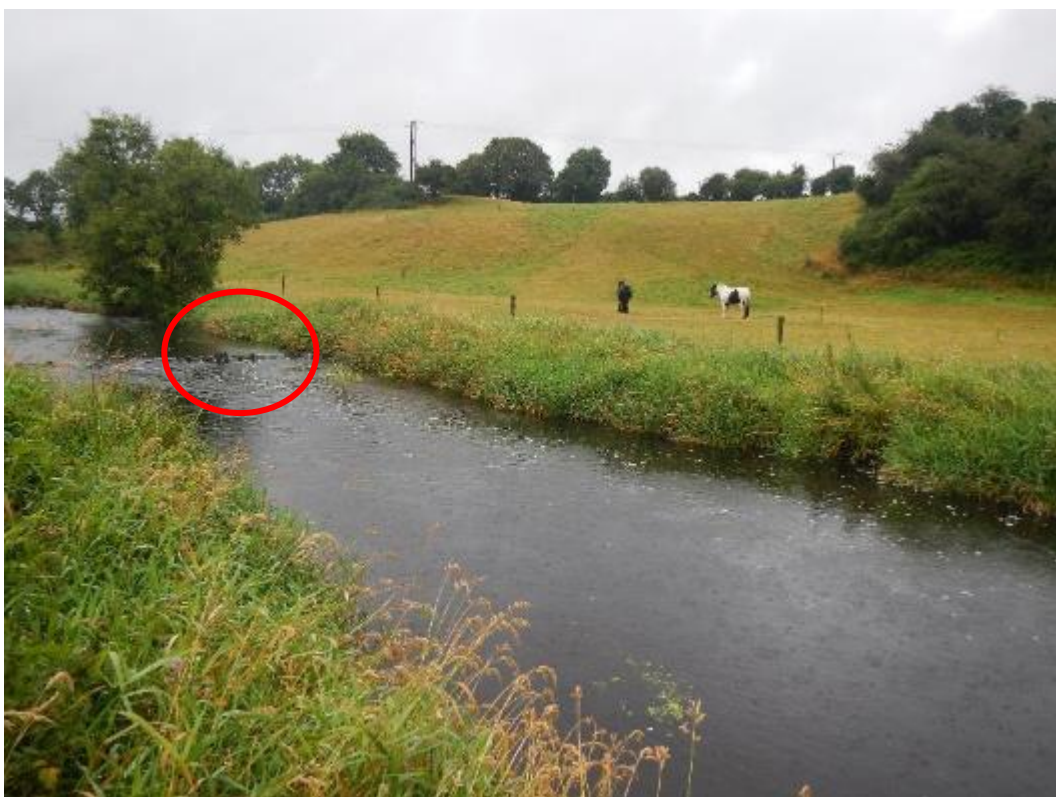
**Photo 24.** Small weirs in the river inhibit its natural flow pathways and trap bed material upstream (54.027212, -6.612428). Removing 1-2 metres of the weir right down to bed level at the LB side (red circle) would encourage flow in that area to create and maintain depth through scour. Where required, partial width deflectors are always preferable to full-width weirs. However, the lack of depth the weirs are intended to address would be better tackled through restoration of a more varied and sinuous channel.

<p><b>Photo 24</b></p>	2	54.027212, -6.612428	Notch 1-2 metres of the weir down to bed level at the LB side, to create a flow deflector (rather than a weir).
Small weir

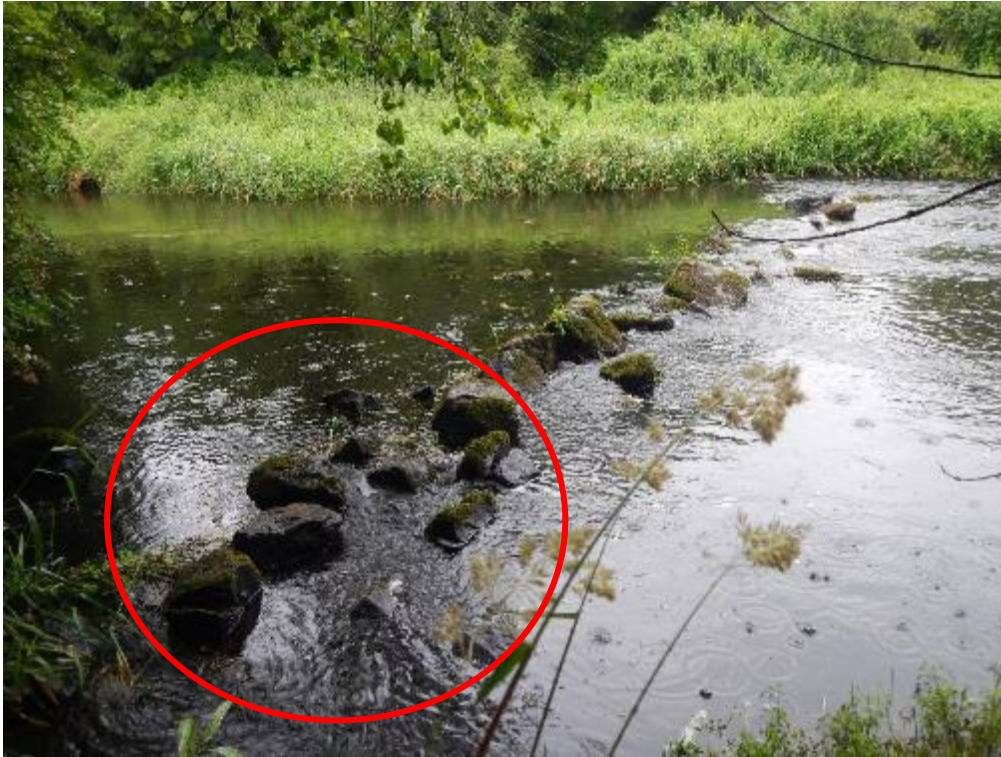
**Photo 25.** A weir a short distance d/s creates a similar issue (54.025323, -6.609878). Here, removing 1-2 metres of the weir down to bed level at the RB side (red circle) would encourage flow along the RB. When removing part of a weir (or installing deflectors), it is important to maintain the movement of the flow from one bank side to the other, to avoid effectively straightening the flow. It is therefore also important to consider which side of the channel the flow would naturally approach from u/s when choosing which side to notch.

<p><b>Photo 25</b></p>	2	54.025323, -6.609878	Notch 1-2 metres of the weir down to bed level at the RB side, to create a flow deflector (rather than a weir).
Potential for laying willow into channel

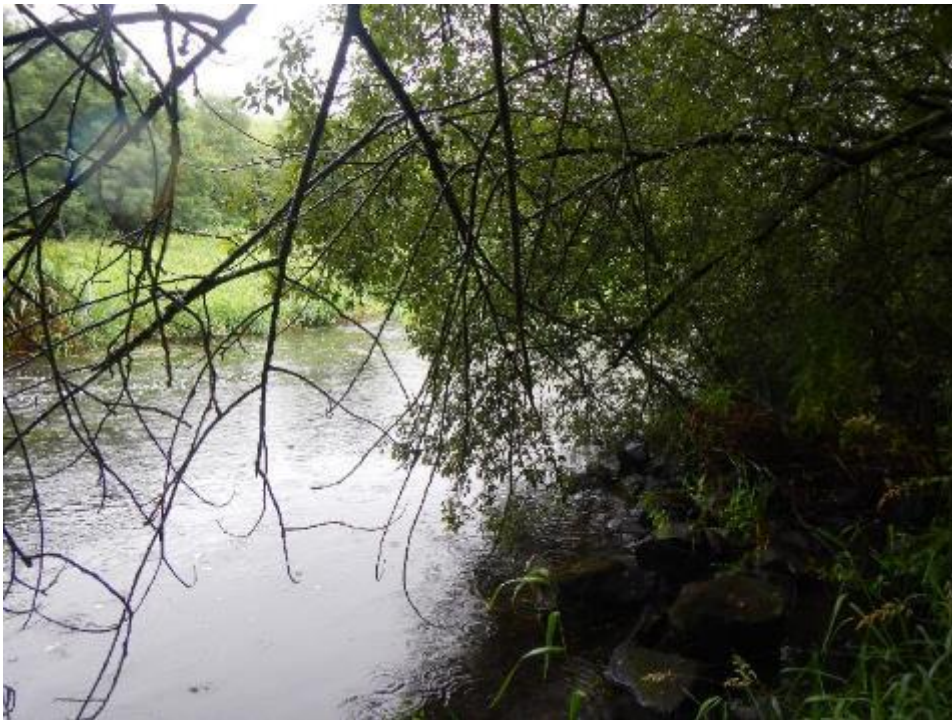
**Photo 26.** In conjunction with removing a portion of the weir, some of the willow trees d/s could be laid into the channel to narrow the channel and increase flow velocities, as well as provide additional, low fish cover.

<p><b>Photo 26</b></p>	3	54.025323, -6.609878	Lay some of the willow branches into the channel to act as a natural flow deflector.

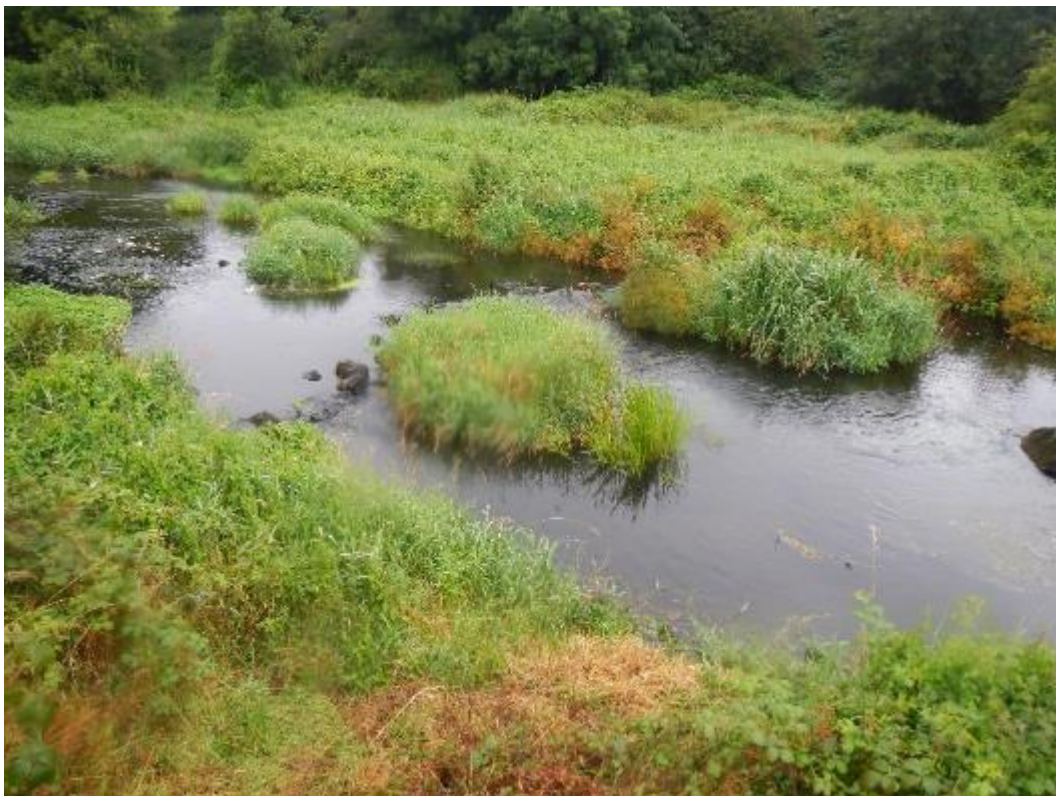
**Photo 27.** Again, removing all or a portion of the weir to maintain a bed depth channel without impoundment would be beneficial (54.025047, -6.609297).

<p><b>Photo 27</b></p>	2	54.025047, -6.609297	Notch a 1-2 metre portion of the weir down to bed level.
Bank revetment
