## Walkover Assessment

## River Fane

5th-7th/08/2019

Undertaken by the Wild Trout Trust

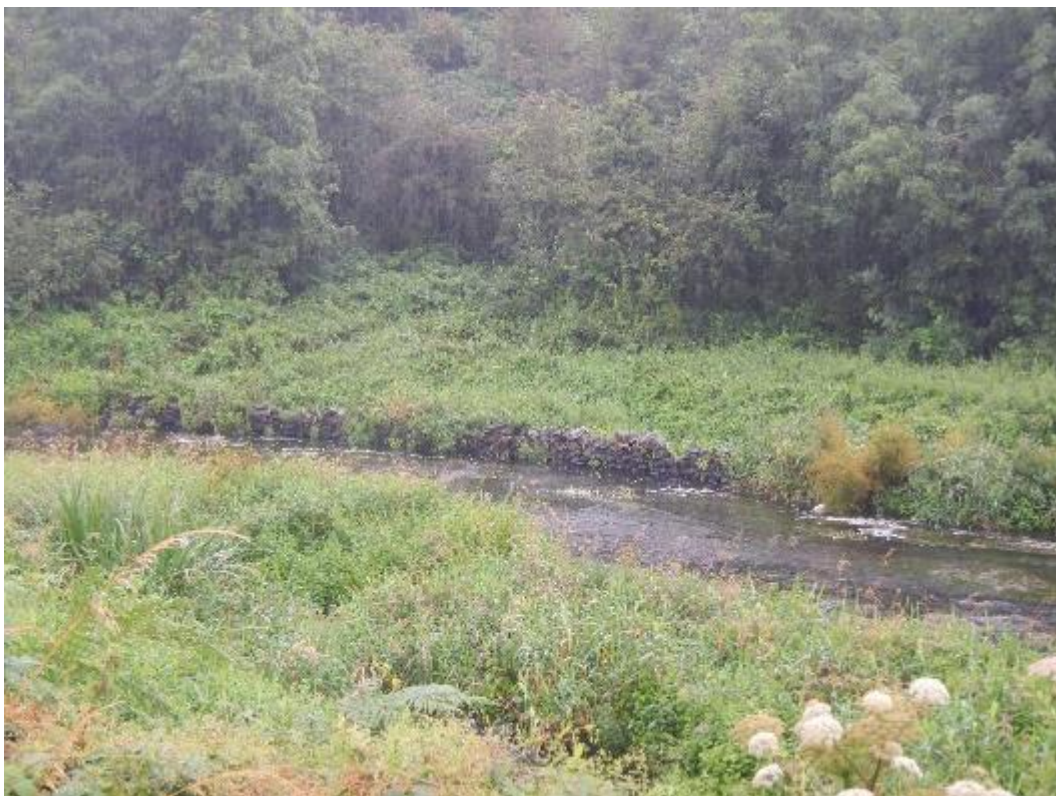
**Photo 28.** Armouring of the LB could be removed to allow natural, lateral movement of the channel into the rough ground on the outside of the bend (54.024075, -6.606928).

<p><b>Photo 28</b></p>	2	54.024075, -6.606928	Remove the bank armouring to allow natural channel migration.
Livestock access (LB and crossing to RB)

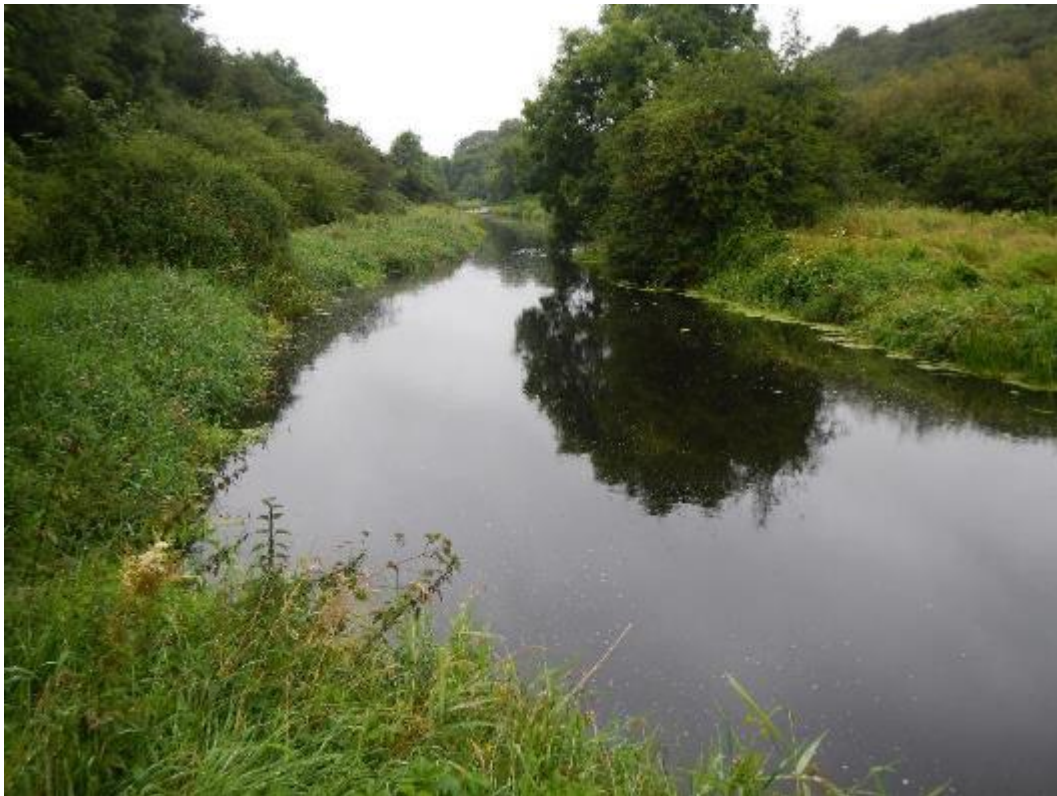
**Photo 29.** The next section d/s is very straight and deep alongside the disused railway line, providing only limited habitat for salmonids, although some larger specimens and a few juvenile fish may reside there. It may well be that material was removed from the channel here to use in the construction of the railway/embankment.

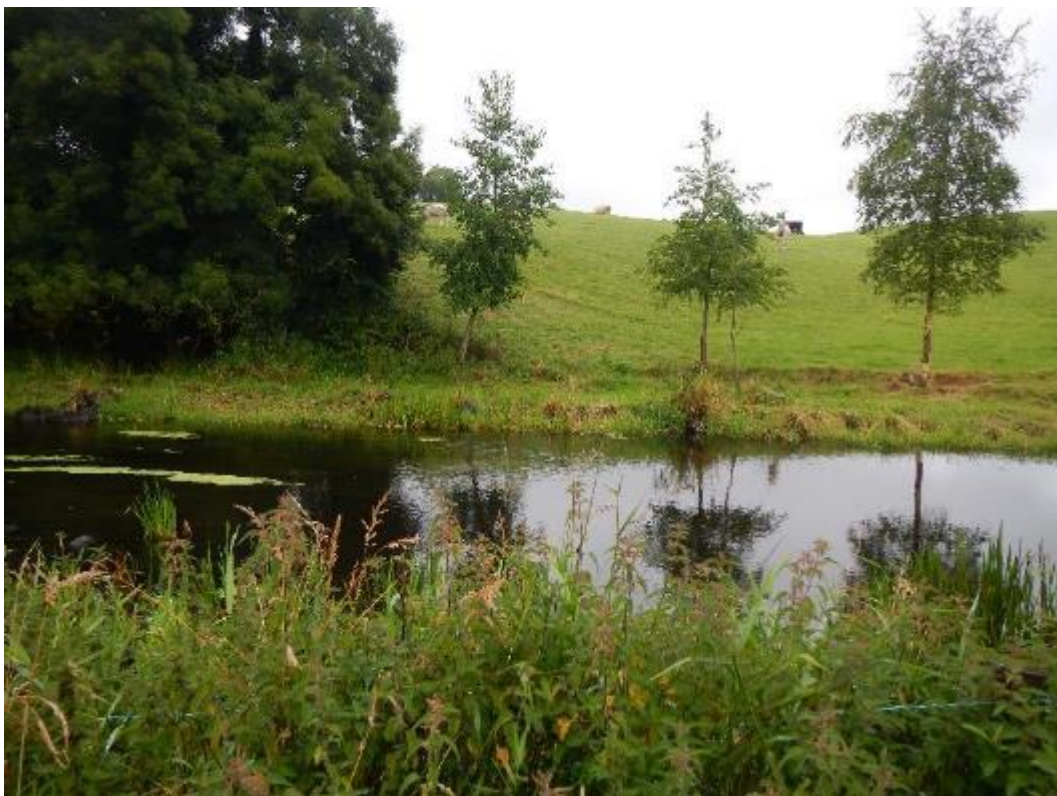
**Photo 30.** Livestock are gaining access to the river from the LB and crossing over to the RB side, within the buffer (54.021845, -6.603547). This should be prevented to protect the riparian habitat.

<p><b>Photo 30</b></p>	2	54.021845, -6.603547	Exclude livestock. This will require discussion with the landowner.
Larger weir

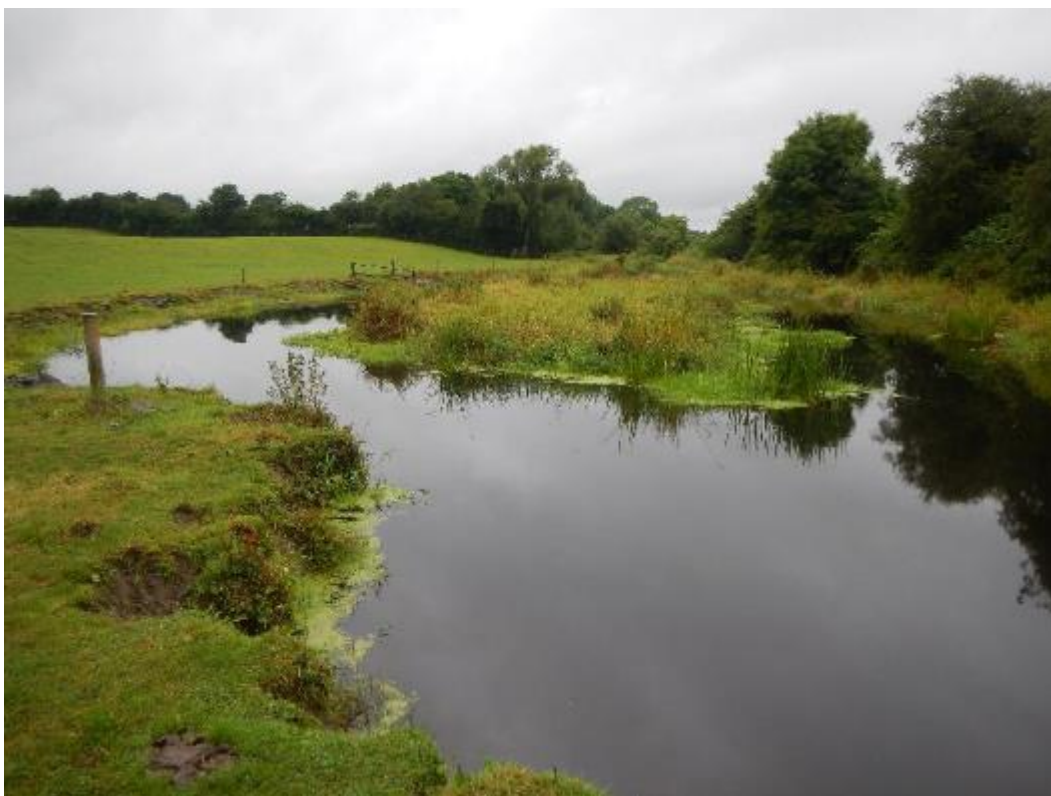
**Photo 35.** Looking u/s at another island/straightened bend (54.019155, -6.600215): Prioritising flow down the RB channel could create/reinstate another meander. This location is a lower priority owing to the deep water and lack of bed features (likely resulting from past dredging) but reinstating the bend would assist with the natural channel/bed recovery.

<p><b>Photo 35</b></p>	3	54.019155, -6.600215	As with other similar features, there would be benefits to consolidating the flow down one bank side to accentuate the bend. However, owing to the heavily degraded nature of this section, this would be a lower priority.
Drinking bay (RB)

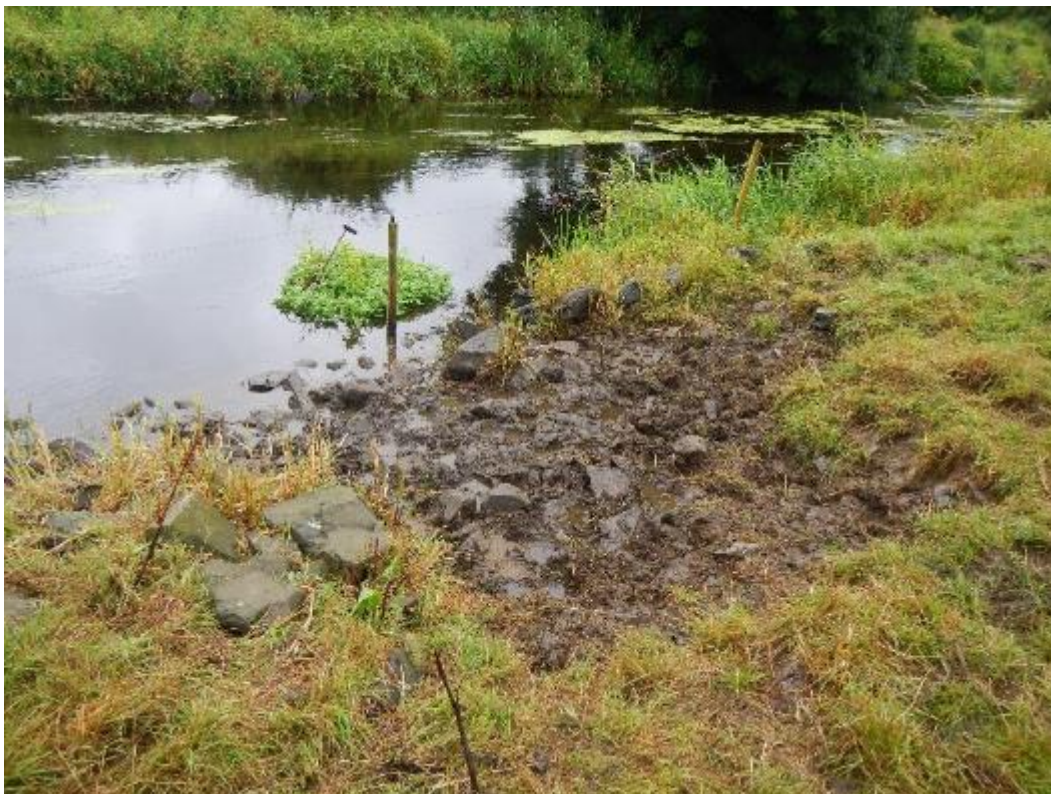
**Photo 36.** The next field is electric buffer fenced (54.018498, -6.598745), but poaching around a drinking bay creates another negative impact.

<p><b>Photo 36</b></p>	2/3	54.018498, -6.598745	Provide alternative watering.
Livestock accessing both banks from the LB

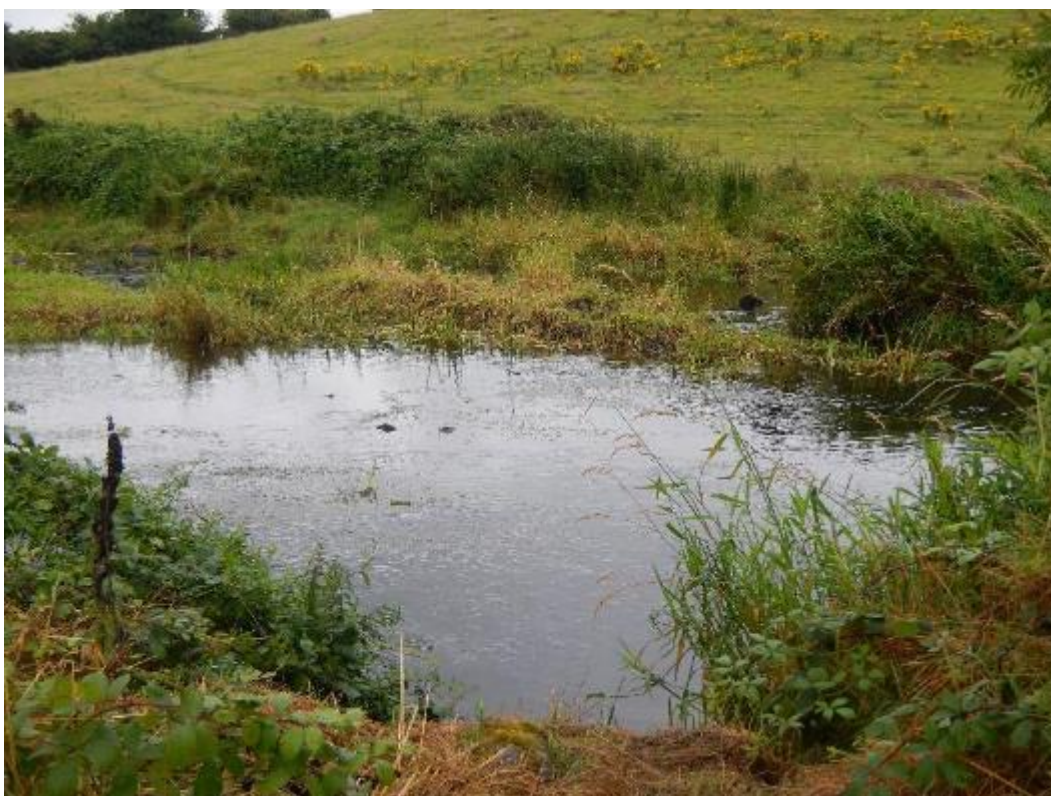
**Photo 37.** Cattle are gaining access from the LB side and crossing the river at 54.016123, -6.597485. Note the much poorer riparian habitat quality resulting from the grazing.

<p><b>Photo 37</b></p>	2	54.016123, -6.597485	Install buffer fencing.

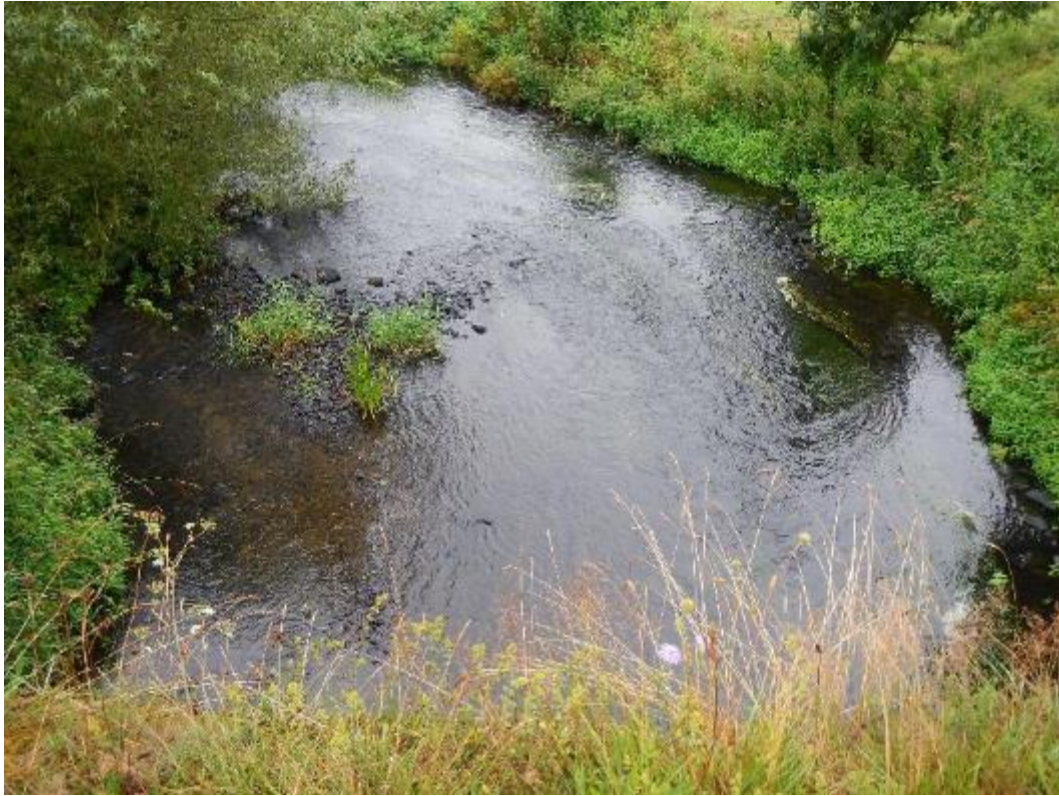
**Photo 38.** Looking u/s (54.014055, -6.595): the bend u/s of the old railway viaduct beautifully demonstrates the kind of features lacking from much of the channel owing to the modifications. Note the scour and deeper water on the outside of the bend (right of shot) and deposition on the inside (left of shot), leading to a more varied cross-section. The trailing willow is also encouraging the deposition by slowing flow along the RB side (left of shot).

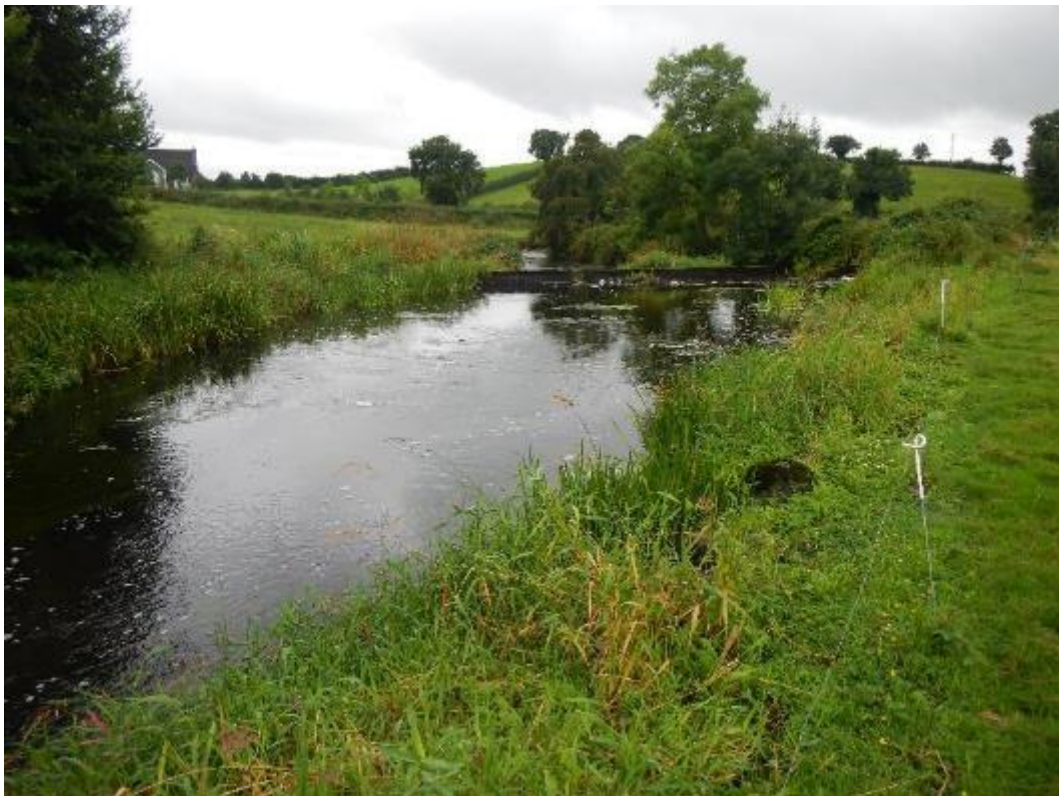
**Photo 39.** Another weir creates a small obstacle but is already breached, reducing the issue (54.01271, -6.595992). However, creating a notch to bed-depth in a section of the weir would still be beneficial.

<p><b>Photo 39</b></p>	2	54.01271, -6.595992	Notch at least a section of the weir to bed level.
Small weir

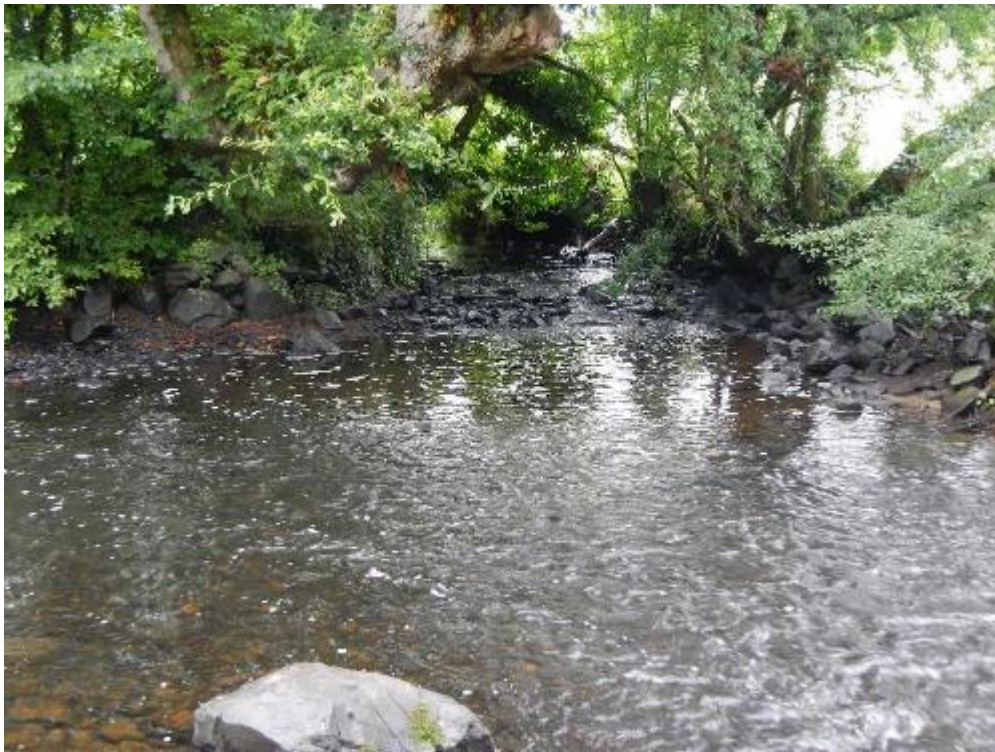
**Photo 40.** In the heavily straightened section alongside the road, a similarly straightened and realigned tributary joins the Fane. Note how the sediment in the tributary has formed a steep, step riffle at the confluence. This is likely due to a combination of factors: the tributary now joins the Fane in an u/s direction, so the flows are opposing; this means that the flow and oversupply of sediment by the straightened tributary will be impounded at the confluence when the main channel is in flood, backing up the tributary so that it loses energy, causing it to deposit the coarse sediment.

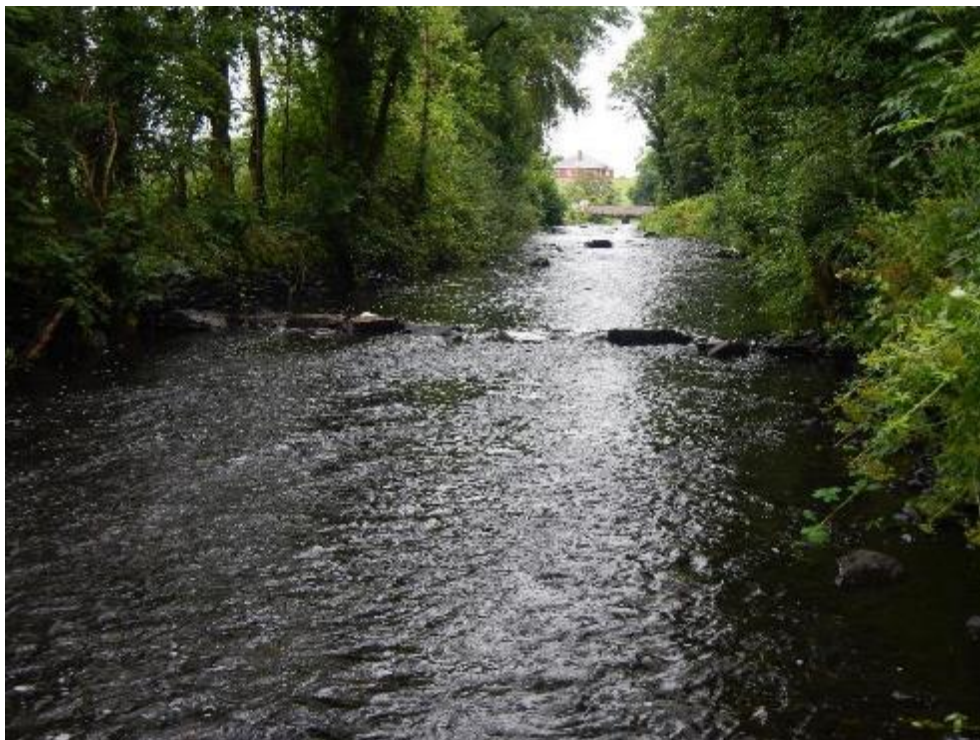
**Photo 41.** The straightened section of the Fane d/s, alongside the road, is subject to uniform scour or deposition (depending upon the flow received) maintaining a uniform bed and lack of water depth (54.01083, -6.598303). It would be worth removing at least a portion of the weir to encourage bed scour that will naturally maintain deeper areas.

<p><b>Photo 41</b></p>	2	54.01083, -6.598303	Remove a portion of the weir to bed level.
Large weir

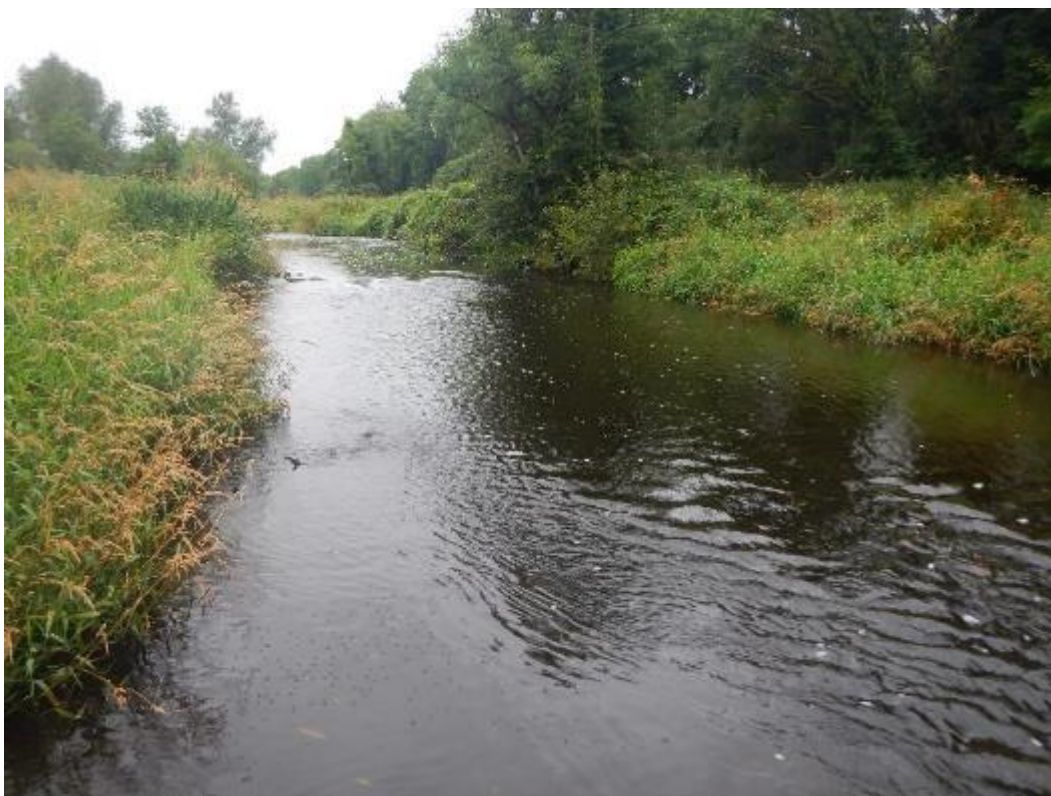
**Photo 46.** D/s of Inniskeen, areas of main channel with potential for salmonid spawning were observed. Here, the extra width created by an old fording point has facilitated the retention of suitable substrate.

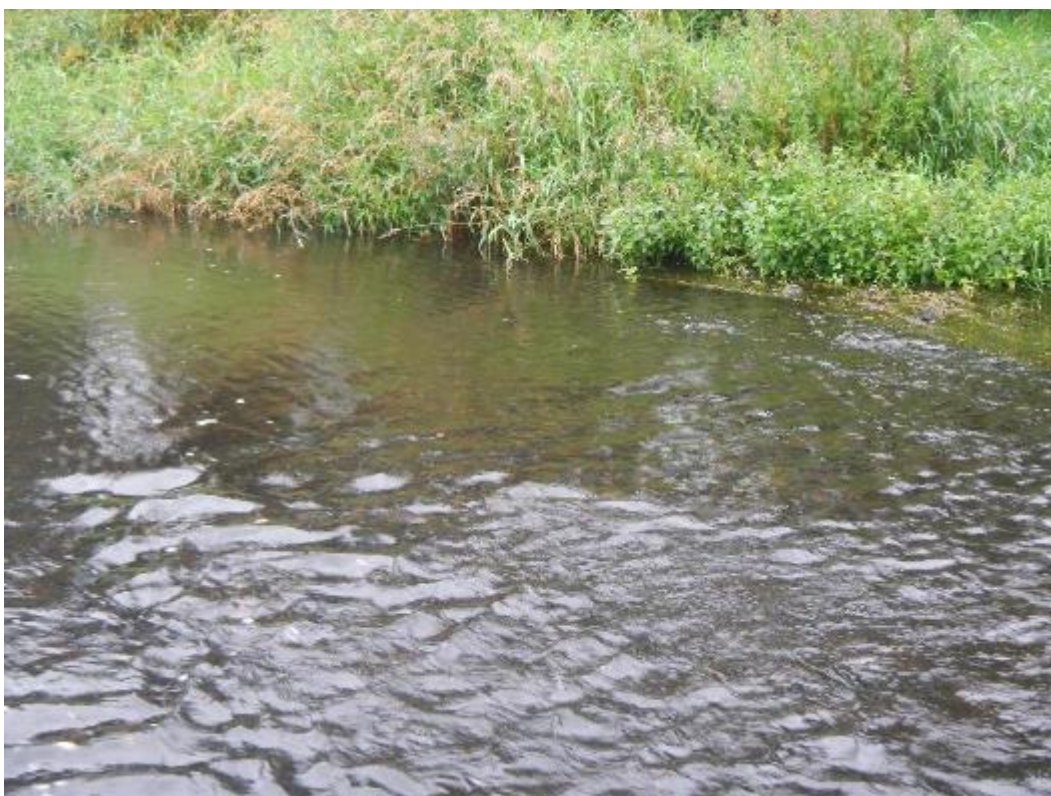
**Photo 47.** If any redd counting is undertaken on the river, this location would be a good spot to check (53.995873, -6.558588).

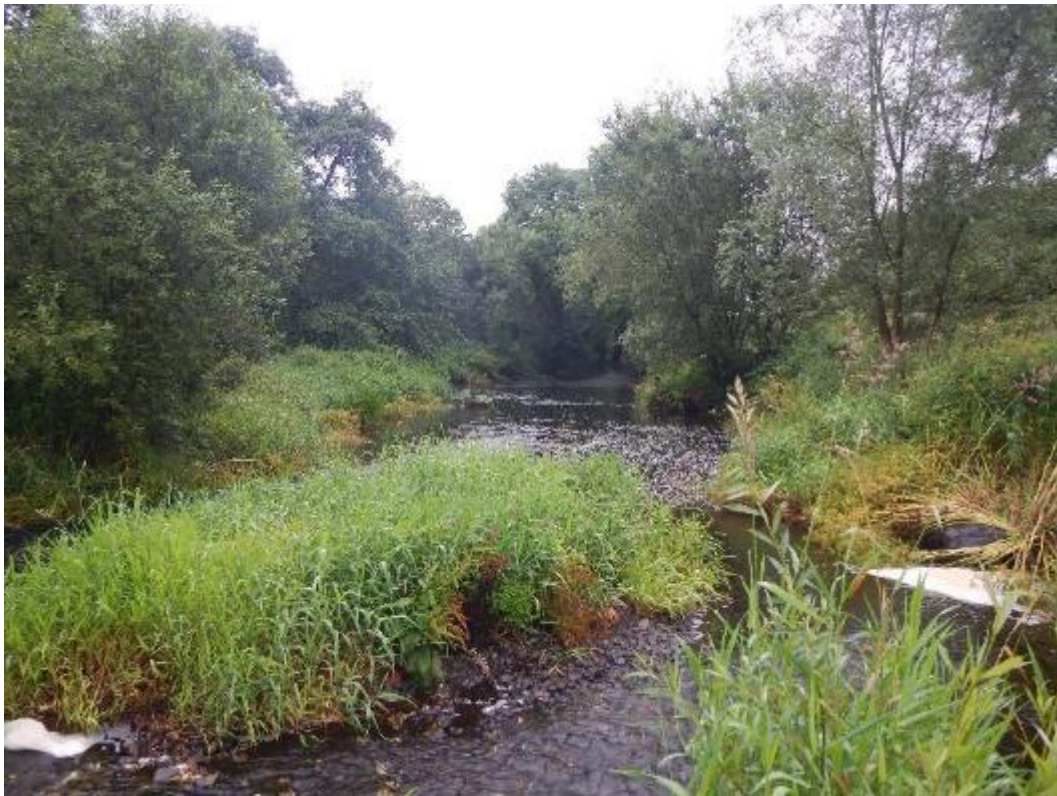
**Photo 48.** Increased deposition d/s of the old ford has also led to the development of a small, vegetated island which adds valuable diversity and focuses low flow down the LB side.

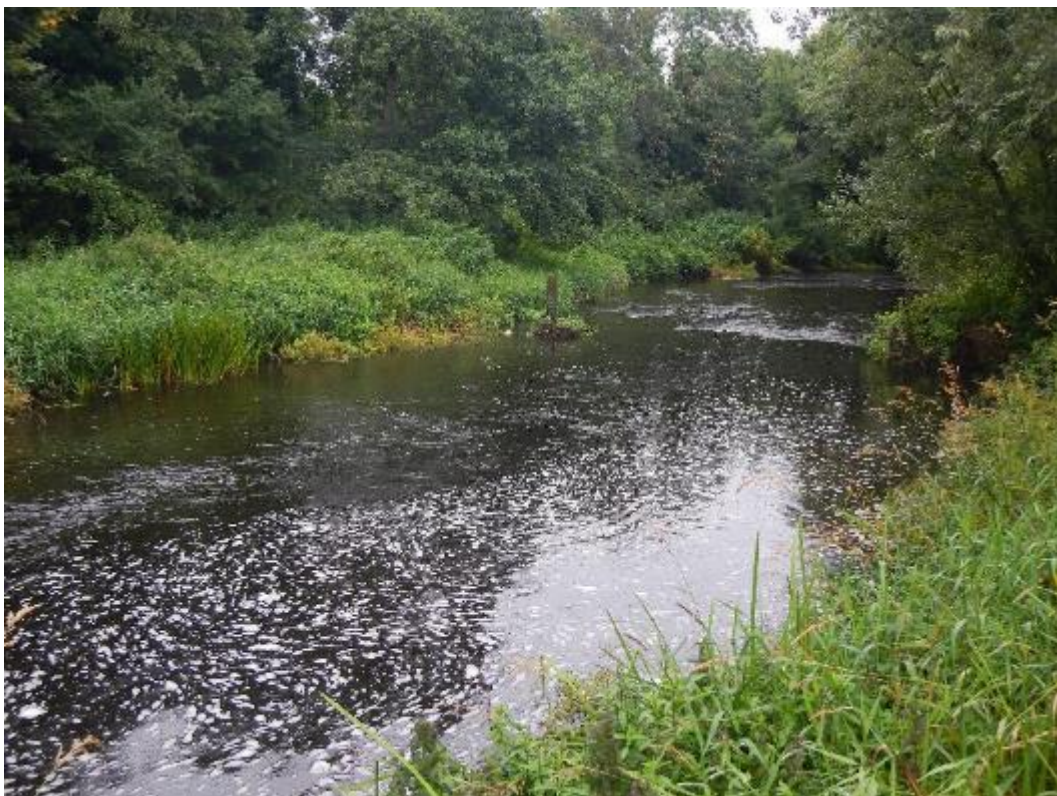
**Photo 49.** Note how the flow focussed down the LB side of the island maintains a deep pool through scour, without the need for an artificial impoundment. That increased depth will be naturally maintained long-term, unlike the short-term depth created u/s of a weir.

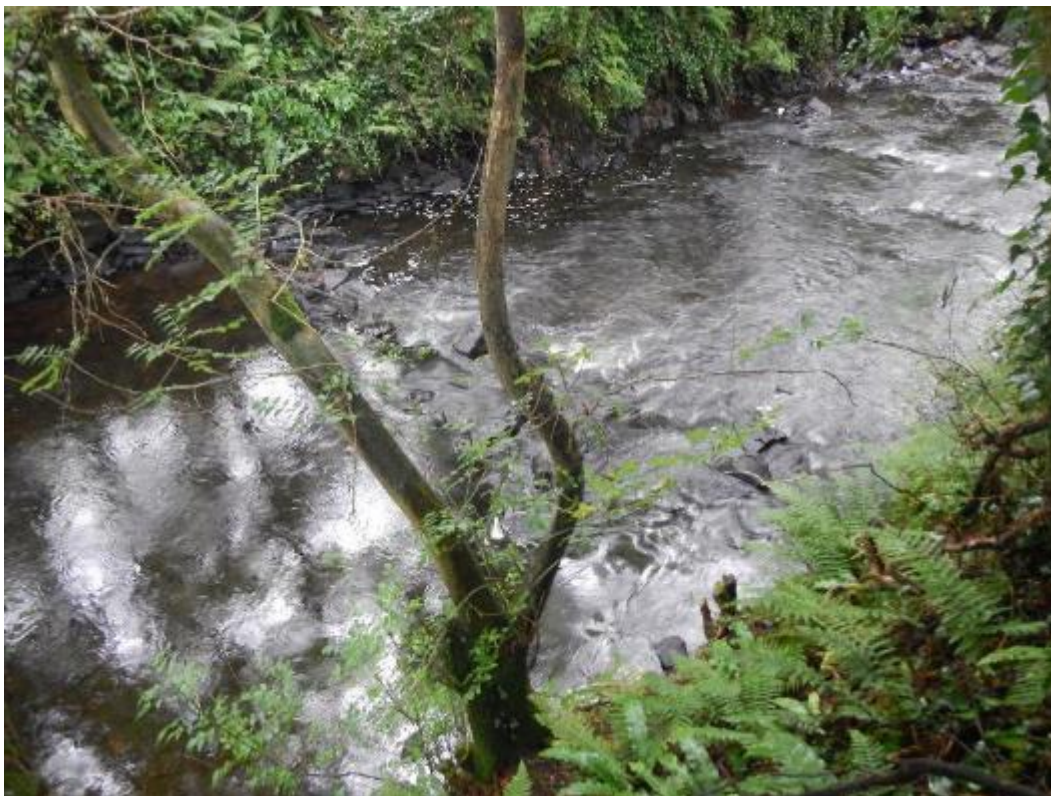
**Photo 50.** The heavily straightened, steepened and incised channel d/s, tight alongside the old railway line, has limited deeper water for adult salmonid habitat but provides some good niches for juvenile fish. The channel is slightly over-shaded by the tree canopy enveloping the lowered channel, but for such a short section it is not a major problem.

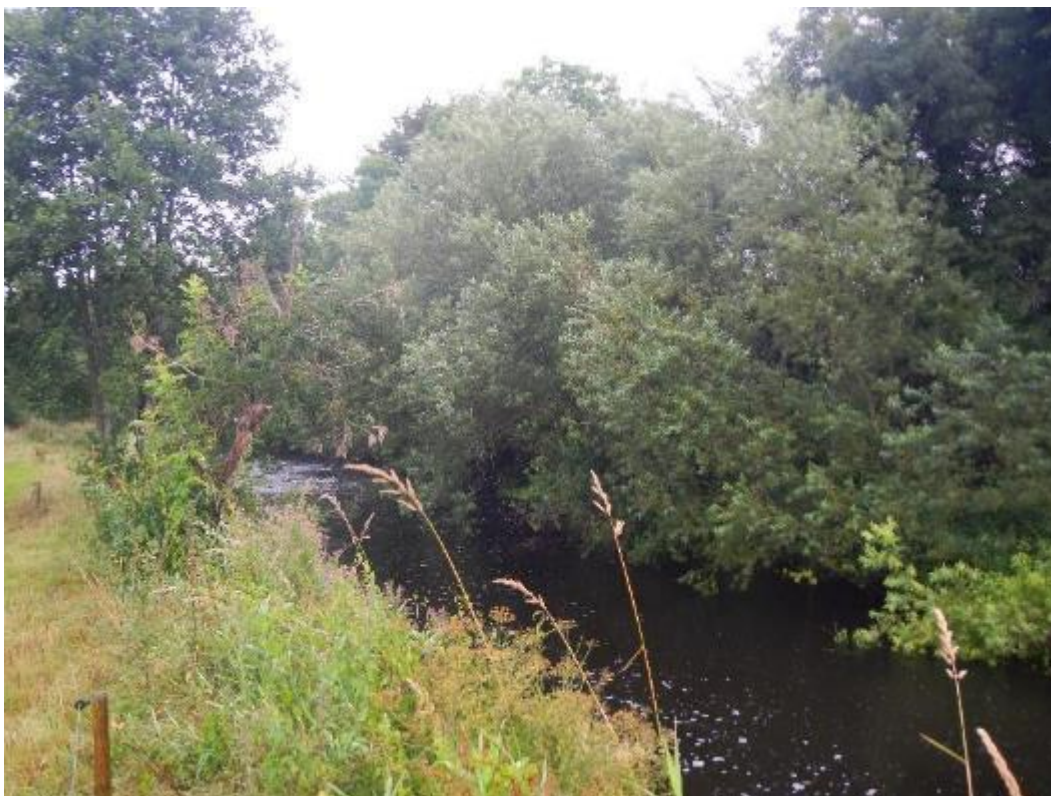
**Photo 51.** Away from the old railway line, the channel retains more natural meanders and a regular pool and riffle sequence, providing habitat for all salmonid life stages. Low and trailing branches provide valuable shade and cover.

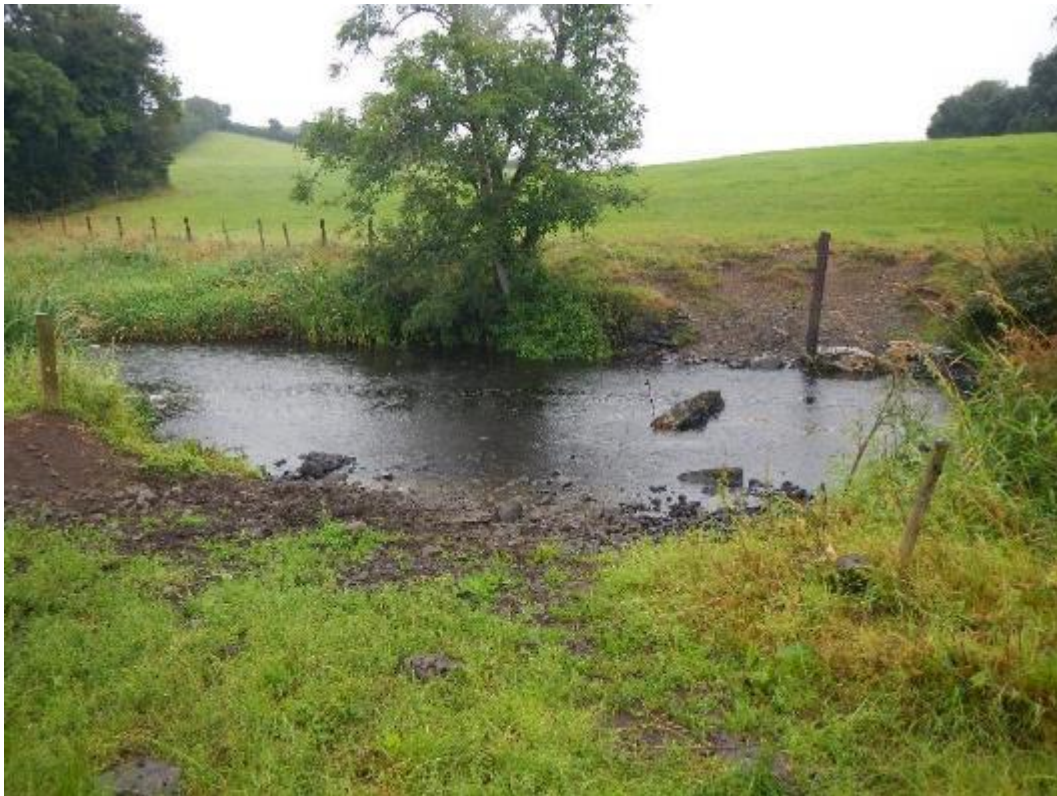
**Photo 52.** Poorer quality habitat and increased erosion are associated with a drinking bay/fording point (53.993025, -6.555733). The crossing may be required to facilitate grazing at either side of the river, but livestock should be excluded when it is not in use (e.g. by simply grazing the fields independently, only opening the crossing to move stock from one to the other).

<b>Photo 52</b>	2	53.993025, -6.555733	Use as crossing point only, with livestock excluded from the watercourse and banks when not in use.
Alder disease

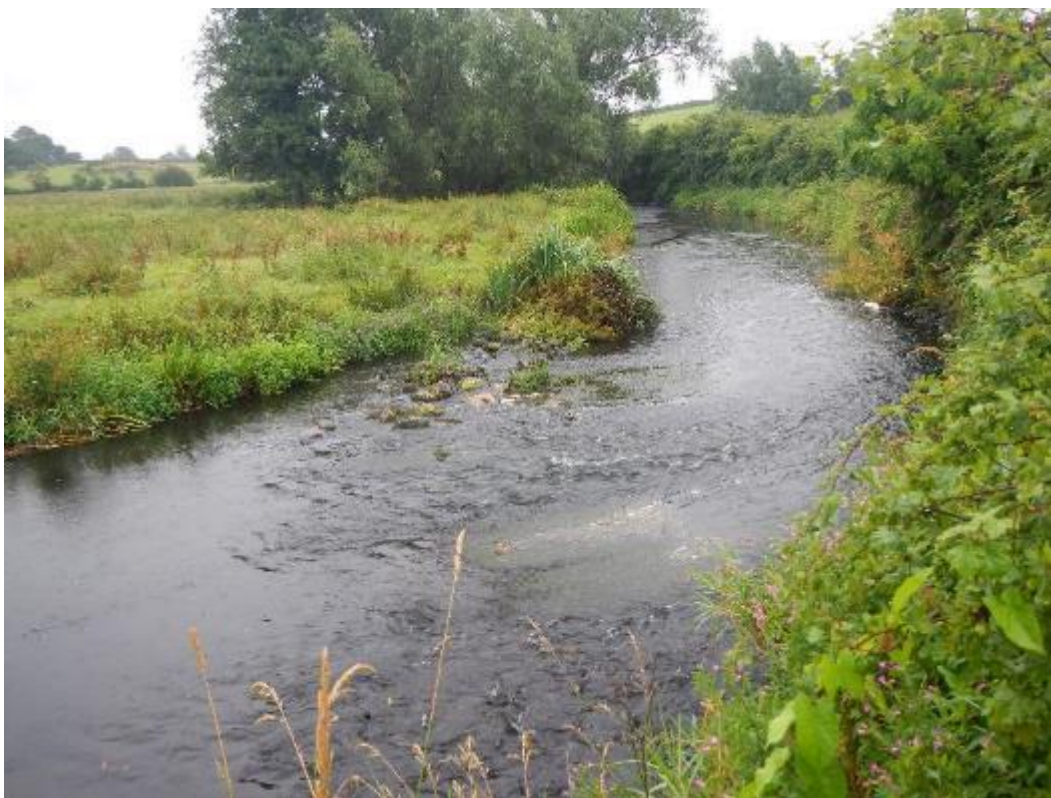
**Photo 54.** Where bends are present, the natural reduction in channel width creates depth through bed scour, producing high quality adult fish habitat. In this example, the only thing missing is low-level cover which could be provided by planting a willow shrub along the RB. In this instance, small, shrub species such as goat willow or grey willow would work best.

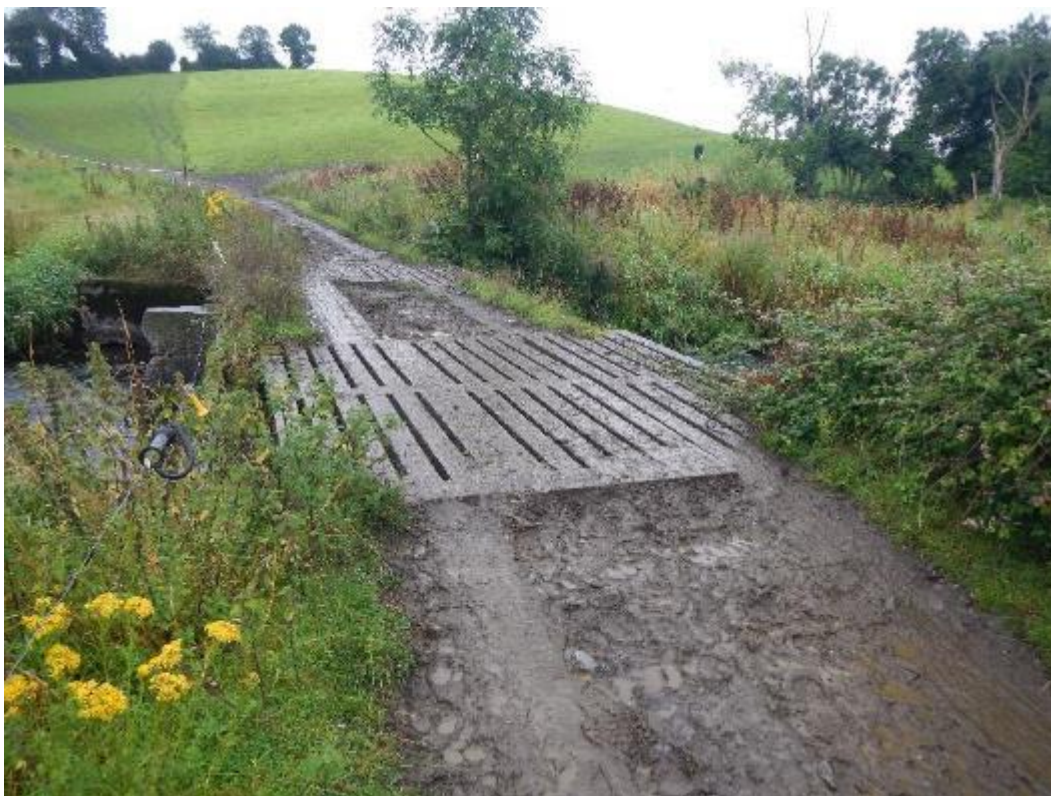
**Photo 55.** A track crossing and slatted farm bridge creates a small pollution issue but as the track is pretty much disconnected from the bridge, the issue is limited (53.986492, - 6.554433). Small cross drains could be cut into (or raised across) the track on LB side to ensure that surface runoff from the hill drains to rough ground, not the watercourse.

<b>Photo 55</b>	2	53.986492, -6.554433	Farm infrastructure improvements including diversion of surface run-off to rough ground.
Track crossing and run-off

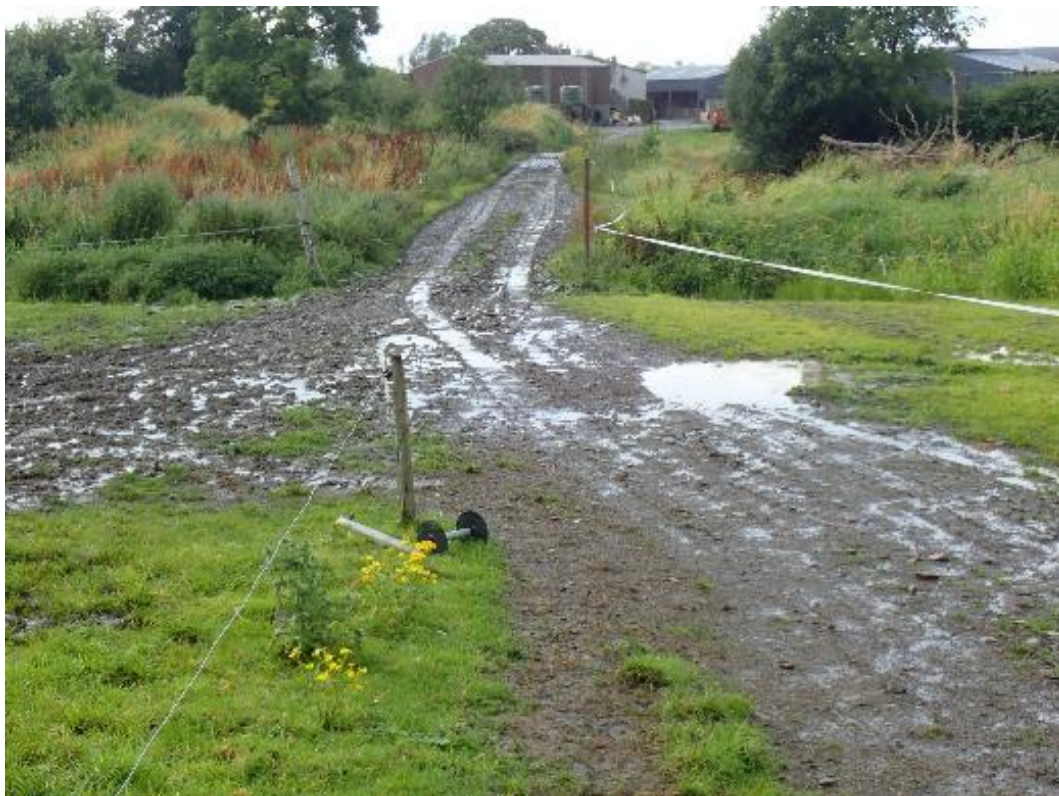
**Photo 56.** The top of the track leading to the slatted bridge (depicted in photo 55) at Fane Farm in the background. Track and field drainage (and associated sediments) could be intercepted and diverted into the ditch system in the foreground.

<b>Photo 56</b>	2	53.986179, -6.553918	Divert surface run-off into ditch and rough ground.

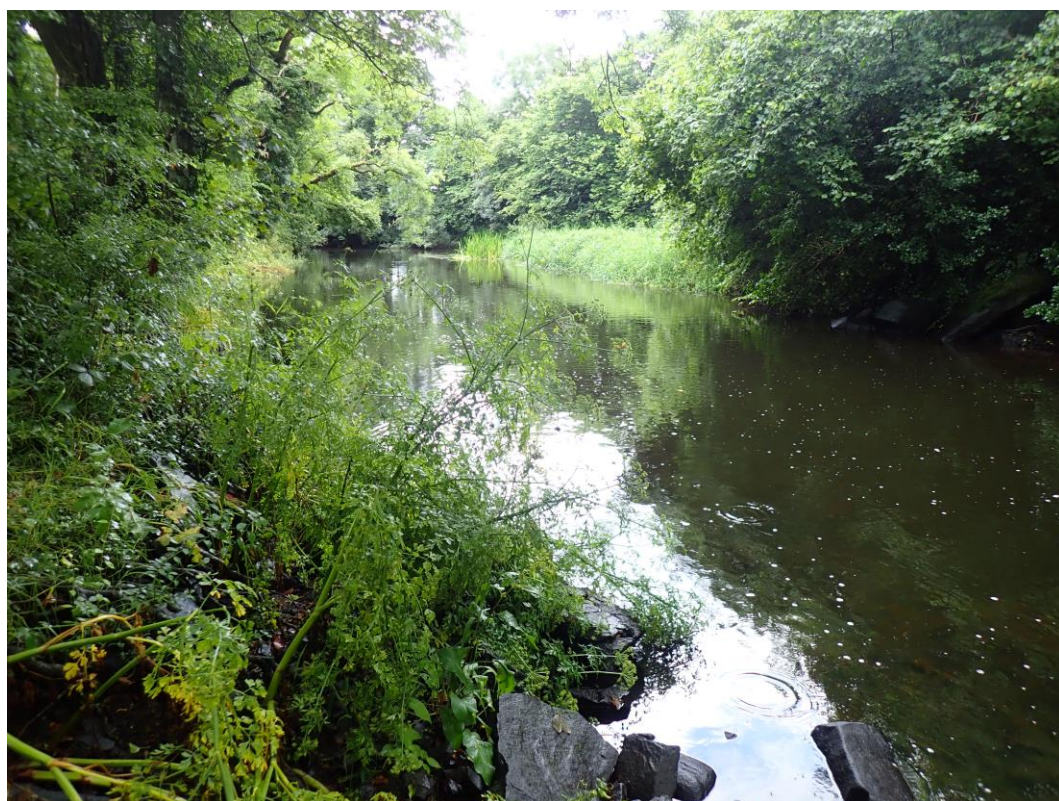
**Photo 57.** Deep, well covered pool habitat (53.983335, -6.551503) in the meandering reach above Fane Farm. A comparatively rare habitat for the Fane.

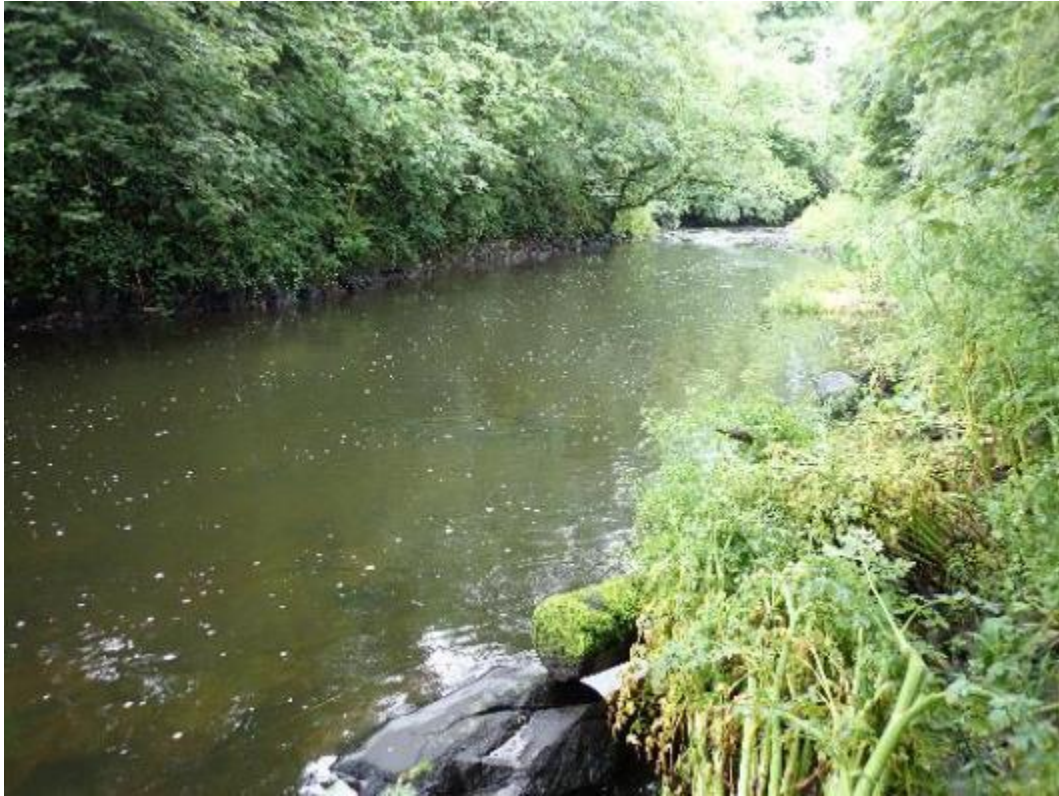
**Photo 58.** Good holding water for salmon and sea trout.

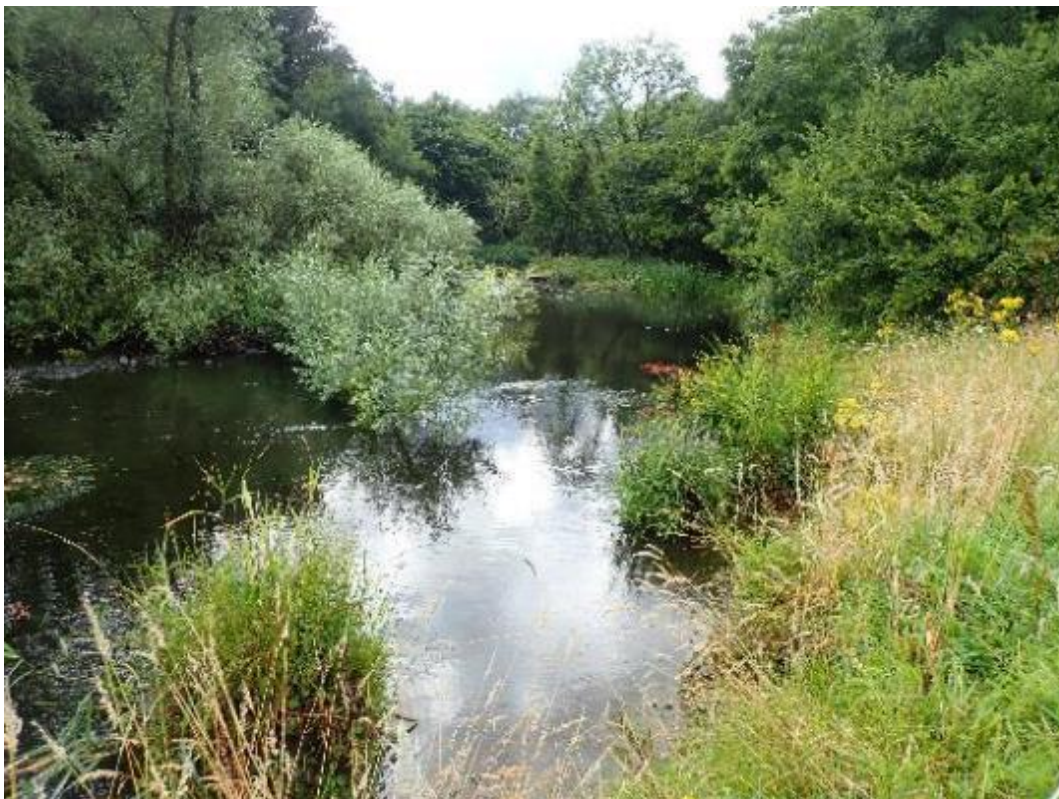
**Photo 59.** Maintaining lots of tree shading is particularly important over pool habitats.

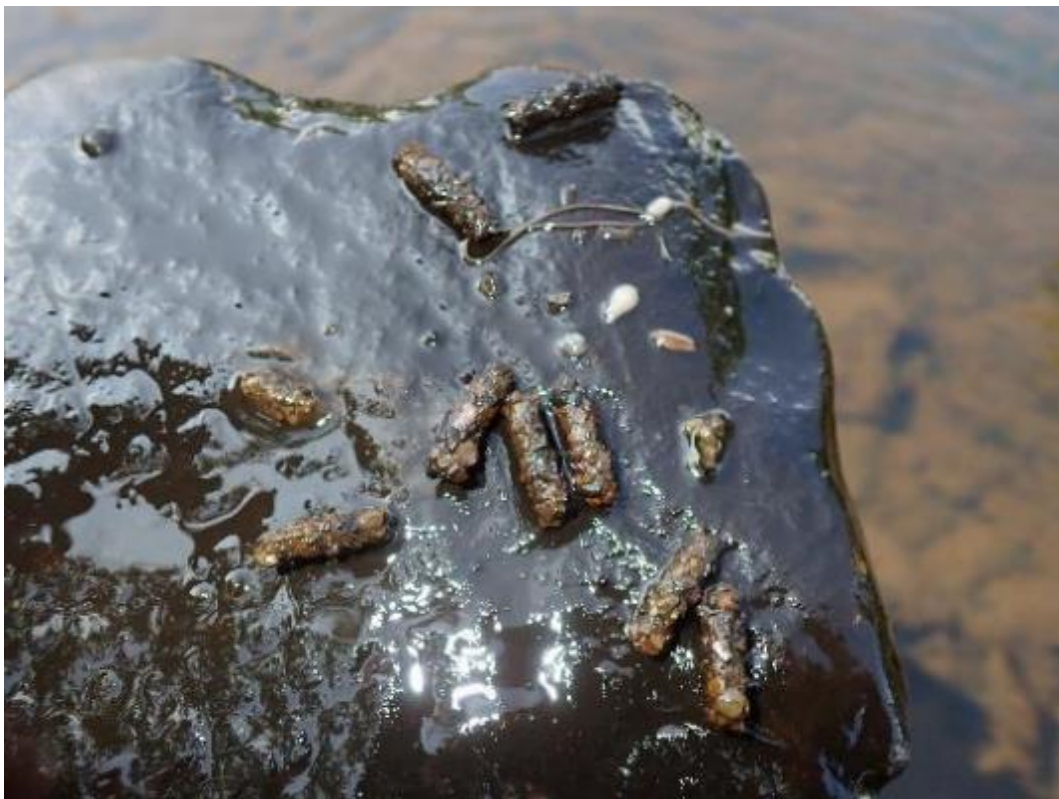
**Photo 61.** Occasional inspection of the riverbed usually revealed evidence of a rich and prolific fauna of macroinvertebrates, cased caddis in this particular example.

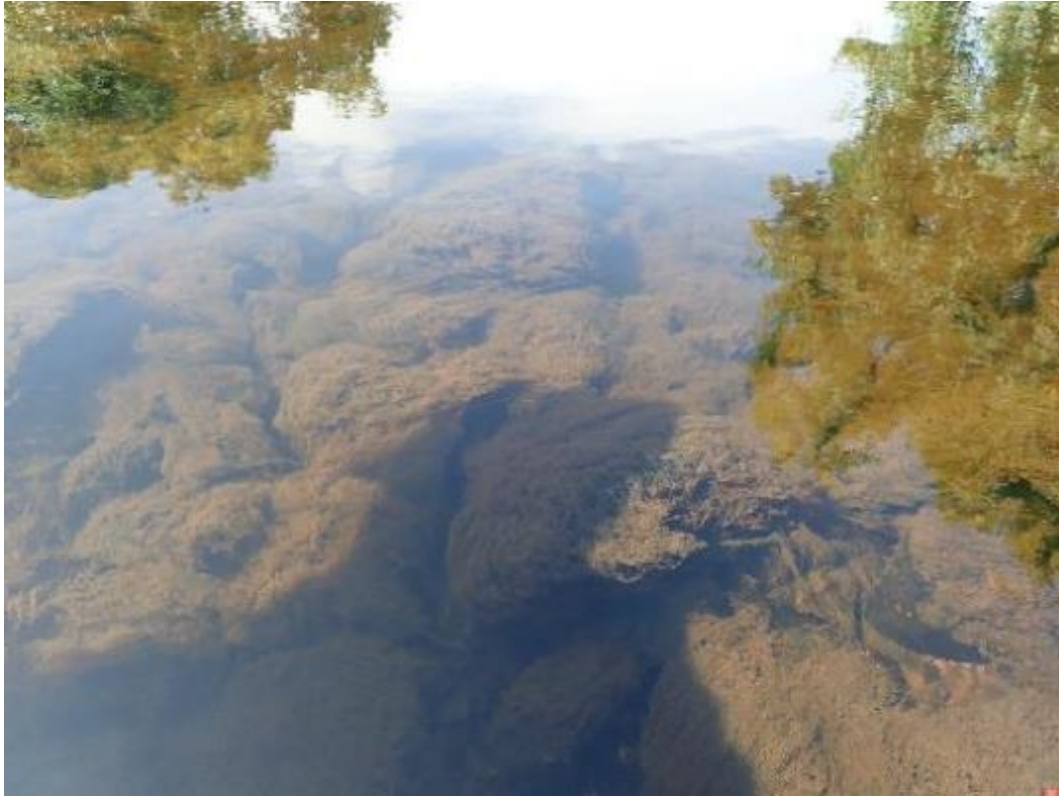
**Photo 62.** Significant filamentous algal growth on bed rock indicates a high nutrient loading, possibly via agricultural diffuse pollution.
