## Walkover Assessment

## River Fane

5th-7th/08/2019

Undertaken by the Wild Trout Trust

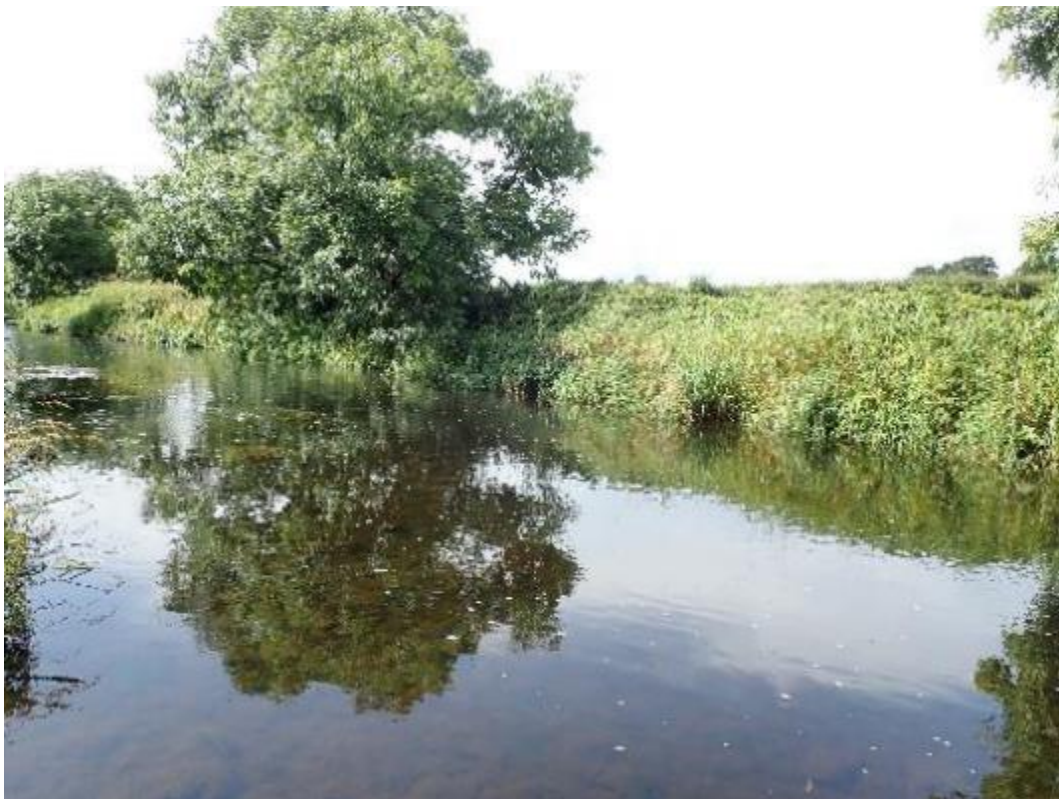
**Photo 63.** Another section of wide, featureless glide, lacking the cover and diverse flow patterns attractive to fish. Planting of the occasional shrub willow species in such areas would be beneficial.

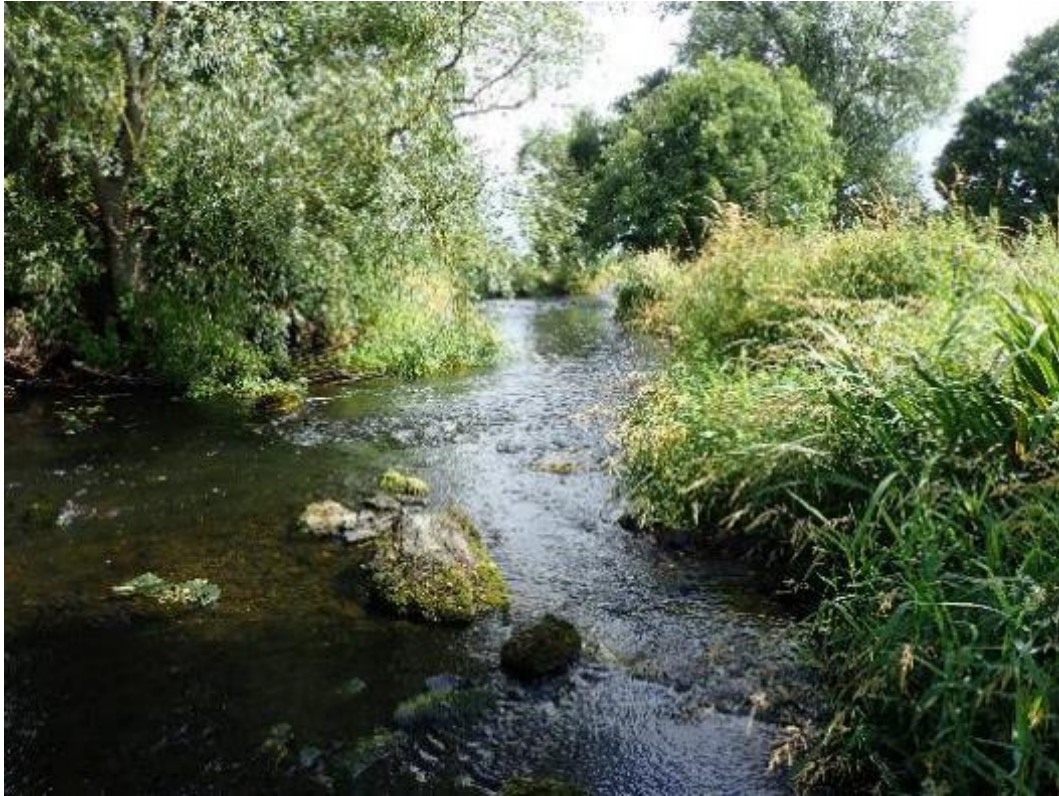
**Photo 64.** By contrast, sections of channel in the reach running down towards Castlering support high class habitat, particularly for trout.

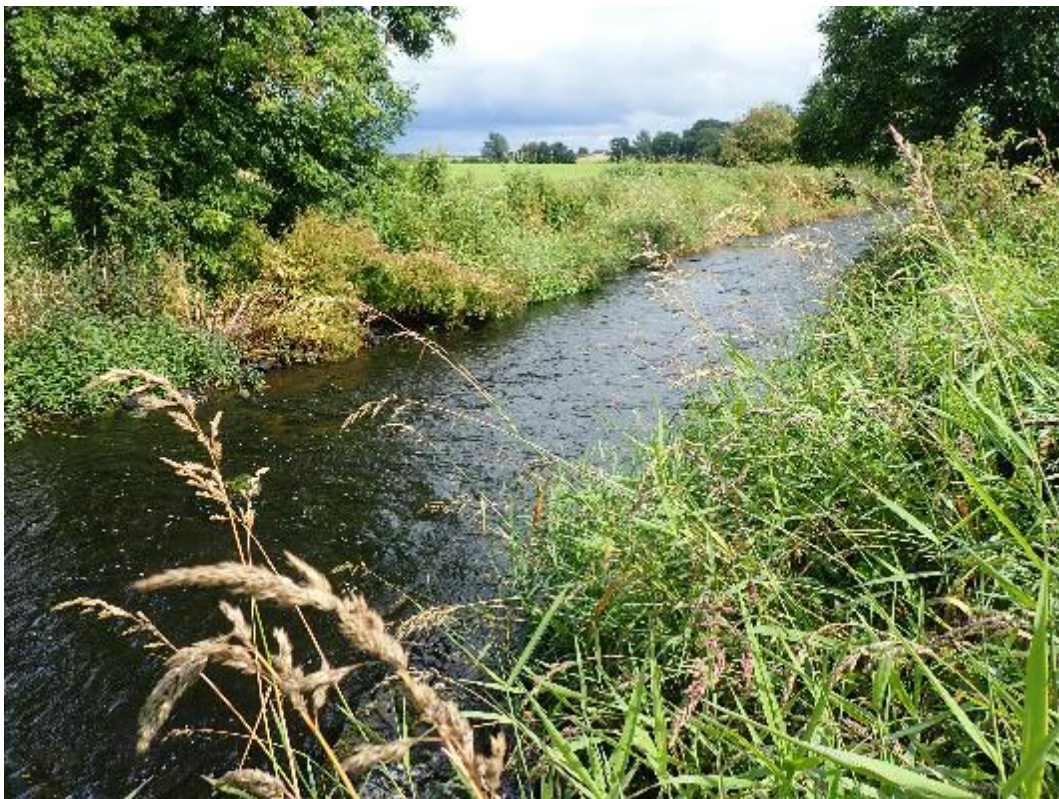
**Photo 65.** A long riffle habitat, with well-vegetated margins is likely to be a wonderful habitat for trout and salmon parr. Providing plenty of direct sunlight to shallow riffles and glides helps improve productivity but keeping long sections of tree shading is also important to maintain cool, adult fish-holding water.

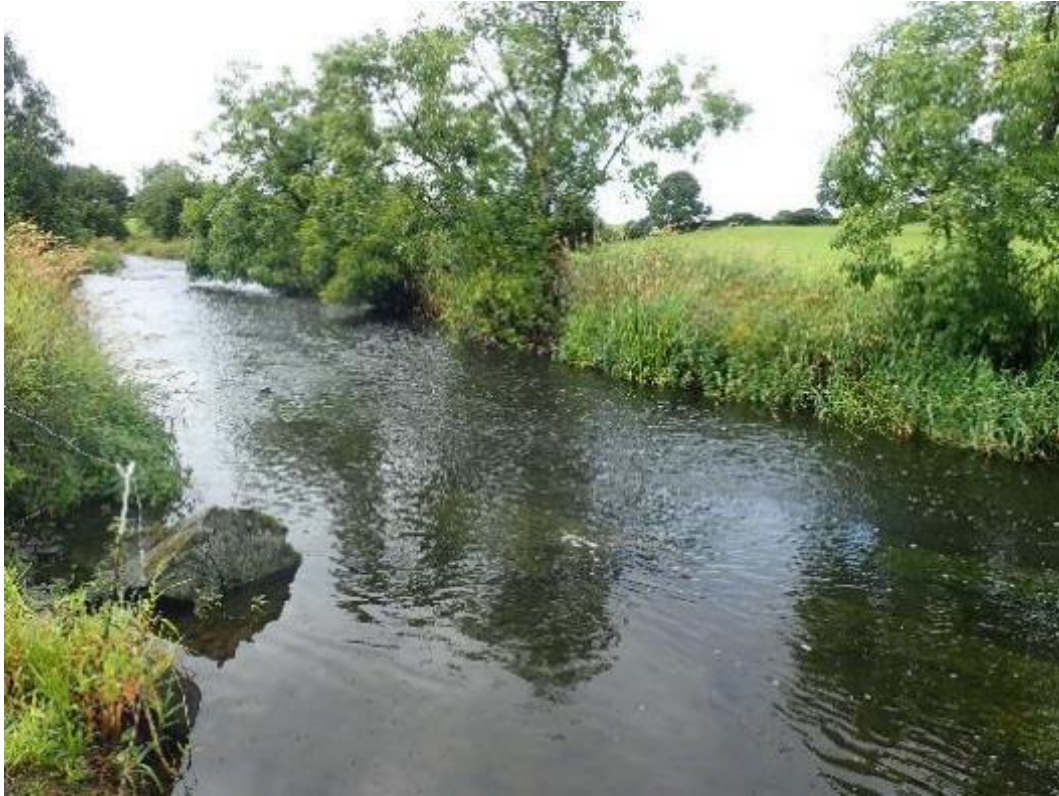
**Photo 66.** Another example of high-quality habitat with luxurious beds of water crowfoot *Ranunculus* sp. in mid channel locations, with good holding water provided by over-hanging cover adjacent, along the LB.

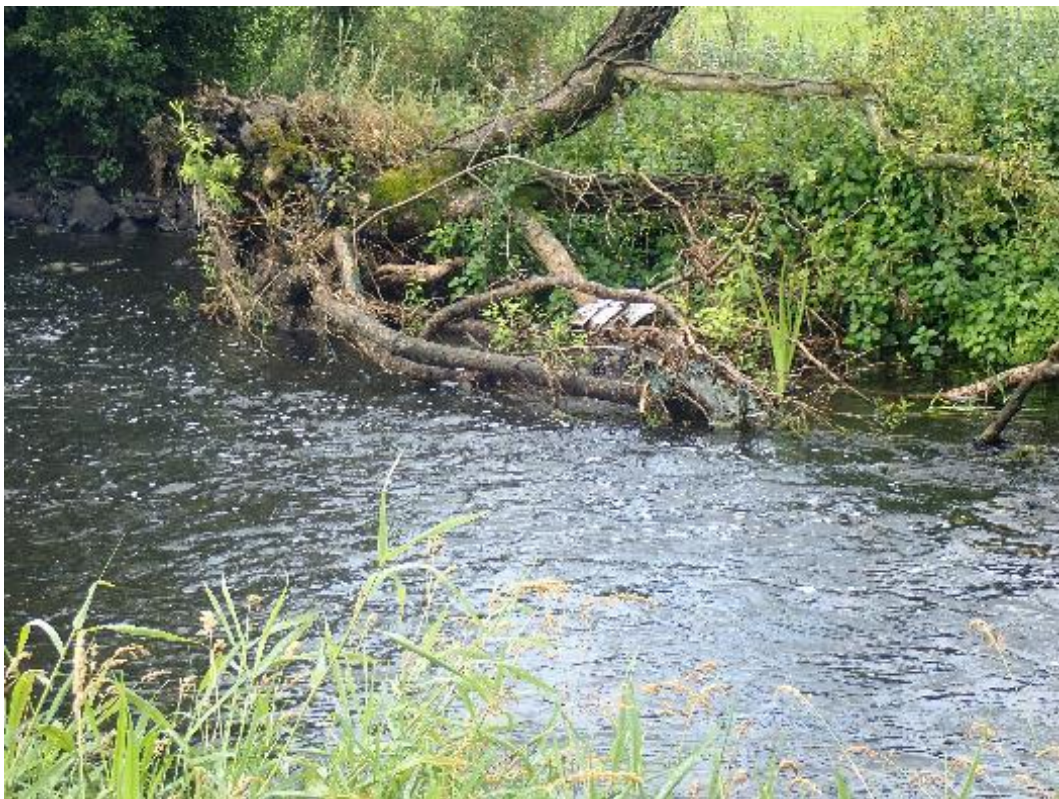
**Photo 67.** A great example of valuable fallen tree cover helping to collect sediments (note emergent reed growth behind). A cover log for a trout and a large meal for grazing invertebrates - trees like this must be left untouched if optimal habitat quality is to be maintained.

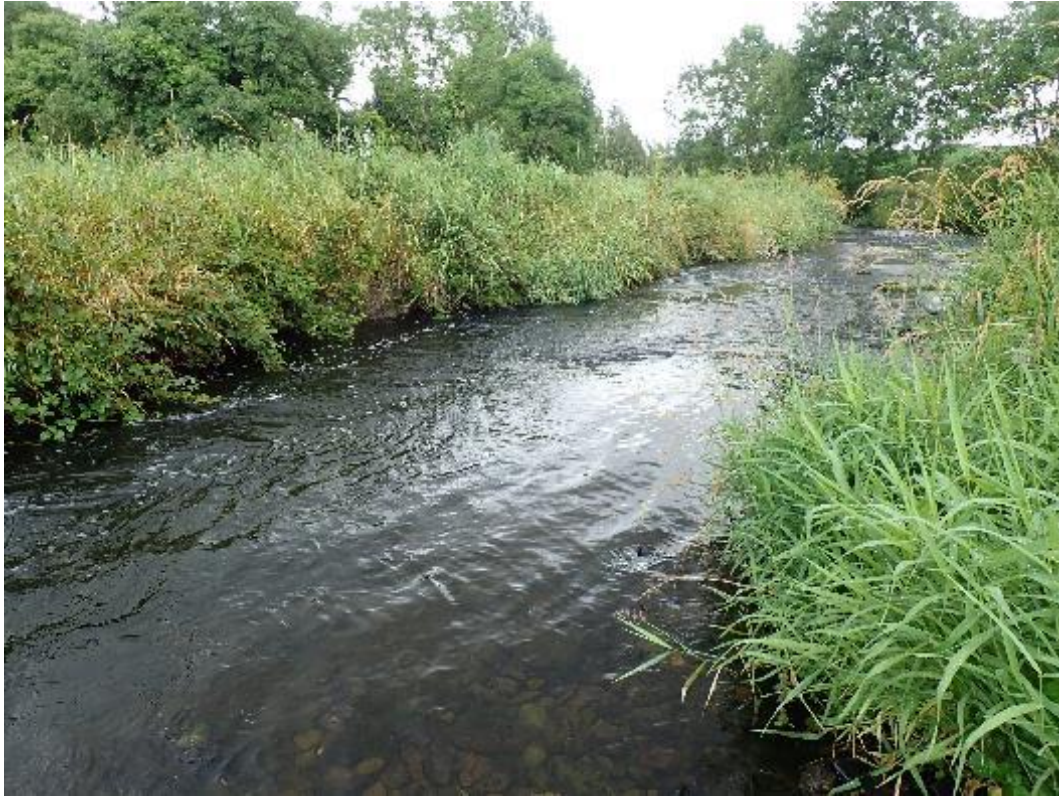
**Photo 68.** Low, wet margins supporting luxurious beds of reed canary grass *Phalaris arundinacea*. Margins like this provide superb bank protection, cover for fish and, crucially, habitat for the adult stages of many species of river flies. Note how the naturally squeezed channel width also maintains flow energy, helping to sweep fine sediments from the gravel bed. A good example of high-quality habitat.

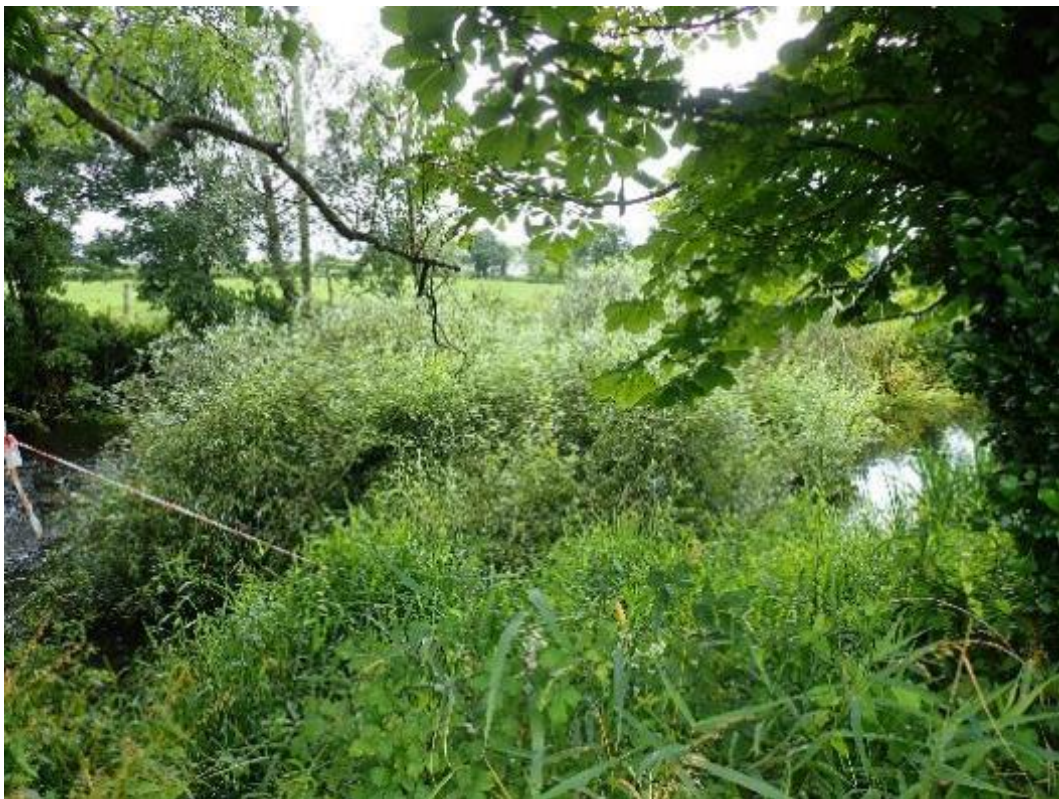
**Photo 71.** Large willow across the full channel width just downstream of the Ballykelly confluence. Removing the top third of the fallen tree and leaving the rest in situ will create a lovely habitat feature.

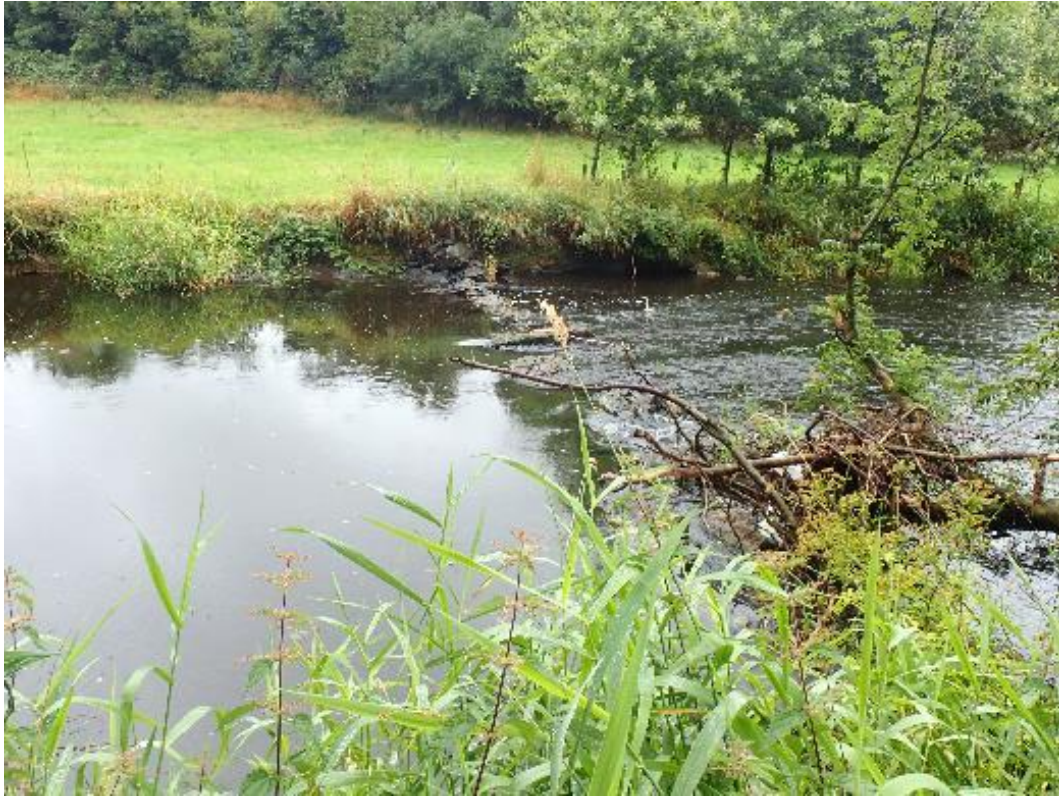
**Photo 72.** One of several low stone weirs in the Castlering to Knockbridge reach. Notching out a 2m wide gap to bed level would reinstate sediment transport and create an attractive flume for fish holding. Ideally, the gap should be on the side of the river where the flow velocities are potentially the fastest (outside of any sweeping bend).

<b>Photo 72</b>	1	Several low weirs	Notch out a 2m wide gap to bed level into all low stone weirs. Select areas where flow velocities would naturally be at their highest.
Over-shading

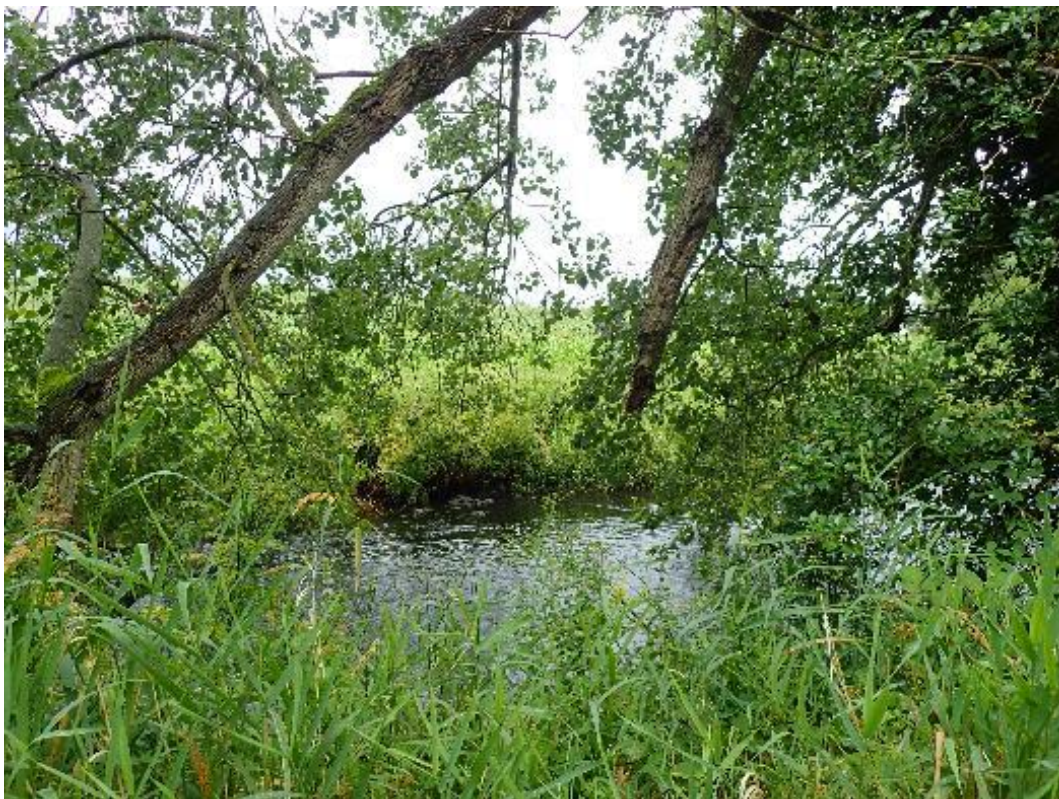
**Photo 73.** Habitat quality in the reach between Castlering and Knockbridge was generally very good. However, there were numerous opportunities to undertake some valuable tree hinging to create more in-channel habitat diversity and to open up one or two areas for increased light penetration.

<b>Photo 73</b>	2	Numerous locations	Undertake tree hinging to increase light penetration.

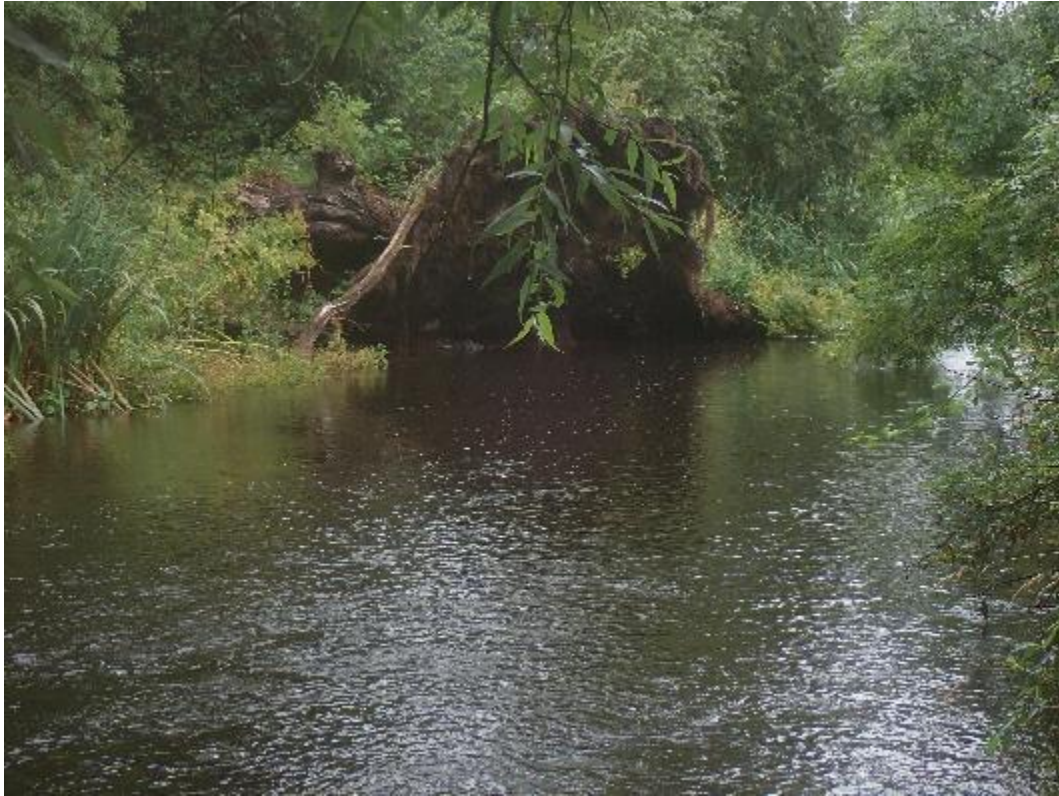
**Photo 74.** The root plate of a large willow that has fallen away from the river. Great habitat and a favoured nesting site for kingfishers.

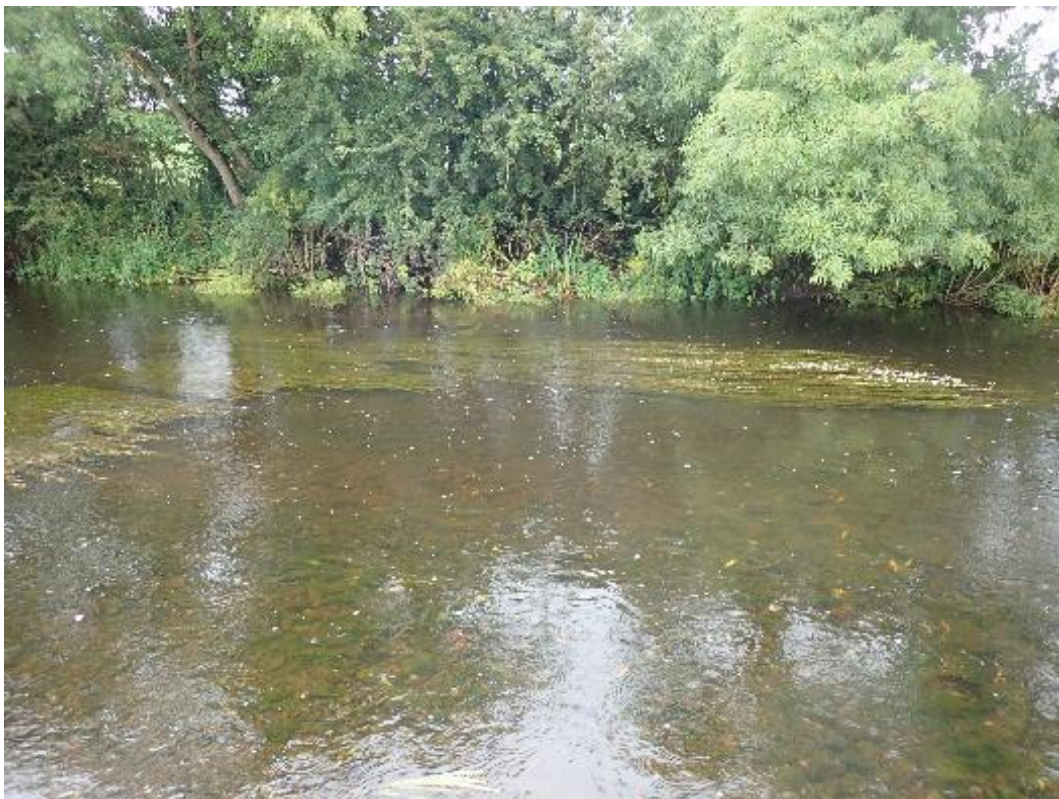
**Photo 74.** Beds of watercress were evident on the DBT&SFA water for the first time (e.g. none observed d/s). This plant is more prevalent in the reaches further upstream and is synonymous with high quality trout streams, providing cover fish and important habitats for specialised invertebrate species.

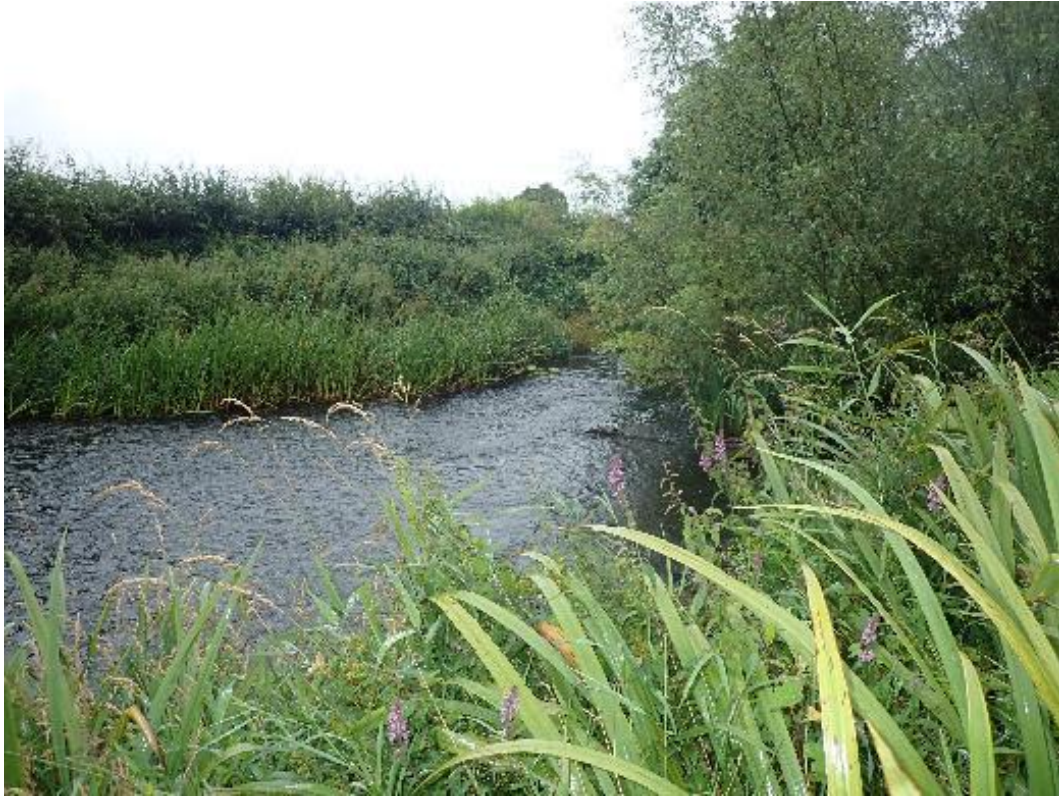
**Photo 75.** The section of river between Knockbridge and Castlerring was extremely diverse and supported good examples of habitat suitable for all salmonid life stages. In this example, excellent parr habitat, with well-covered low natural margins and low overhanging willow likely to be valuable holding water for larger fish.

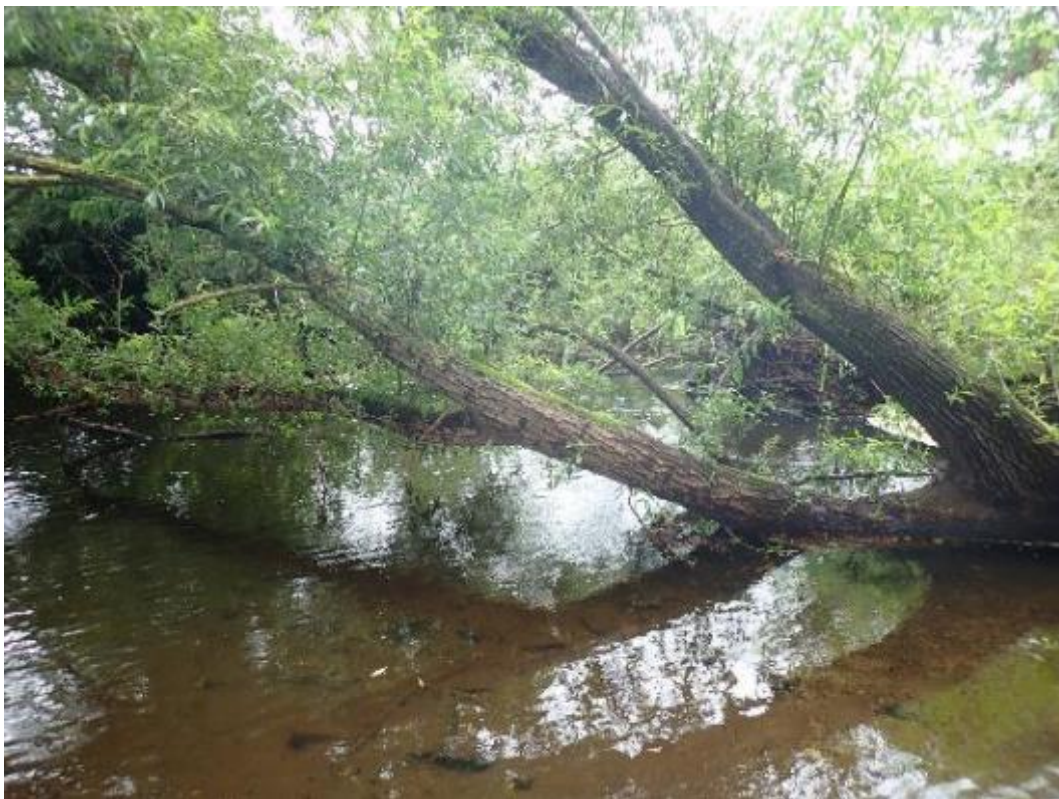
**Photo 76.** Where large crack or white willows fall into the river there are opportunities for further hinging to creating cover logs and natural flow deflectors.

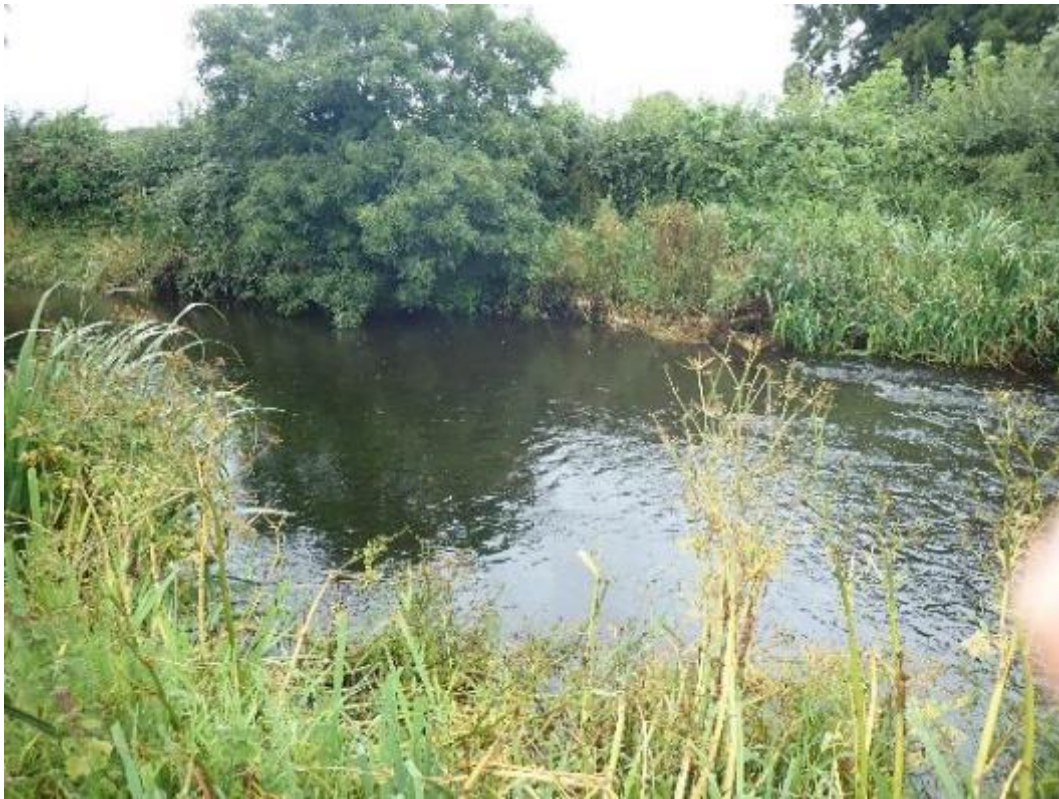
**Photo 77.** The tail of smooth shallow glide with broken riffle below is likely to be a good spawning site. Retaining all the overhanging willow branches on the far margin is vital to provide cover for pre- and post-spawning adults.

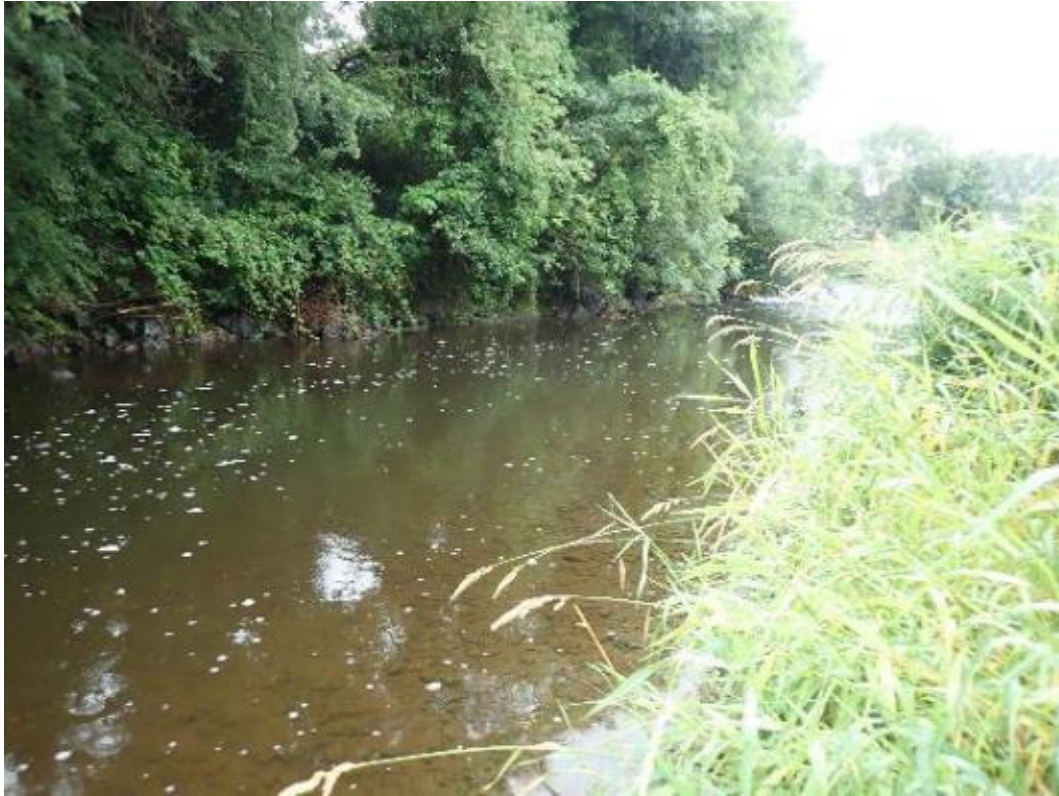
**Photo 79.** The far margin is defended with pitched stone. These should be removed to encourage bank and bed scour so that deeper pools can develop.

<b>Photo 79</b>	1/2	Numerous locations	These should be removed to encourage bank and bed scour so that deeper pools can develop.
Poor land management and inappropriate bank work

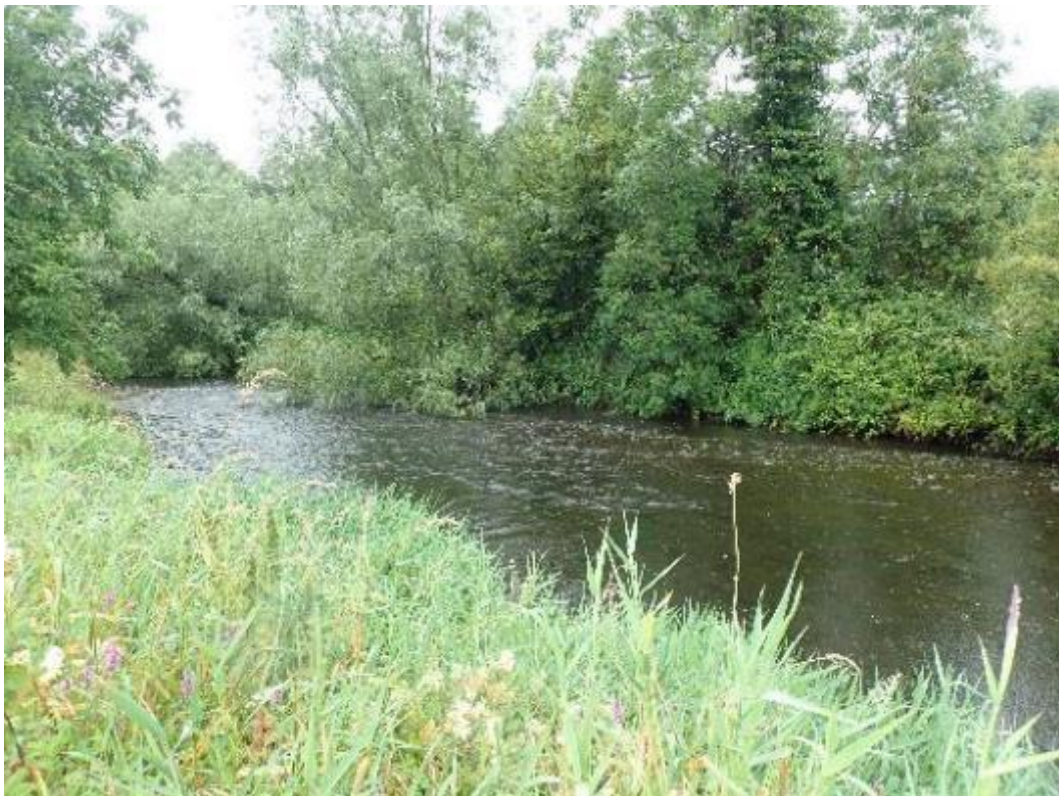
**Photo 80.** Good spawning and nursery habitat for both salmon and trout at the very top end of the DSAA water, a short distance below Knockbridge. First class parr habitat made more valuable by the low trailing willow cover.

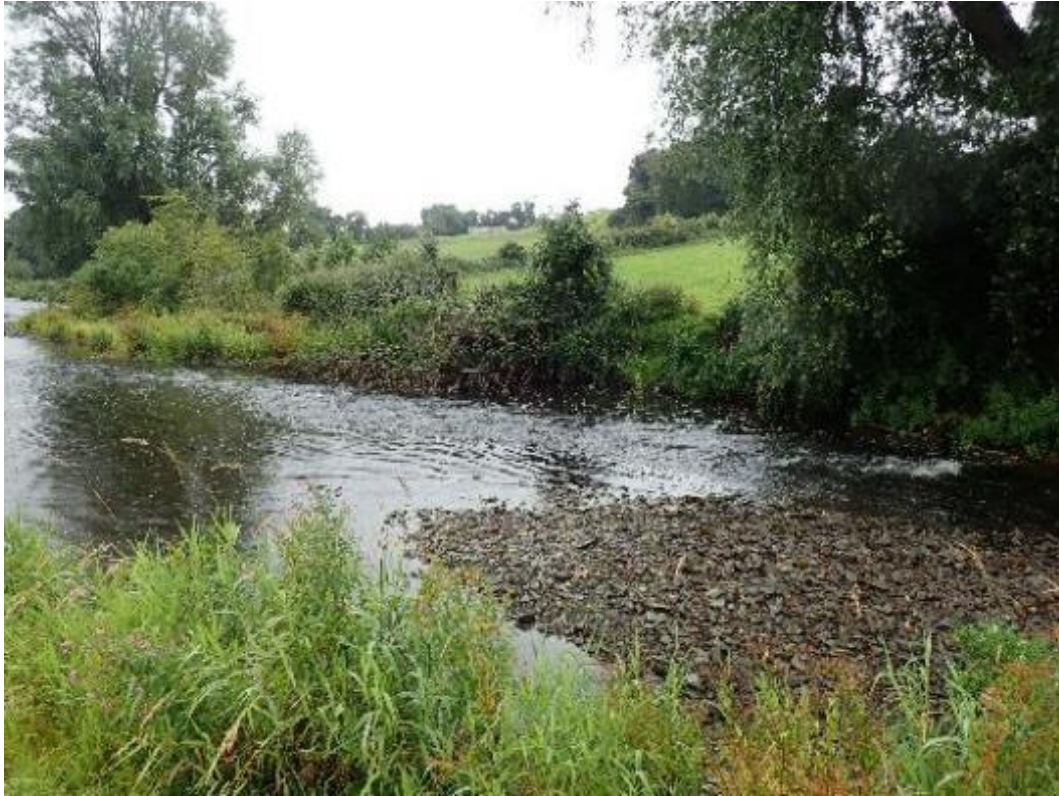
**Photo 81.** Lovely pool & run habitat within a sinuous planform – high quality habitat.

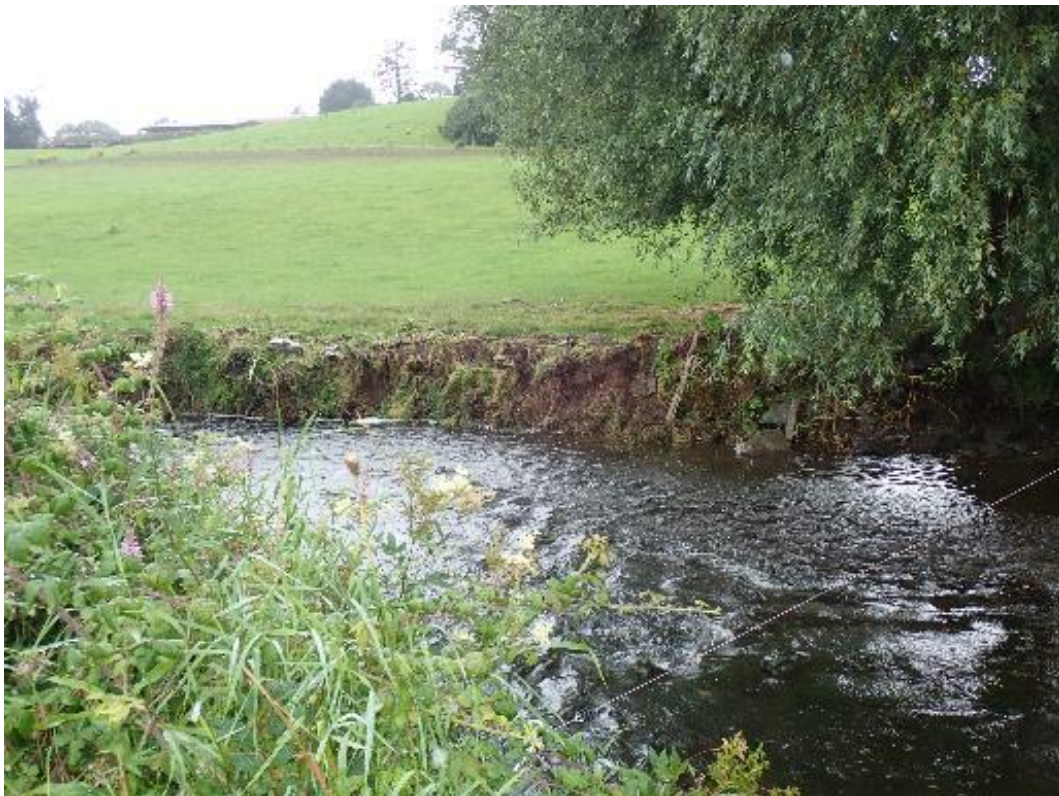
**Photo 82.** The next 250m of RB appears to be in single ownership and is blighted by poor management of the riparian zone (grazing and bank poaching pressures) with areas of the bank inappropriately defended with imported waste. The whole reach between 53.964985, -6.490593 and 53.963552, -6.485808 has examples of poor riparian management.

<b>Photo 82</b>	1	53.964985, -6.490593 to 53.963552, -6.485808	Enter discussions with the landowner to seek buffer fencing and cessation of bank work with waste material.  If no improvement is achieved, report to the relevant authority (e.g. EPA in RoI).
Extensive horse chestnut growth and shading along the riverbank

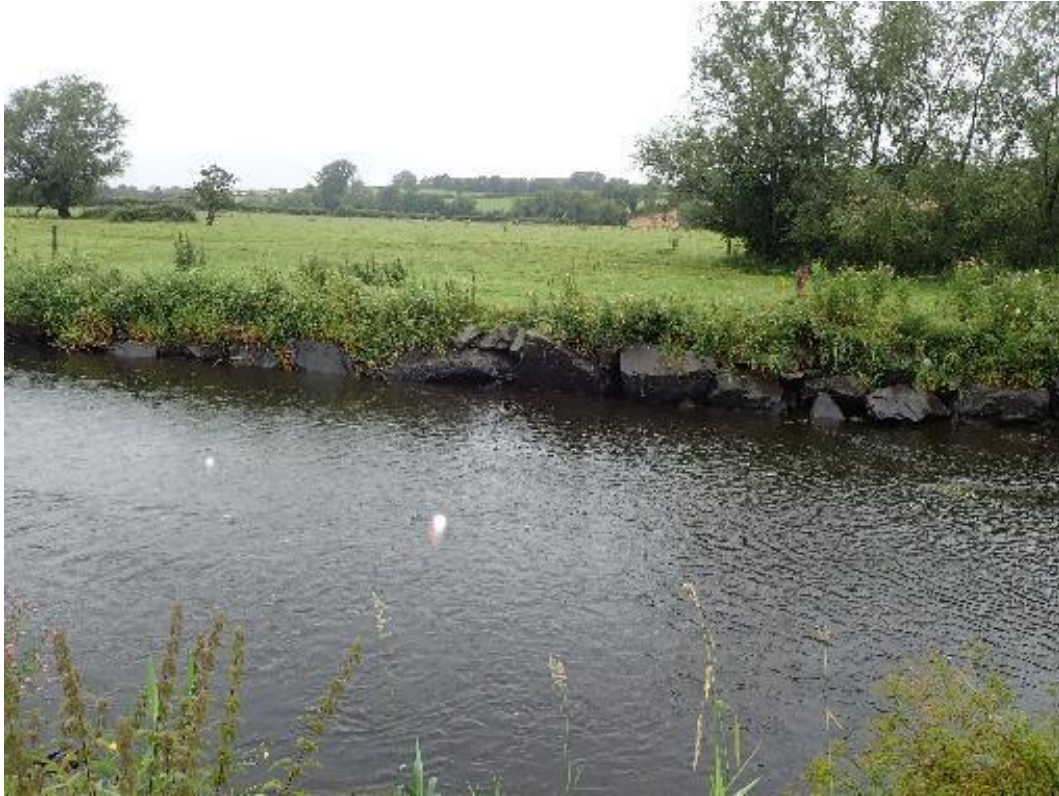
**Photo 85.** A short distance downstream there was evidence of more substantial bank protection work using large pitched rocks for rip-rap adjacent to the LB. This would appear an excessive measure to reduce bank erosion when a simple stock fence and narrow buffer zone would have provided adequate protection - also cover and food for fish and invertebrates. Although it could be argued that pitched stone provides gaps and micro niches for small fish, it is a poor substitute for a naturally functioning "soft" margin and invariably leads to further erosion problems elsewhere.

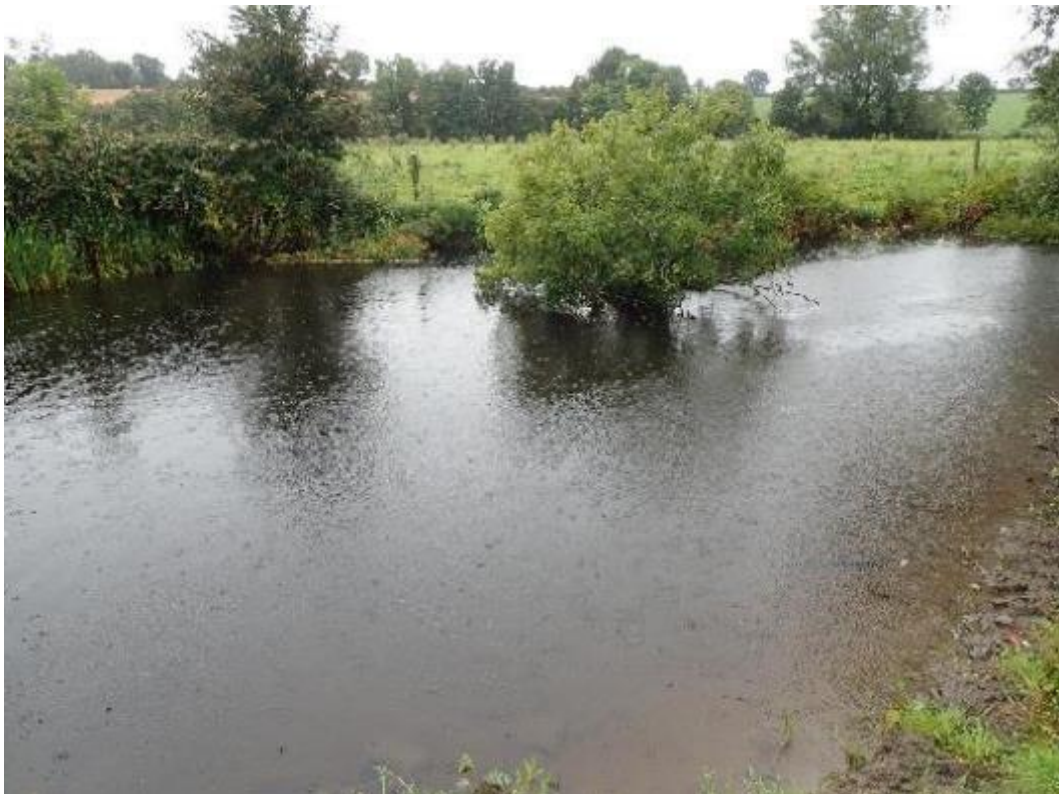
**Photo 93.** A lovely deep holding pool for adult salmonids with valuable willow cover near the tail.

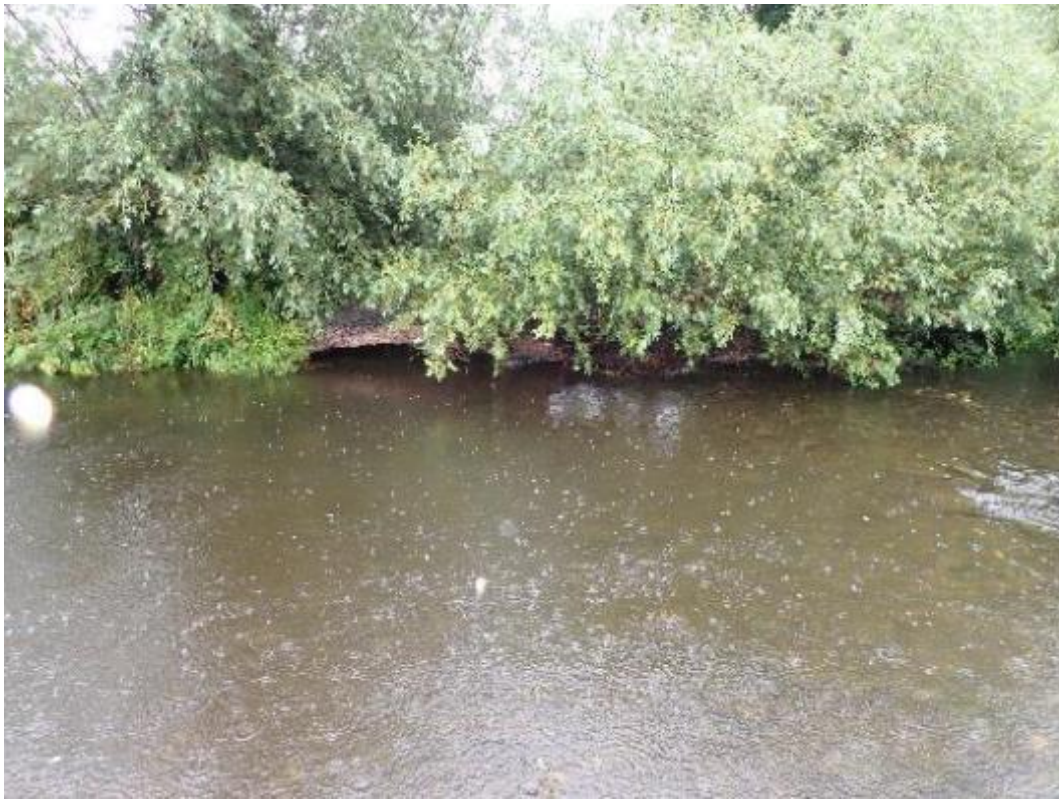
**Photo 94.** A great example of a partially fallen willow providing a brilliant marginal cover log. When these coincide with sufficient depth, they are hugely attractive to fish. Such features are often utilised by sea trout laying up during the day and can be a great means of increasing fish holding water, spreading fish throughout a river rather than restricting them to the few deeper pools/bends.

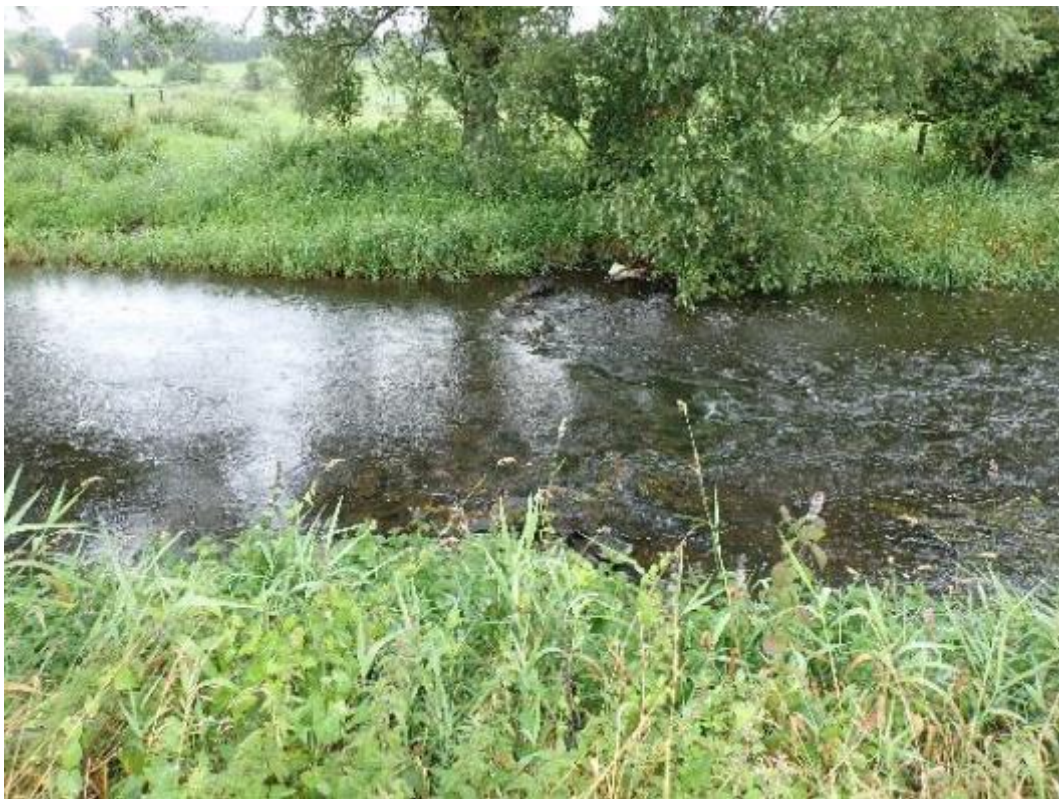
**Photo 95.** An old stone weir with the centre blown out: a much better outcome for the river. In such scenarios, it should be ensured that the foundations of the weir are also dislodged/removed to allow bed scour and depth creation.

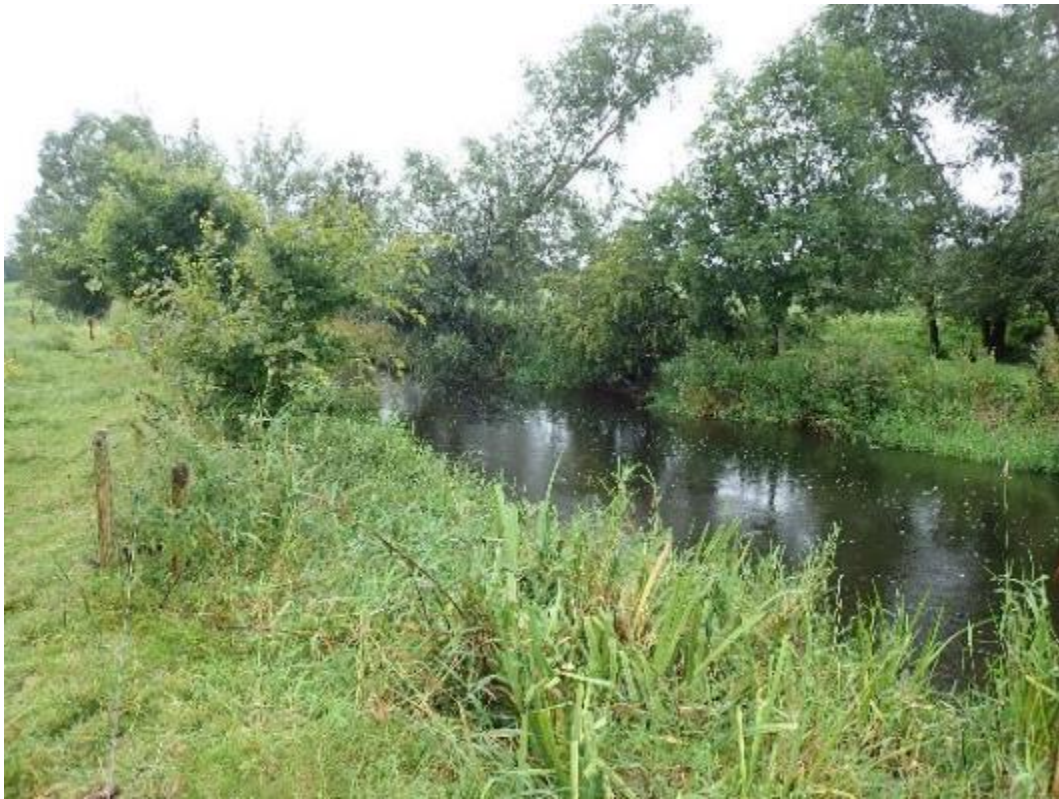
**Photo 96.** Stock fencing and some tree planting (mainly hornbeam) has been undertaken adjacent to the RB. This is much more sustainable bank protection work and provides a fish-friendly river margin.

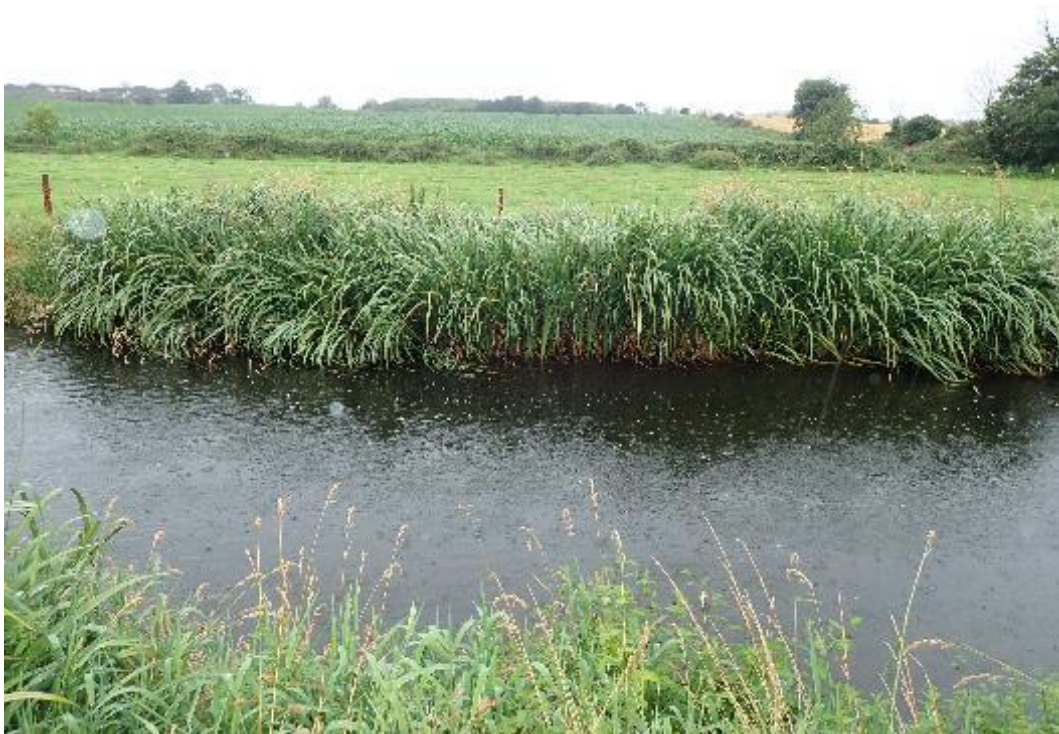
**Photo 99.** A better-sized buffer meadow between the riverbank and the start of the arable meadows on the valley sides. This would be considered good practice riparian management.

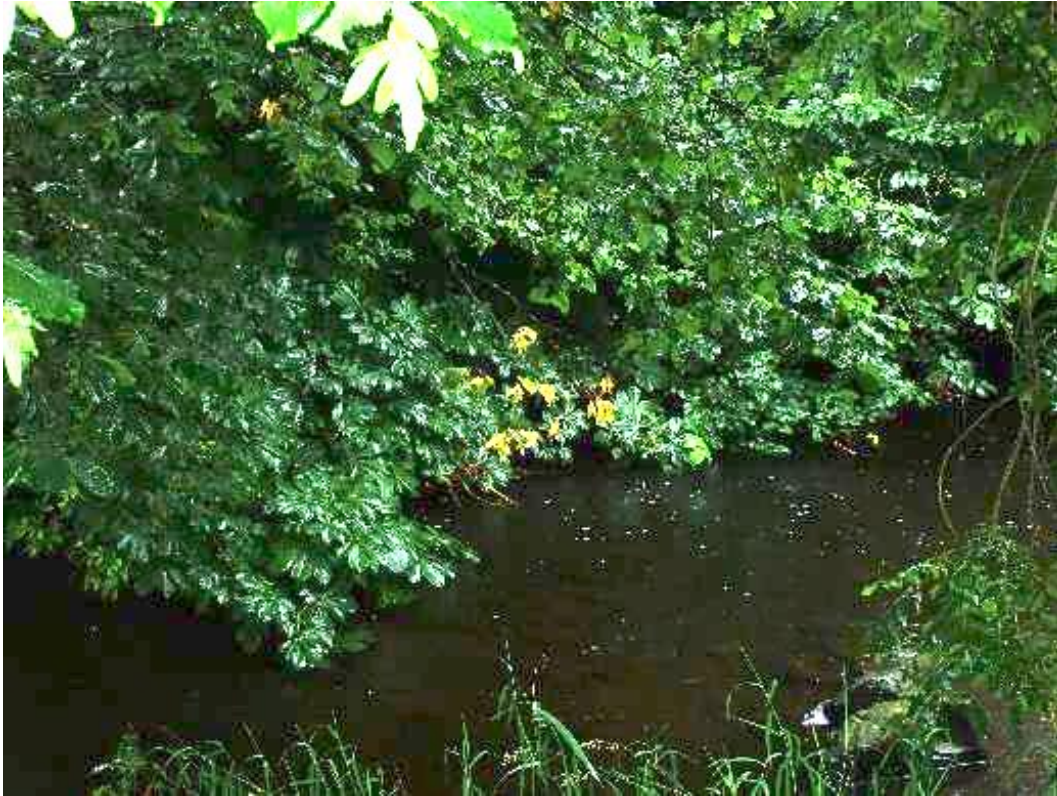
**Photo 100.** A dark avenue of dense shading around 53.958713, -6473519 is thought to be associated with ornamental planting in the grounds of the old derelict house, which sits back on the northern ridge. These horse chestnuts are an inappropriate riverside tree. The conkers themselves if crushed produce saponin, which is a highly toxic piscicide. Any horse chestnut that drops fruit on a farm access track for instance, where conkers might be prone to crushing, should be carefully assessed to ensure any run-off does not enter any nearby stream or river.

<b>Photo 100</b>	1/2	53.958713, -6.473519	It would be beneficial to thin-out the trees and replace with alternative species.
Bamboo – non- native and invasive species
