## Walkover Assessment

## River Fane

5th-7th/08/2019

Undertaken by the Wild Trout Trust

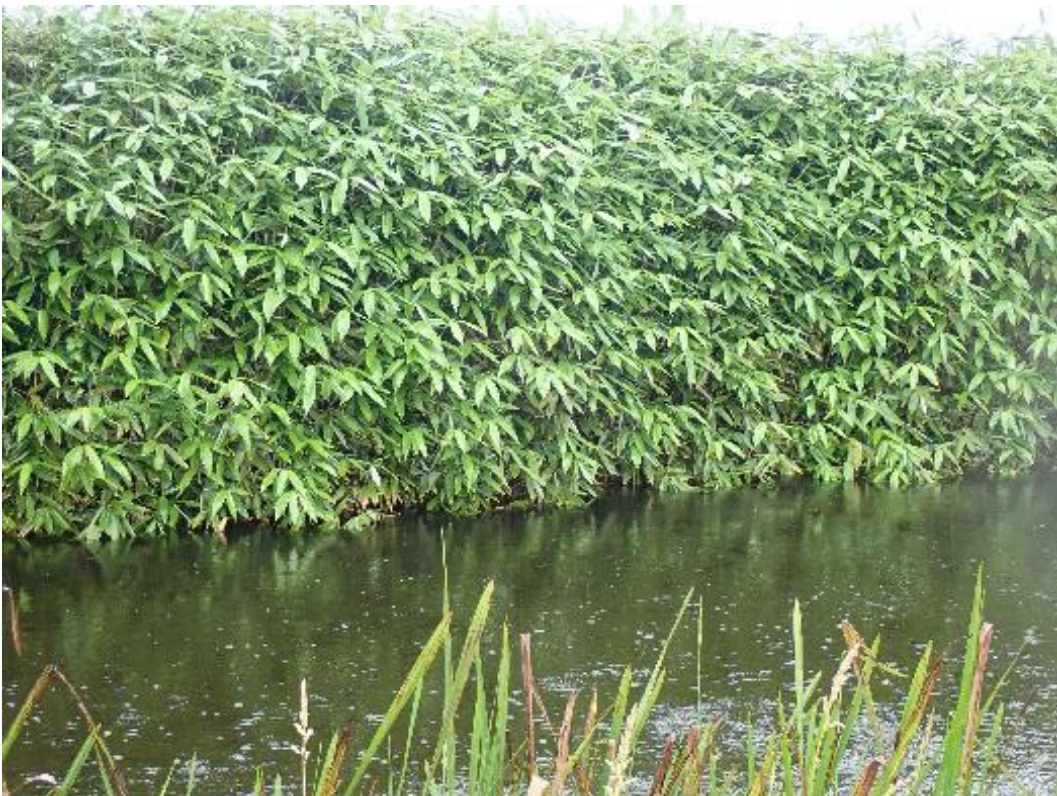
**Photo 101.** Another non-native legacy from the old estate, although not usually categorised as an "Invasive Non-Native Species": bamboo is nevertheless not native, highly invasive and undesirable as a riverside plant (53.957863.-6.470611).

<b>Photo 101</b>	1	53.957863, -6.470611	Eradicate the plant from the wild (e.g. riverbank).

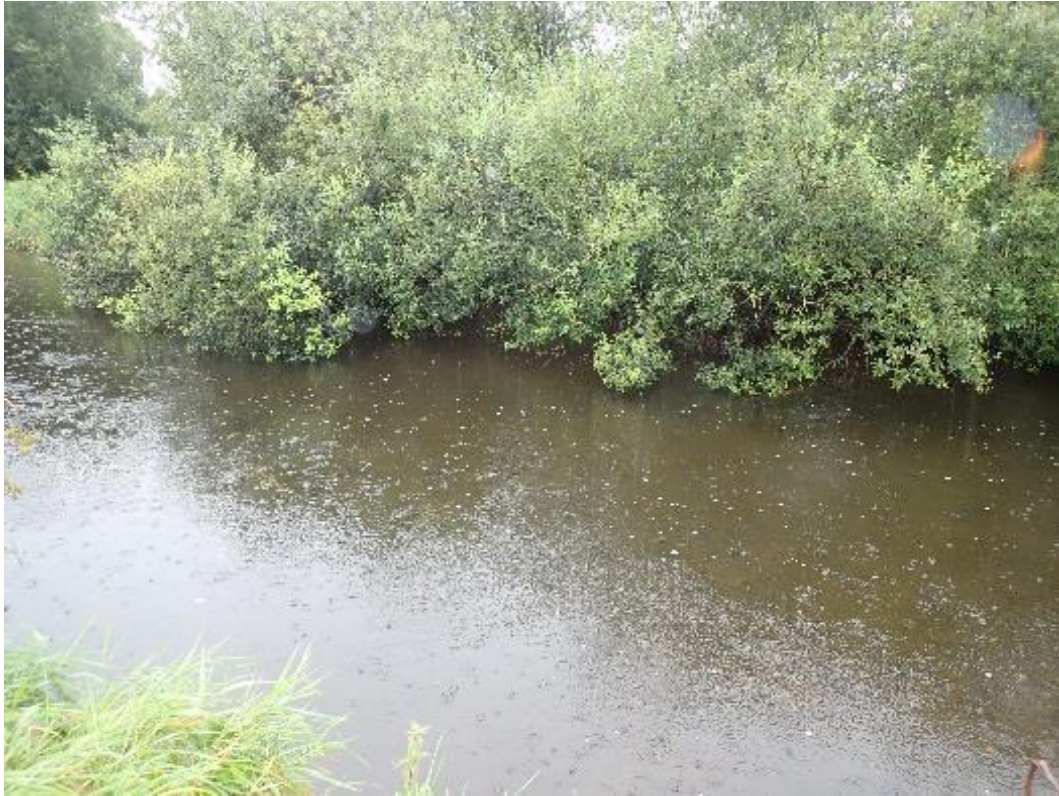
**Photo 102.** However, banks lined with native willow are desirable and provide great opportunities for locally adapted native invertebrates (fish food) as well as fish cover and root systems that bind in bank soils.

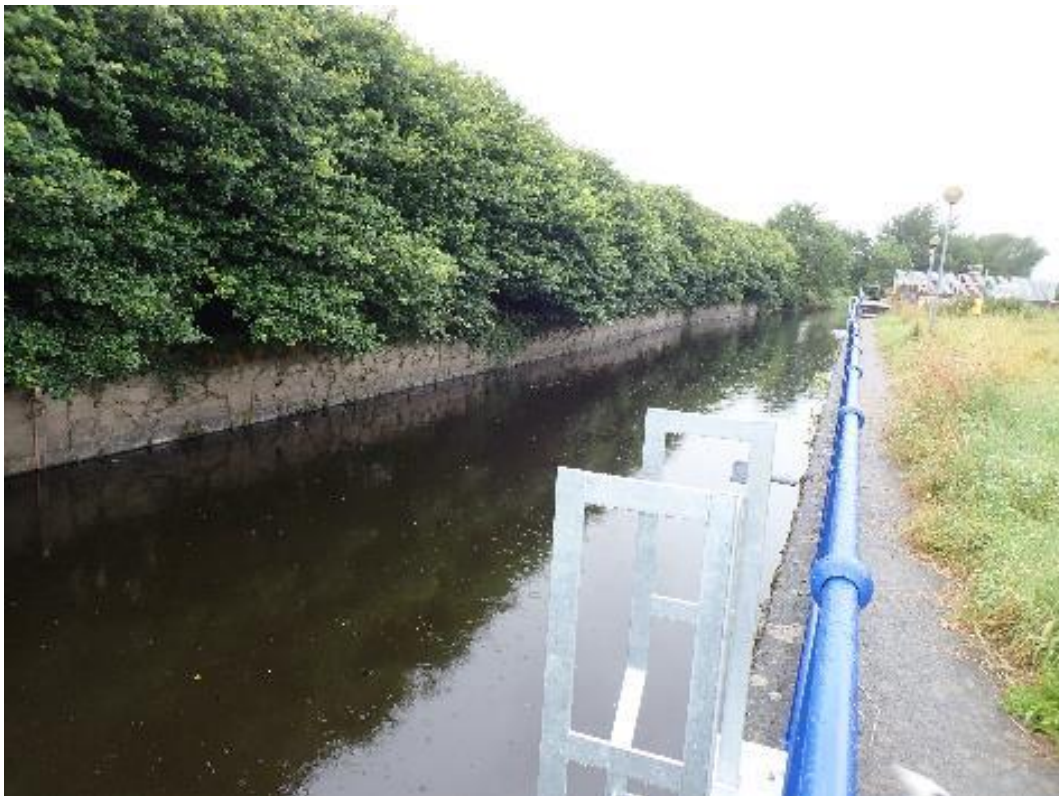
**Photo 107.** The long concrete channel constructed at the downstream end of the abstraction appears set up for flow gauging. It would be worthwhile ascertaining whether the data are available to the club. Dialogue with the regulators and water company might also identify if the long section of sterile channel could be improved via box planters to provide shade and cover without interfering with the laminar flows within the gauging box.

<b>Photo 107</b>	2	U/s of 53.954030, -6.460303	Contact the water company and regulator to ascertain whether in-channel improvements could be achieved with planters, without compromising monitoring at the site.

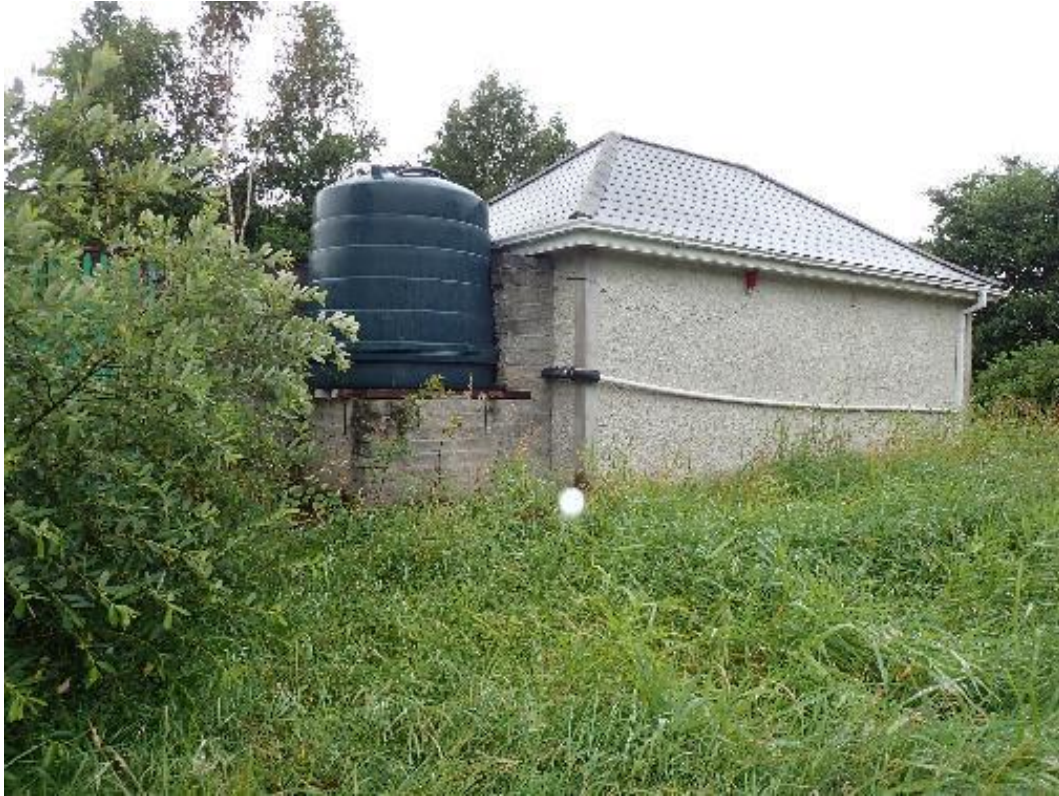
**Photo 108.** The DSAA hatchery building: it is understood that the hatchery has not been used for several years. The WTT position on hatcheries and local broodstock schemes is unequivocal and based on sound science collected from numerous schemes operated around the world. The overwhelming evidence suggests that at best hatchery schemes don't help to improve runs of wild salmonids and at worst are just another negative impact upon the wild population. The WTT recommends that the club keeps the hatchery closed and redoubles efforts to improve river habitats as the best methods for supporting Fane salmon and sea trout runs.

Finally, the presence of the old fish hatchery was noted. The WTT strongly recommend that clubs resist any call to recommission the hatchery, this would be counterproductive to the development of a healthy wild salmonid fishery. Instead, improving wild salmonid populations through a programme of fish passage improvement and habitat restoration that will naturally boost smolt output is highly recommended. Further information on the pitfalls of fish stocking and hatchery schemes can be provide upon request from the Wild Trout Trust.

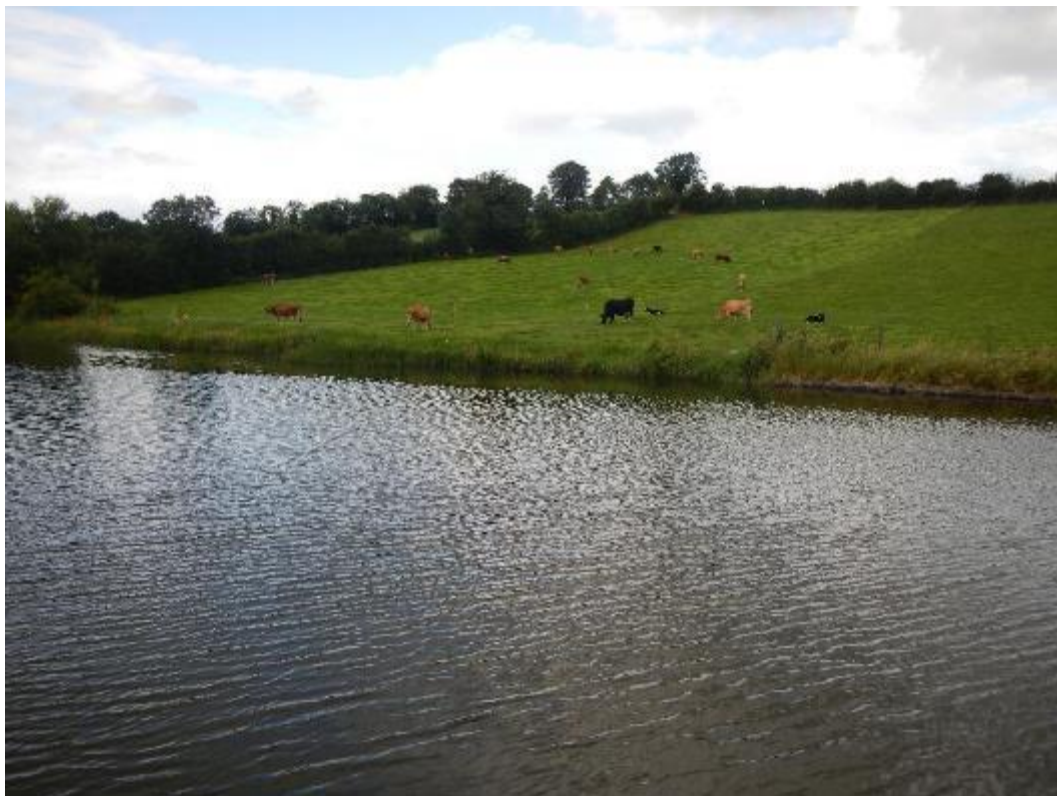
**Photo 110.** The furthest u/s point on the Clarebane River inspected was from the d/s end of Lough Muckno (54.099832, -6.676972). Livestock are grazed on the LB but there is at least a small buffer strip.

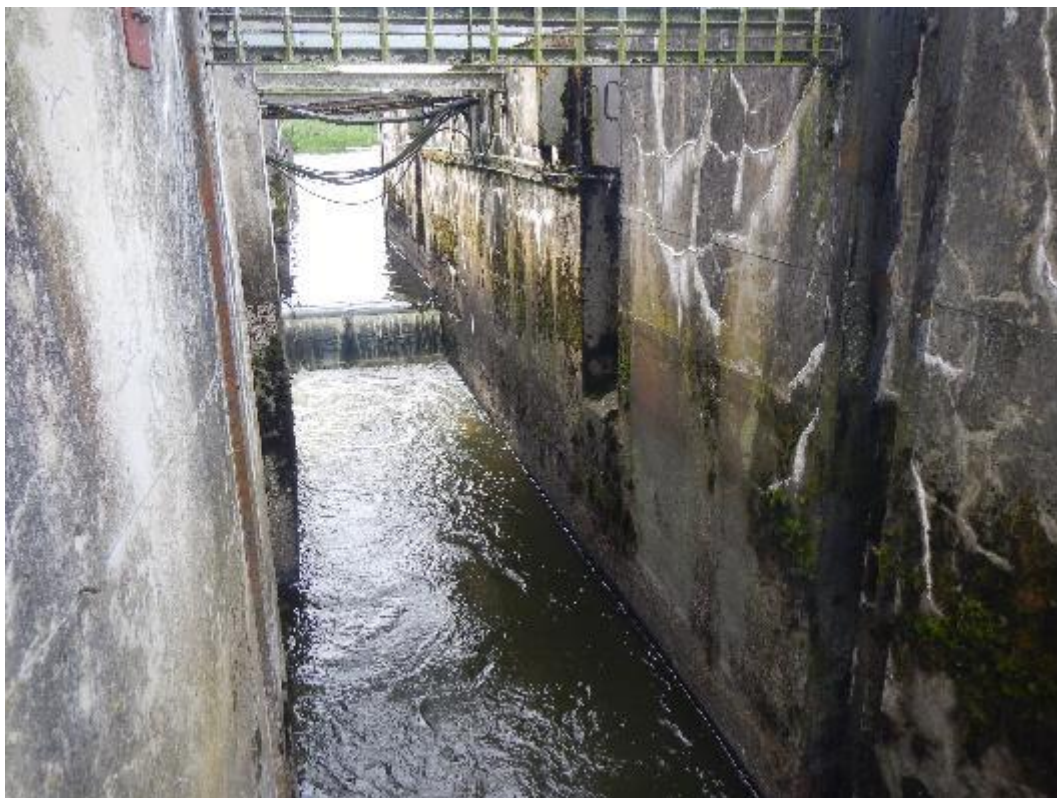
**Photo 111.** The dam just d/s of Lough Muckno (54.099668, -6.67637) regulates flow in the Clarebane River. The overspill of the weir and narrow approach create an obstruction to fish movement u/s and the abrupt lift and flow constriction almost certainly inhibits d/s fish migration, particularly for smolts whose run-timing can be critical for successful seaward migration. Again, the delays also increase predation and disease risk.

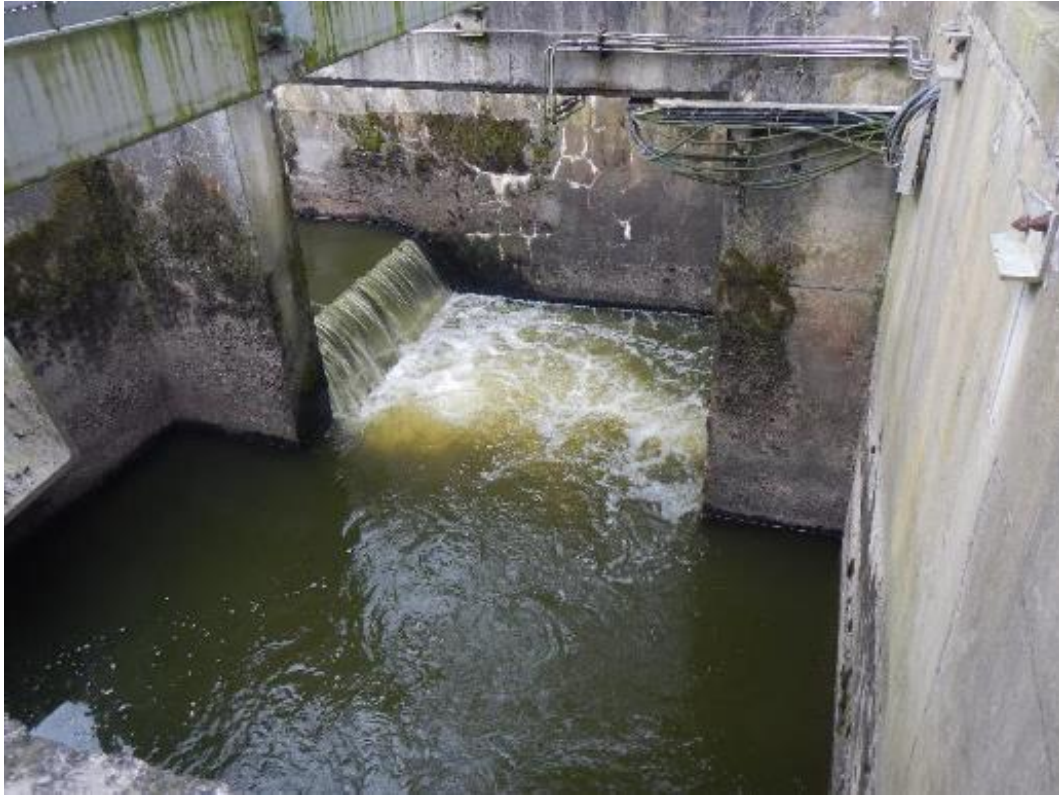
**Photo 112.** The air behind the over-spilling water prevents fish from swimming up through in the water column, requiring a well-timed leap to ascend the structure. The heavily aerated water immediately d/s also reduces the amount of force fish can create within the water to make the jump (i.e. the high content of air bubbles means there is less resistance for the fish to drive forward from).

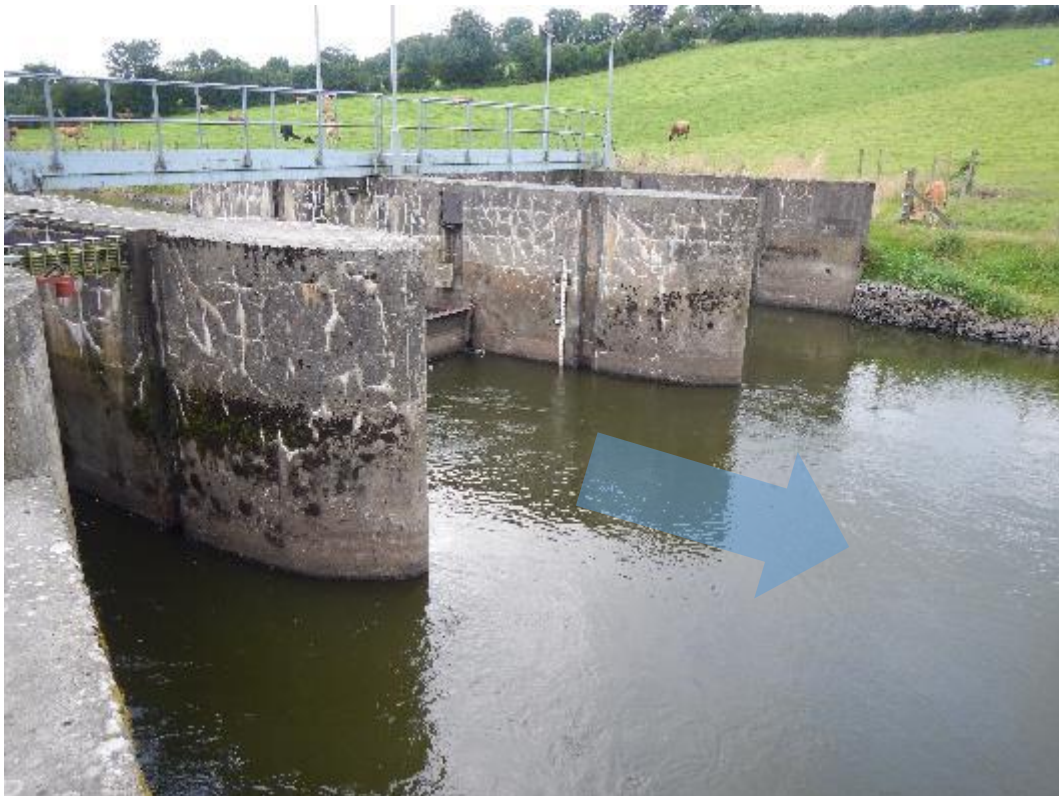
**Photo 113.** Looking at the d/s side of the structure: it appears some flow is also passing under the weir. This may provide some potential for fish passage, at certain times, but undershot structures are notoriously poor at facilitating d/s fish passage. Note the high turbidity of the water. Much of this is suspected to be algal/diatom growth, potentially indicating the enrichment/eutrophication recognised in the river system.

<b>Photo 113</b>	1	54.099668, -6.67637	Without details of how this structure is operated, it is difficult to advise but improvements to both u/s and d/s passage are likely to be required.
Artificially uniform channel - poor habitat quality

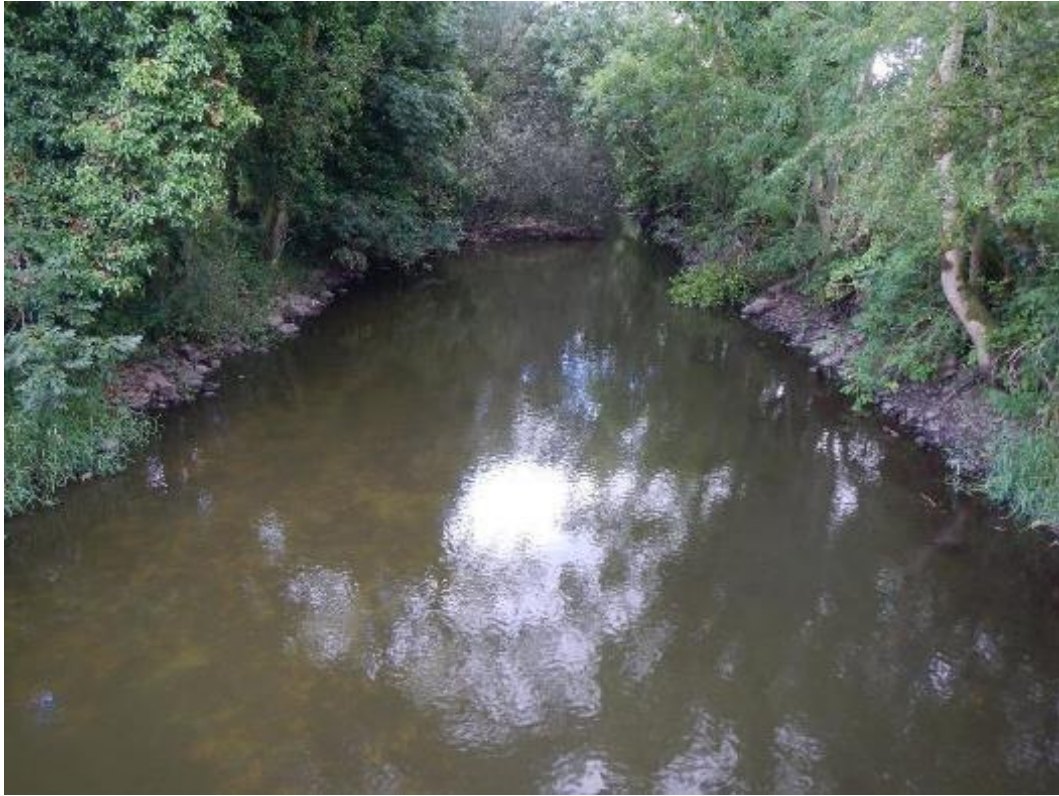
**Photo 114.** D/s of the weir, the artificial, straightened, uniform width and heavily incised channel offers poor habitat for flow-loving salmonids. Occasional overhanging trees provide some cover and refuge but the area is better suited to coarse fish. Introducing more structure into the channel here could improve the flow characteristics and fish-holding potential.

<b>Photo 114</b>	2	D/s of 54.099668, -6.67637	Install tree kickers or other large, lodged woody material to provide in-channel structure and diversify flow.

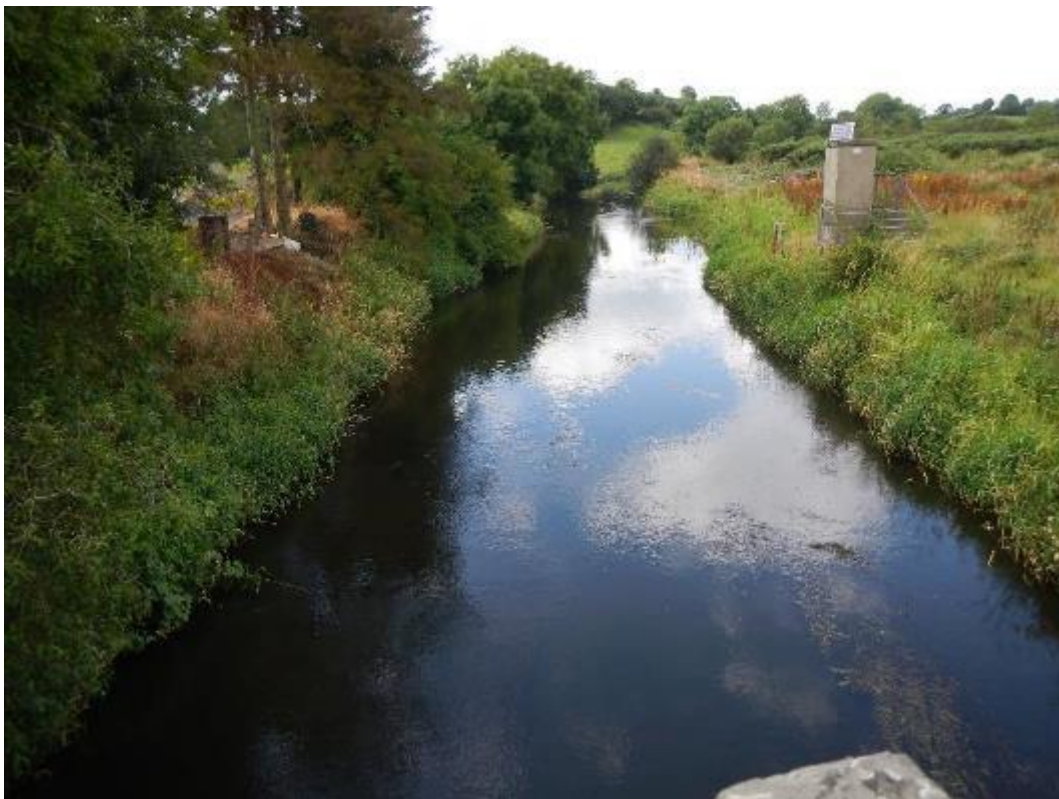
**Photo 115.** Further d/s, just u/s of the L4400 road bridge (54.09279, -6.66574), habitat quality begins to improve, with a more varied channel width and depth, areas of shallower-water and increased flow diversity. Healthy riparian vegetation provides good marginal habitat.

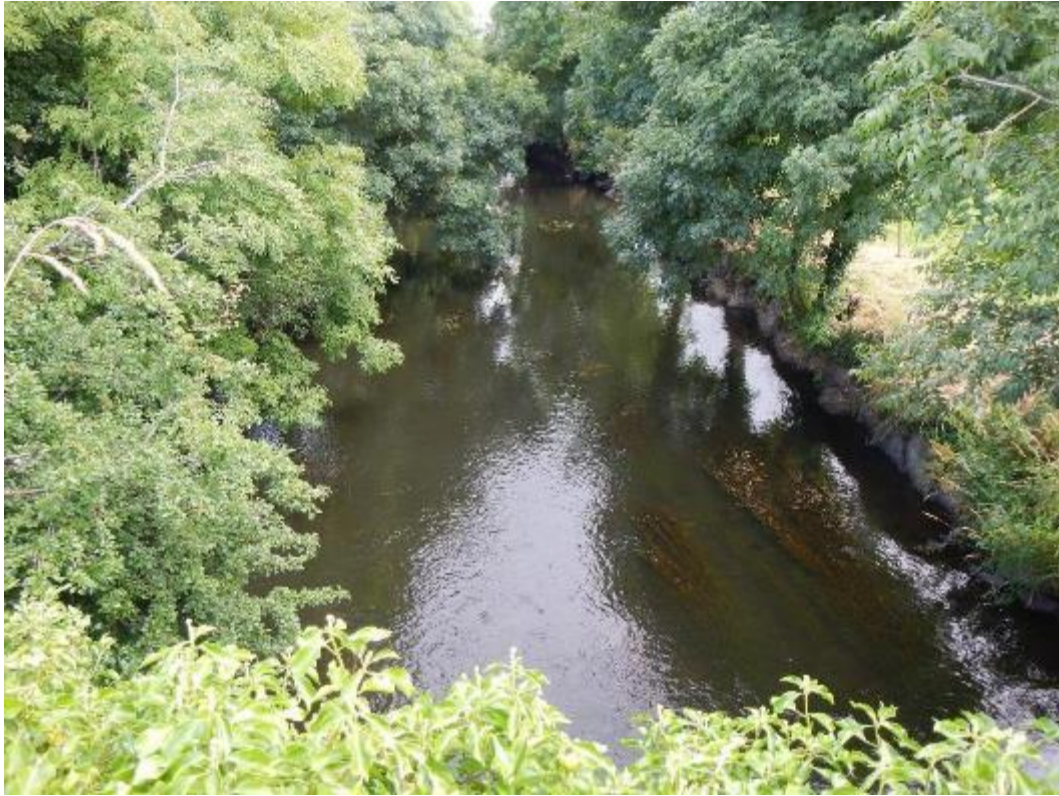
**Photo 116.** D/s of the road bridge, the addition of more low-hanging trees creates ideal adult trout habitat, with several observed. While the low branches may make casting tricky, they greatly enhance the angling opportunities of the area which undoubtedly supports greater numbers and sizes of fish than it would without such cover.

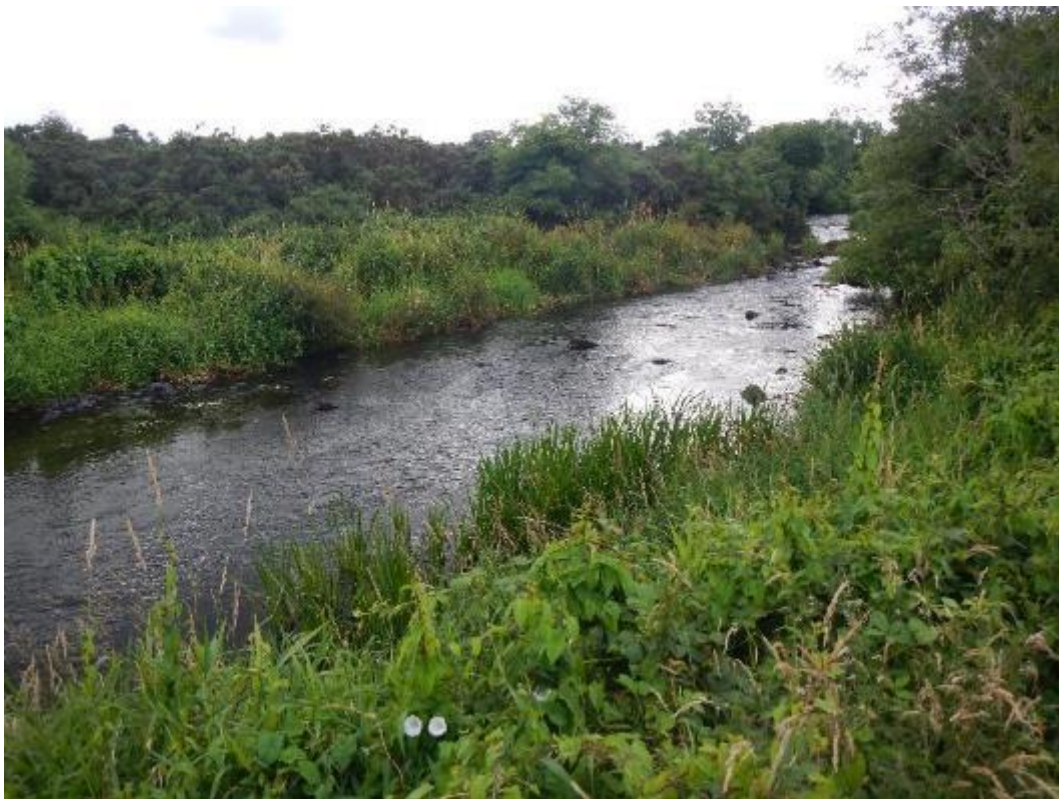
**Photo 117.** Increased gradient and flow diversity create a range of pool and riffle habitat, with valuable pocket water among areas of bedrock.

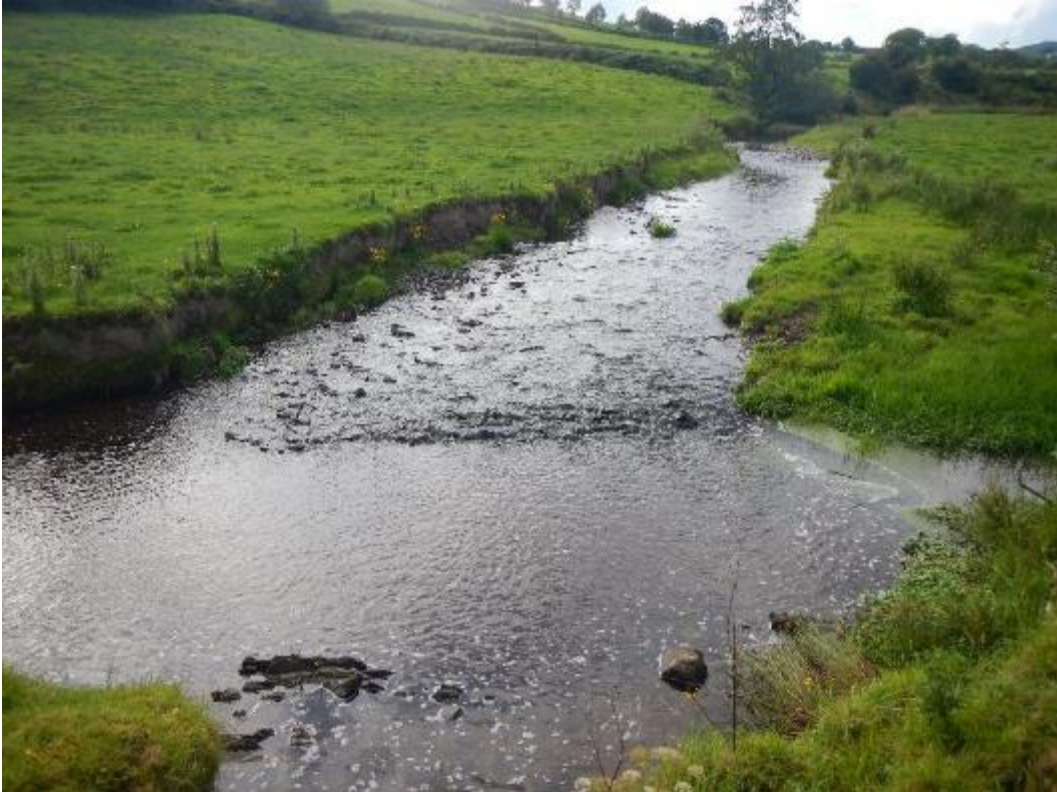
**Photo 118.** A section of the County Water was walked d/s from around 54.140357, -6.640045. Here, gravel and cobble riffles create valuable potential spawning habitat, particularly for larger migratory salmonids. However, grazing is leading to a lack of riparian vegetation, erosion and poorer habitat than could be achieved through livestock exclusion.

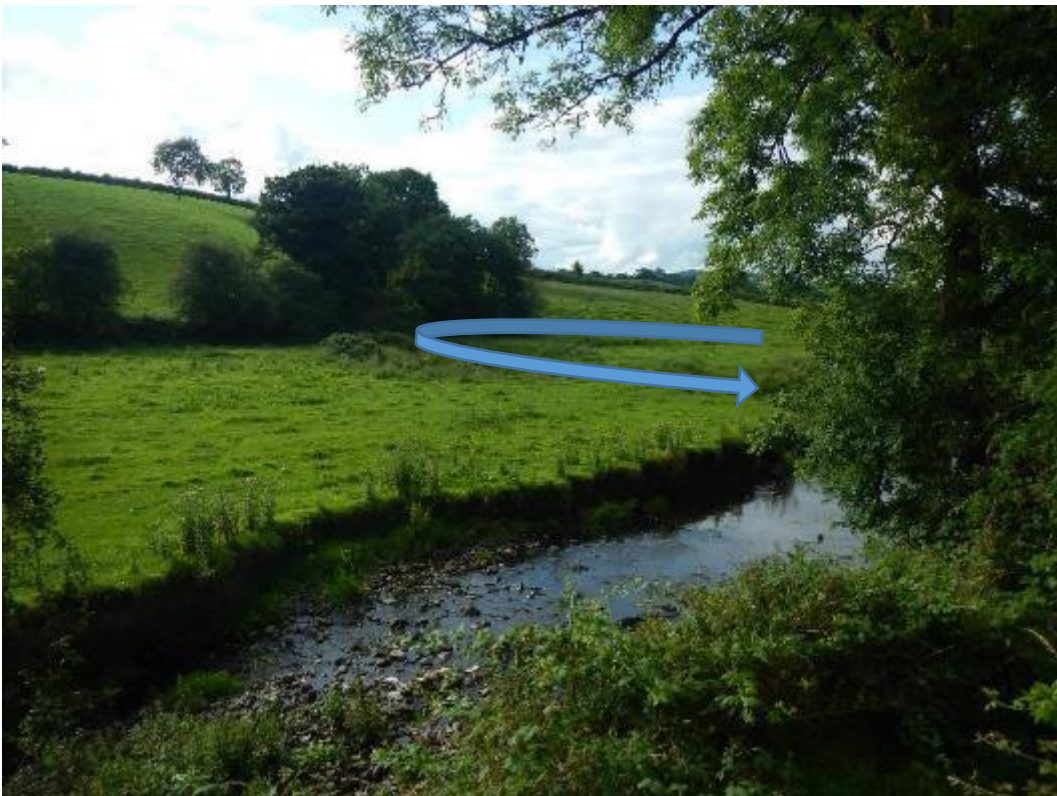
**Photo 119.** An old meander in the river course (blue arrow) was observed in the field but is now disconnected from the watercourse and is highly suggestive that the channel has been straightened (54.1400448, -6.6409435). This kind of feature can be reinstated as part of a river restoration scheme, but that requires landowner buy-in to the scheme.

<p><b>Photo 119</b></p>	2	54.1400448, -6.6409435	Potential for channel restoration/re-meandering.
Cattle poaching/bank erosion

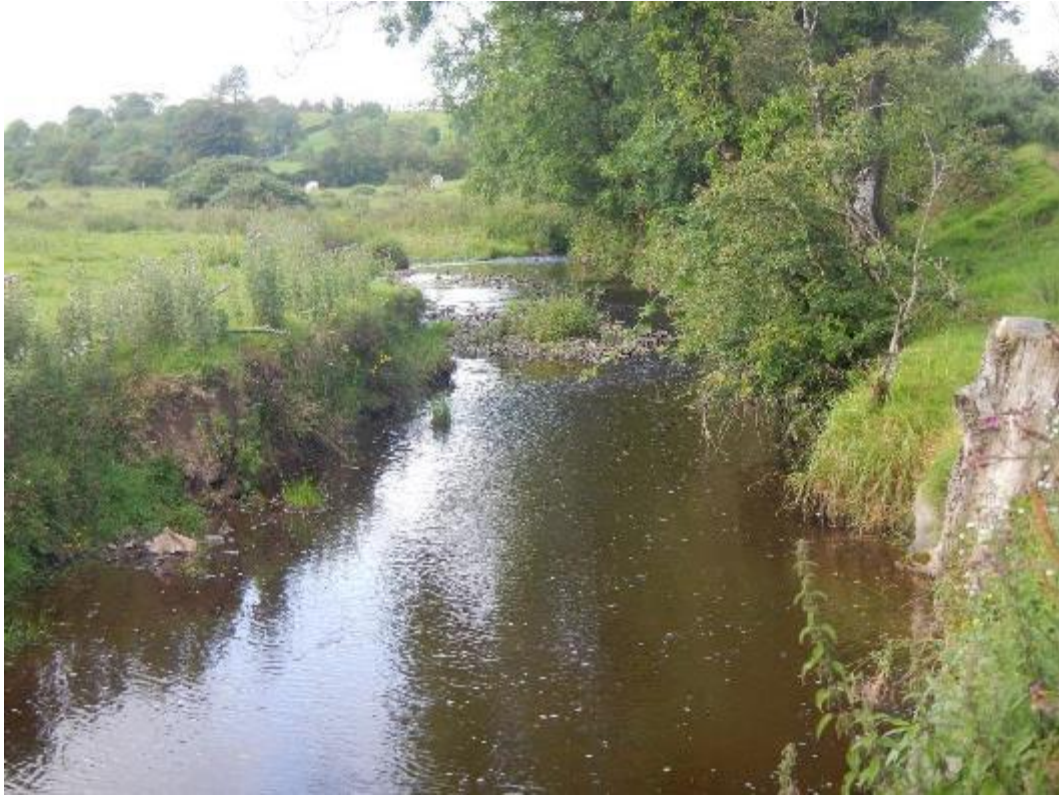
**Photo 120.** Active sediment transport is creating valuable bed erosion and deposition, facilitating a varied channel profile and niches for a range of fish ages, along with potential spawning riffles.

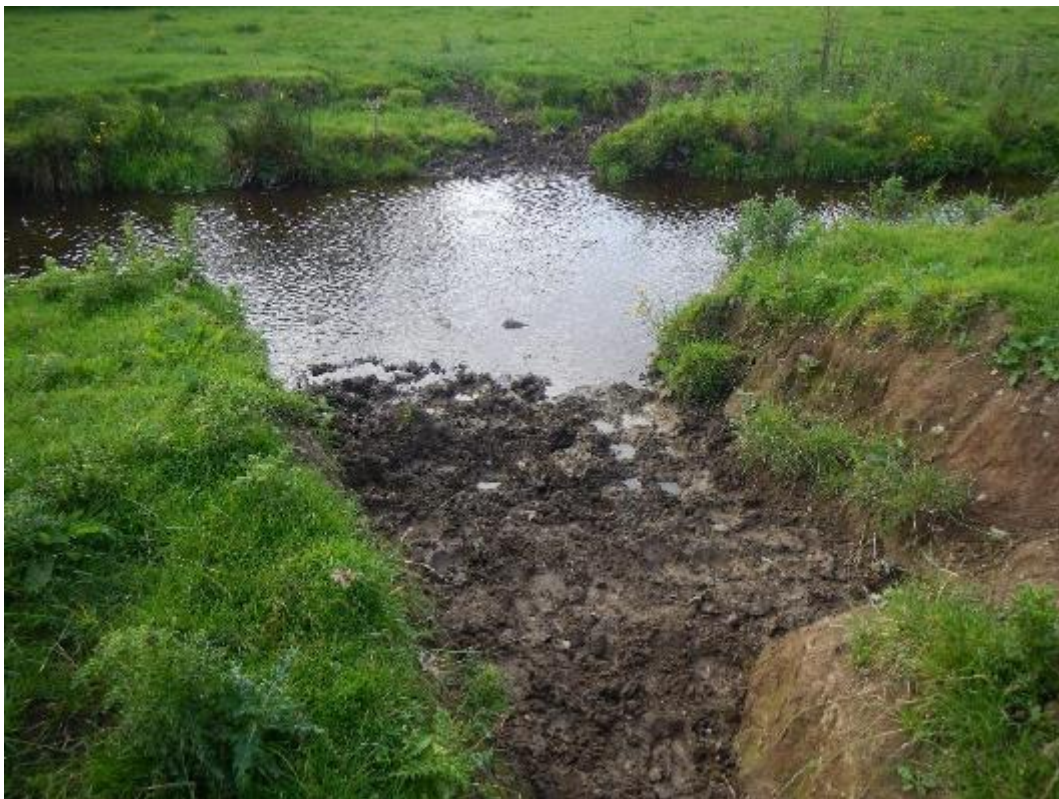
**Photo 121.** Un-natural bank erosion created by livestock access is not beneficial and is contributing to greatly increased fine sediment input that can clearly be seen smothering the bed (54.139115, -6.640402).

<p><b>Photo 121</b></p>	1/2	54.139115, -6.640402	Buffer fence the field and provide alternative watering system (pasture pump, solar pump ram pump etc.).
Failed bank protection

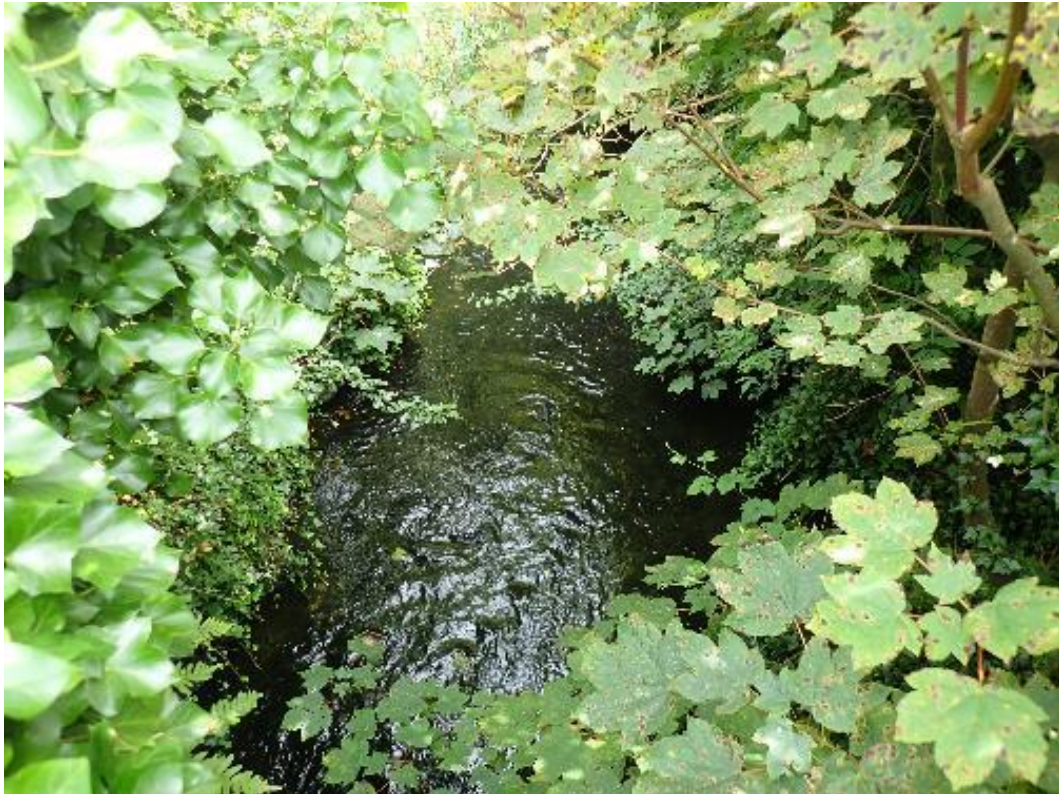
**Photo125.** The Ballykelly stream was inspected either side of the road bridge at 53.970310, -6.559003 and further downstream from 53.972160, -6.532505 to the Fane confluence (53.972061, -6.524963). The stream is heavily modified and straightened.

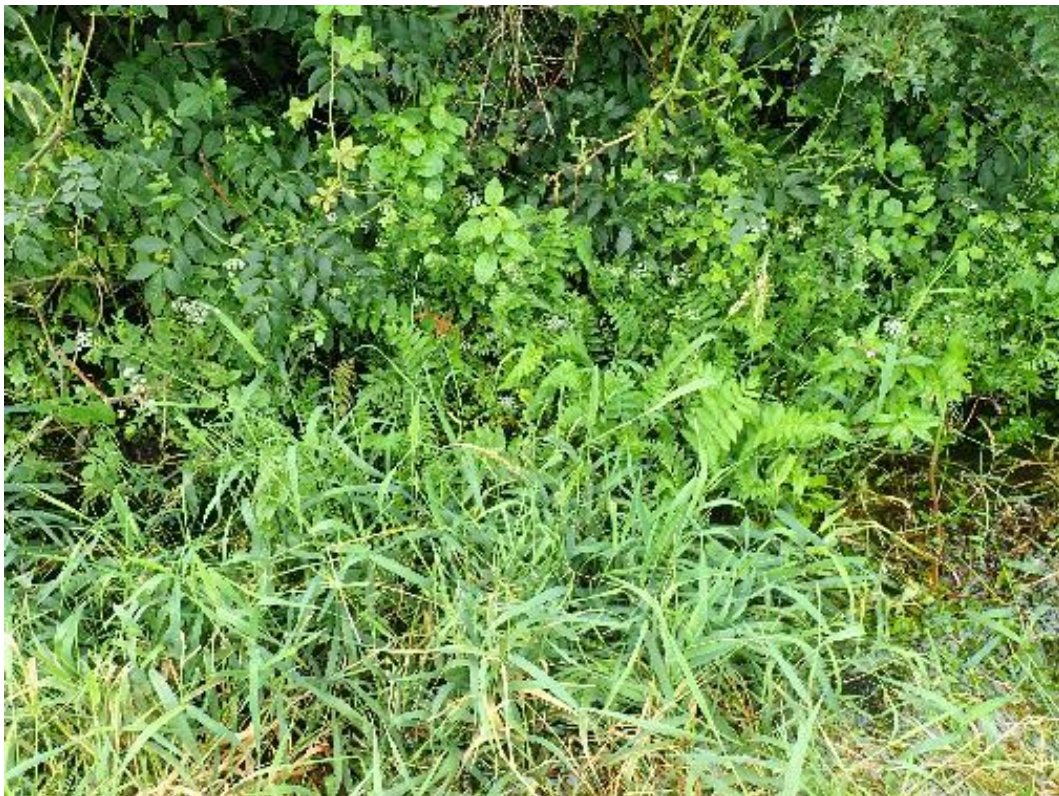
**Photo 126.** The section u/s of the bridge runs parallel with an open farm track. The heavy vegetation here covers a high quality, gravel bottomed nursery stream that will support juvenile trout. The nature of the plants observed indicates a neutral to slightly alkaline environment, possibly limestone-based, suggesting that this should be productive. The plants will die back very quickly come the first frost, so intervention is not needed.

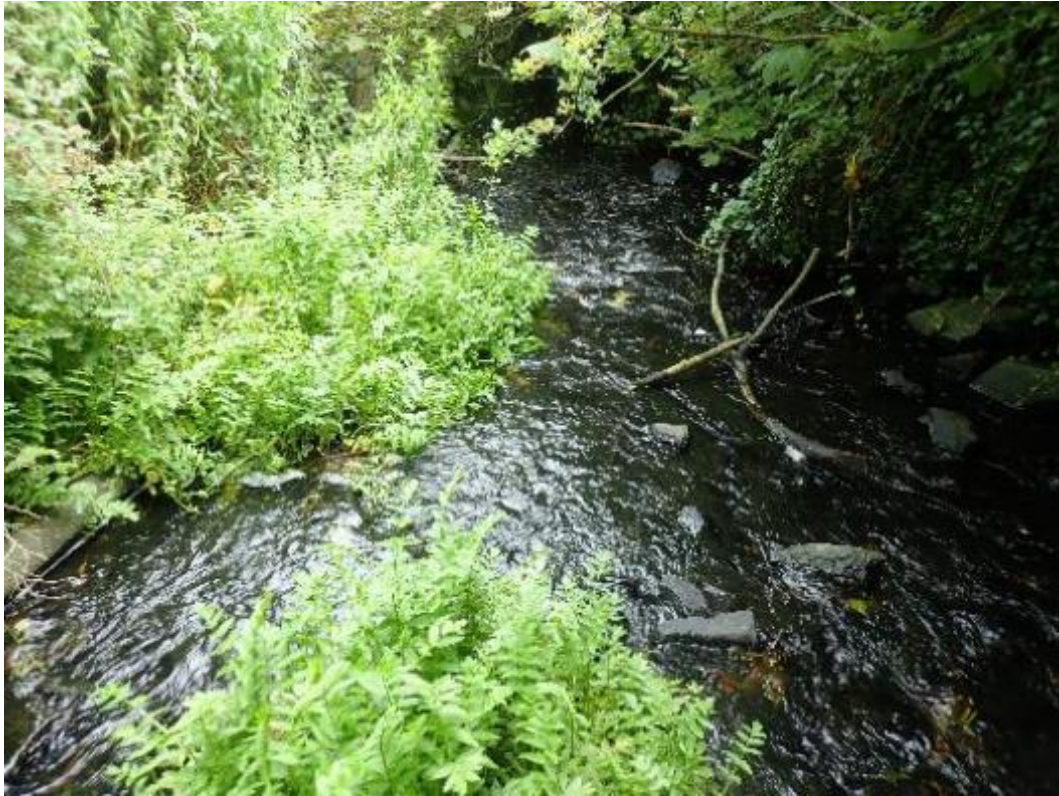
**Photo 127.** The stream running down from the bridge is shaded but provides excellent in-channel cover for fry and parr.

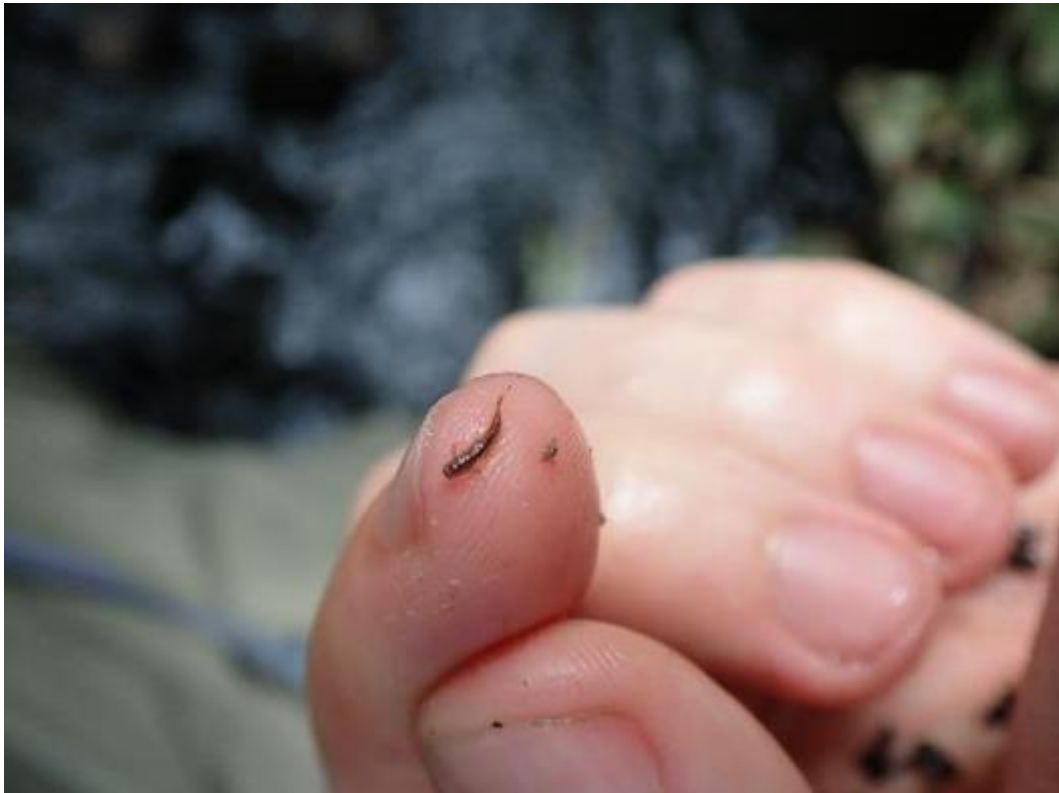
**Photo 128.** An inspection of the bed highlighted the presence of a healthy invertebrate community, including fairly sensitive species such as olive nymphs (*Baetis* spp.).

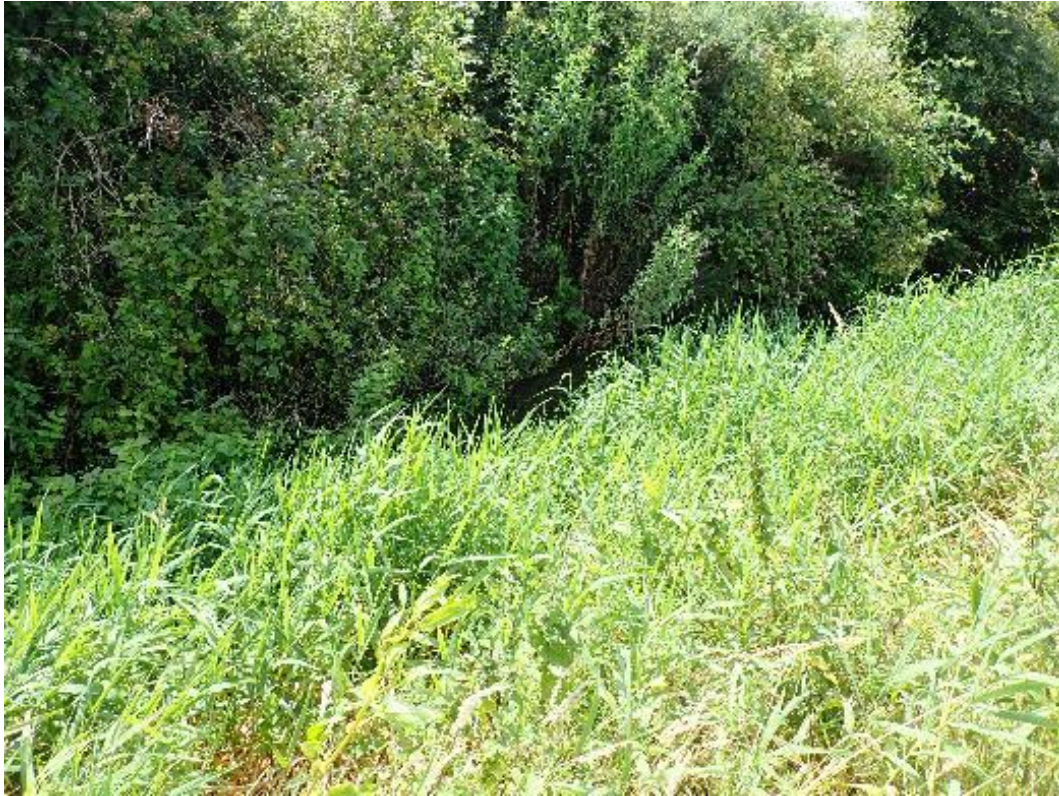
**Photo 129.** The vast majority of the Ballykelly stream has been straightened and dredged but, on the positive side, most of it has been fenced and the extensive riparian cover provides protection for the offspring of fish that manage to run this stream for spawning. What is likely to be lacking is the diverse morphology associated with an unmodified stream. This is a common reason why this, and many other Fane tributaries, are not meeting their full potential as spawning and nursery streams.

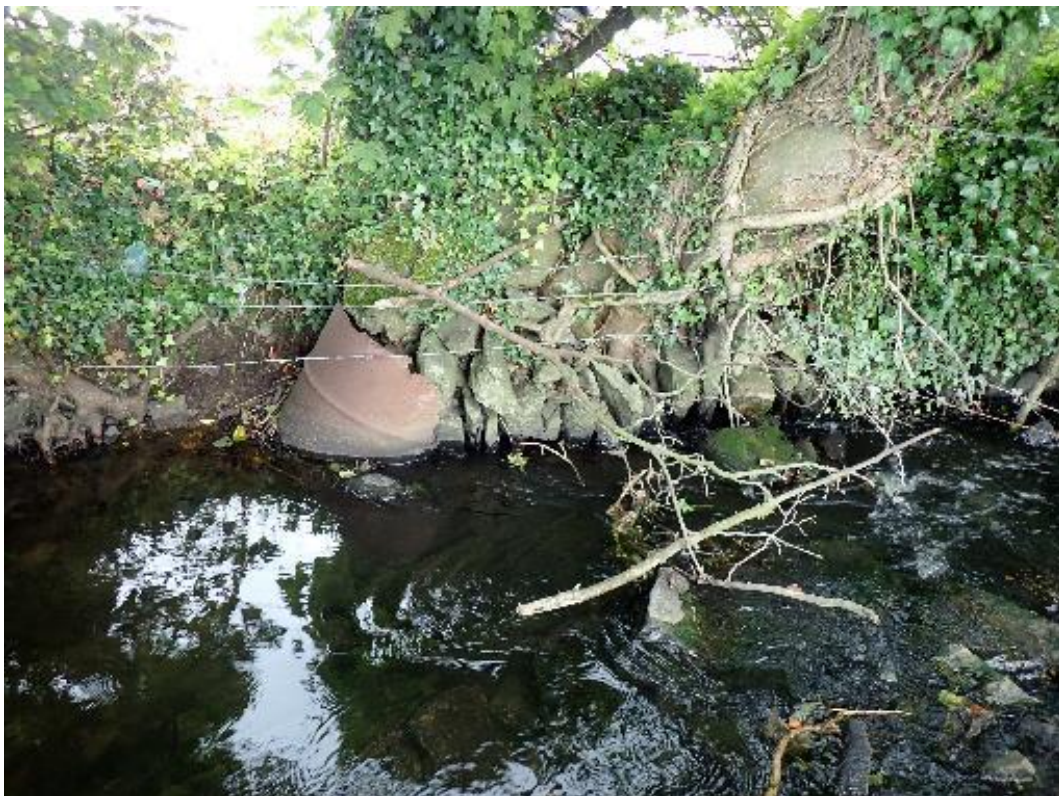
**Photo 130.** A section of the lower Ballykelly with pitched stone revetment, a legacy of enthusiastic modification.

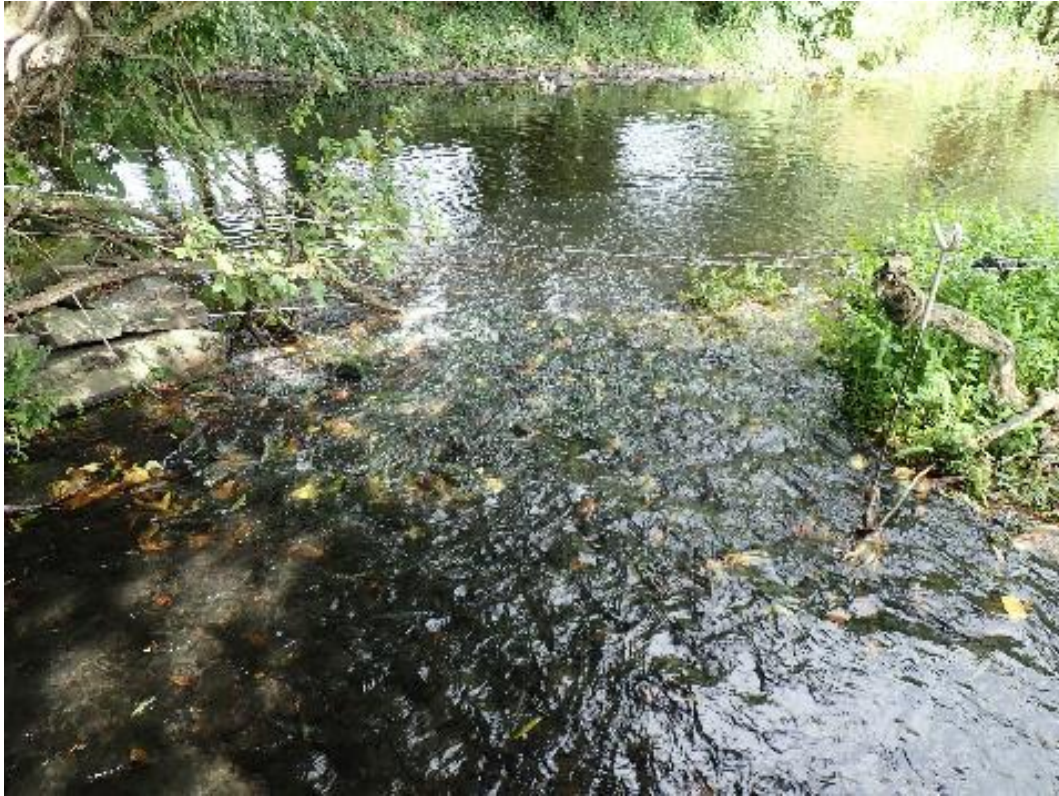
**Photo 131.** The confluence of the Ballykelly with the Fane: the bed of the stream here is considerably higher than the bed of the main river. All three of the tributaries inspected that join the Fane in the Castlering to Knockbridge reach were similar, suggesting that sediment transport is arrested when the main river is in flood, resulting in disposition of coarse bed sediments in the straightened, lower tributary reaches.

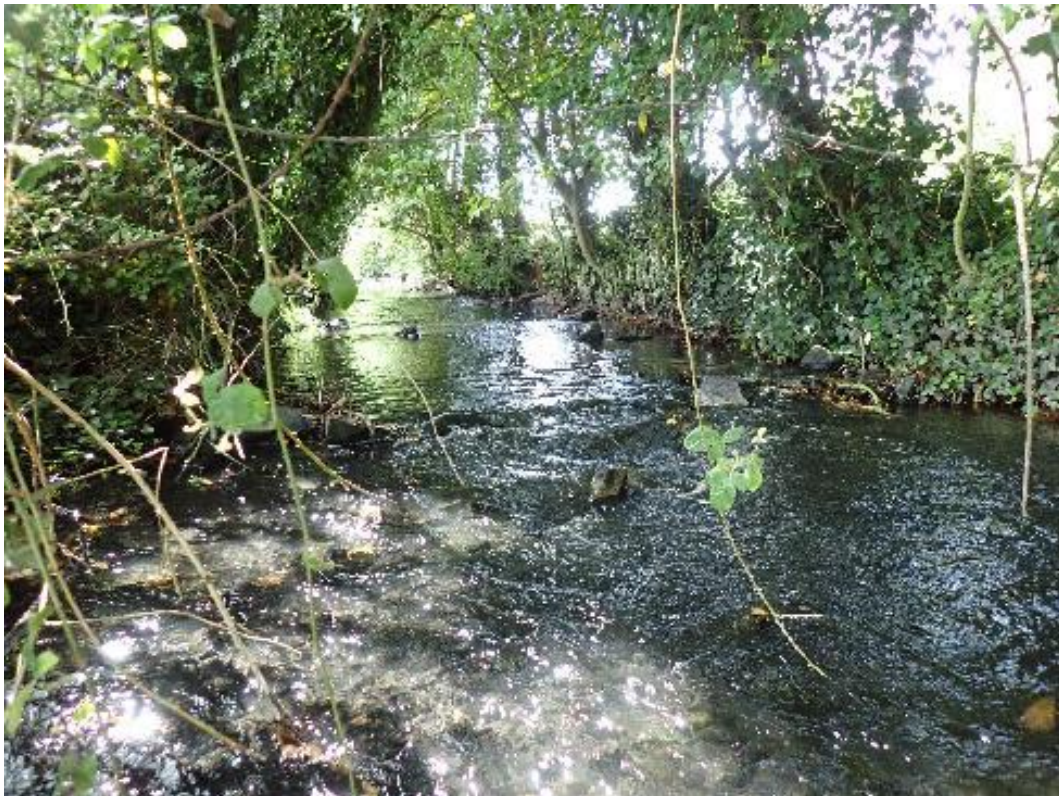
**Photo 131.** These small side streams and tributaries are critical to the overall productivity of the Fane system. Opportunities to restore them should be explored, with priority given to this stream, which appears to have the most reliable flow. In this case, any project to restore more natural morphology and river processes should begin at the d/s end to provide enhanced spawning and nursery opportunities for fish migrating into the system.

<b>Photo 131</b>	2	Throughout tributary, particularly the lower reaches, towards the Fane confluence.	The creation of a series of sinuous pool and run features will provide improved holding opportunities for pre and post spawning adult fish. The WTT can help with simple enhancement designs. Prioritise the reach in the lower two meadows.
