## Walkover Assessment

## River Fane

5th-7th/08/2019

Undertaken by the Wild Trout Trust

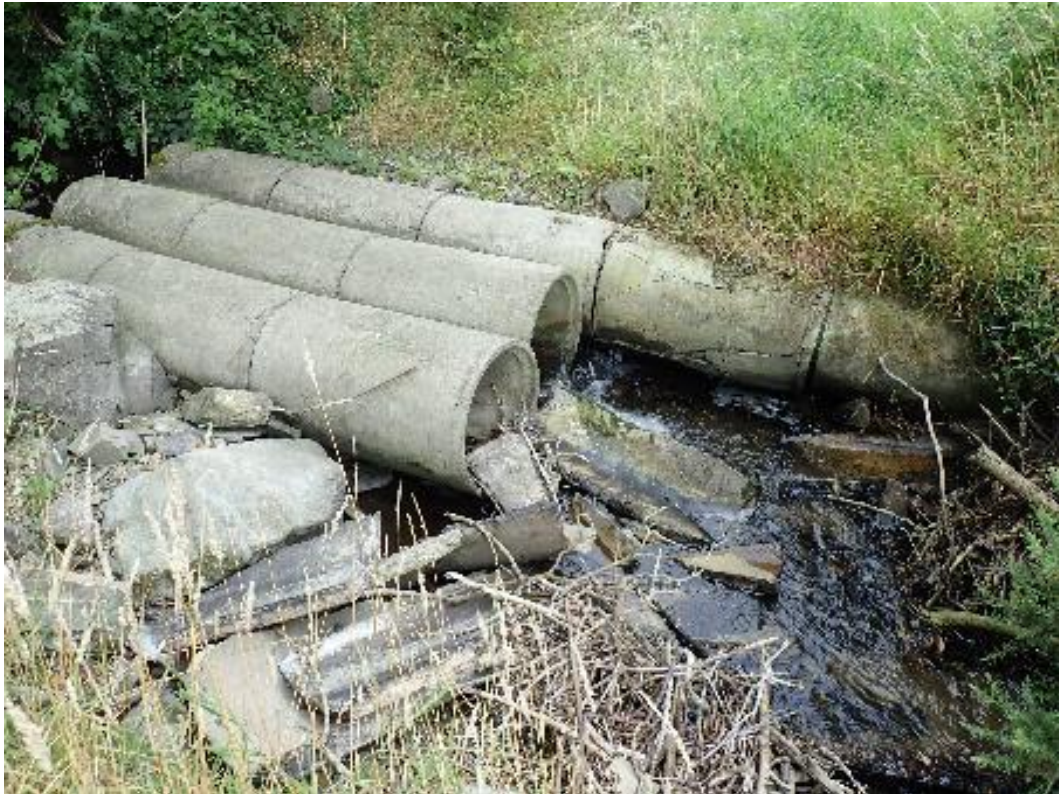
**Photo 132.** The Carrickrobin tributary has been horribly abused with inappropriate channel modifications and culverts.

<p><b>Photo 132</b></p>	2	53.980446, -6.516709	Inappropriate crossing points like this should be removed, particularly if now redundant. If necessary, they should be replaced with a single, much larger, partially sunken (below bed level) pipe.
Culvert/buried watercourse

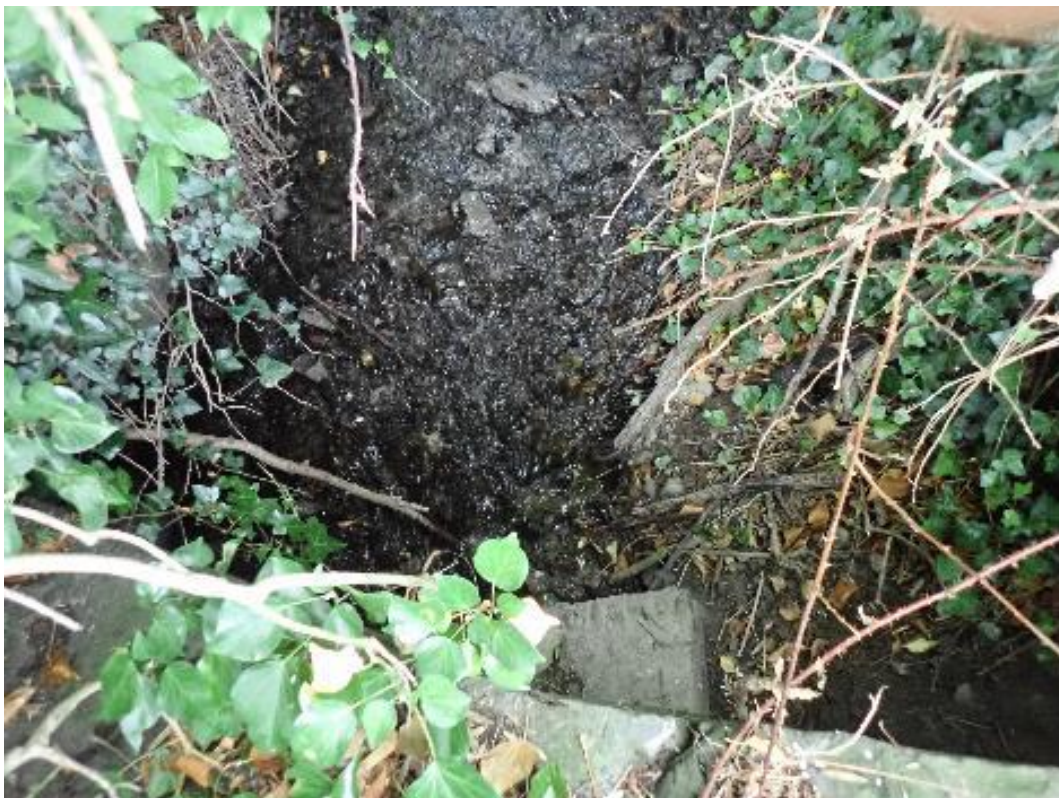
**Photo 133.** 53.978724, -6.517539 is the point at which the Carrickrobin disappears from view into a >100m-long culvert. This is likely to be a behavioural barrier to fish on spawning migrations, even if the culvert is not also a physical barrier to migration.

<p><b>Photo 133</b></p>	2	53.978724, -6.517539	This tributary could potentially be restored to a surface watercourse, massively improving habitat quality and fish passage.
Straightened and incised channel

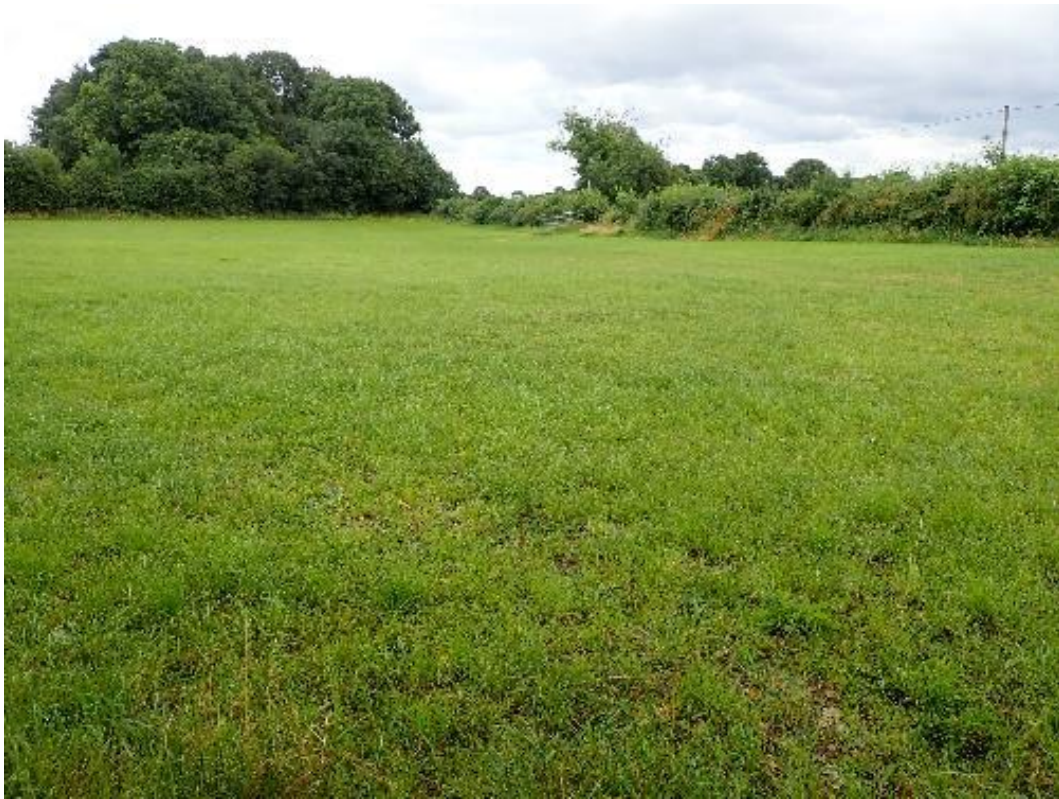
**Photo 134.** The Carrickrobin flows beneath this meadow. An average grazing meadow and no justification for committing the stream to a subterranean existence.

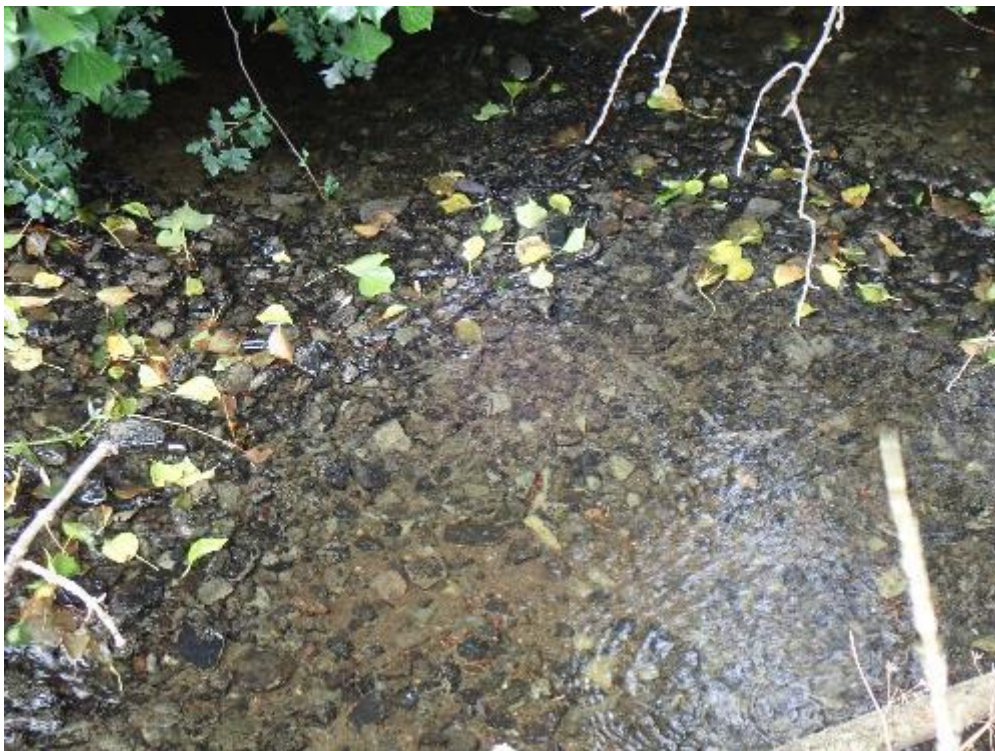
**Photo 135.** The water in this particular stream was very clear and may be a limestone groundwater source. Like all the tributaries inspected, the Carrickrobin is gravel-rich and, like the Ballykelly, the confluence with the Fane discharges over a plug of coarse gravels, suggesting that the bottom section of the stream backups during local spate conditions.

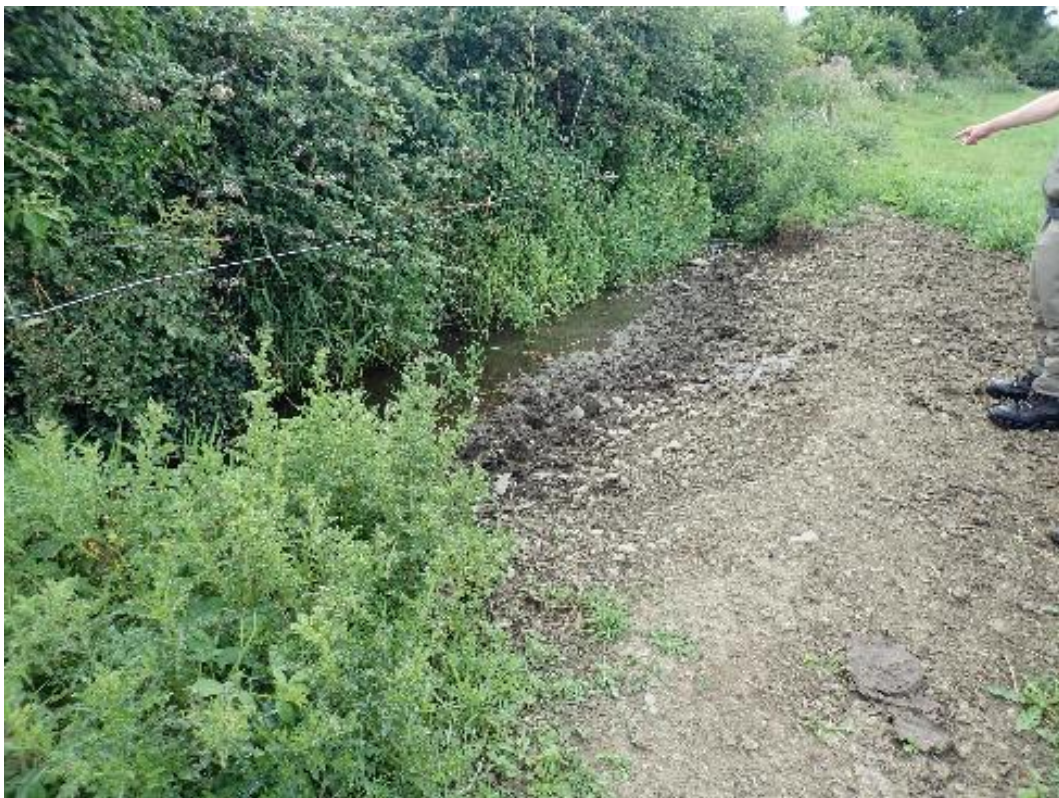
**Photo 137.** Along much of its length, this stream is fenced off from livestock access although the example above clearly demonstrates what happens when cattle have access for drinking.

<p><b>Photo 137</b></p>	1/2	Throughout the Halftate tributary.	Engage with the farmers to seek alternative livestock watering (mains water or pasture, solar or ram pumps).
Suspected enrichment

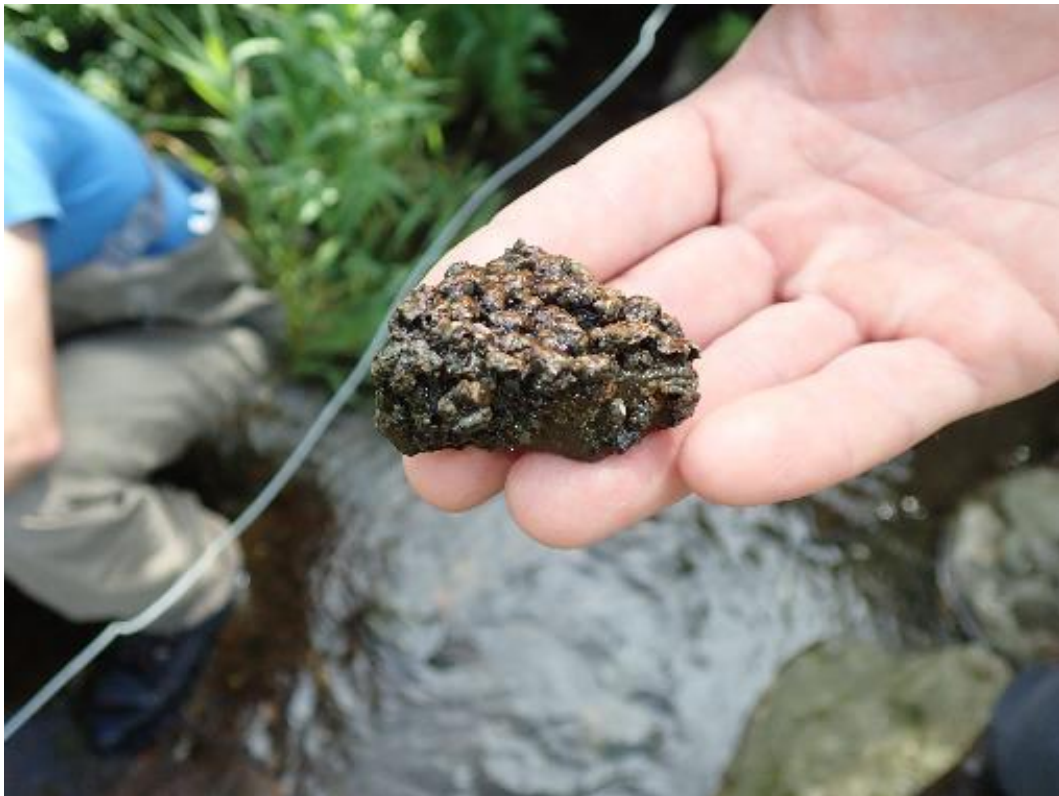
**Photo 139.** Judging by the number of caddis found here there will be no local shortage of sedge hatches. A proliferation of caddis numbers relative to the numbers of mayfly species can also indicate enrichment. Taken with the high numbers of *Gammarus*, there is good cause for further investigation.

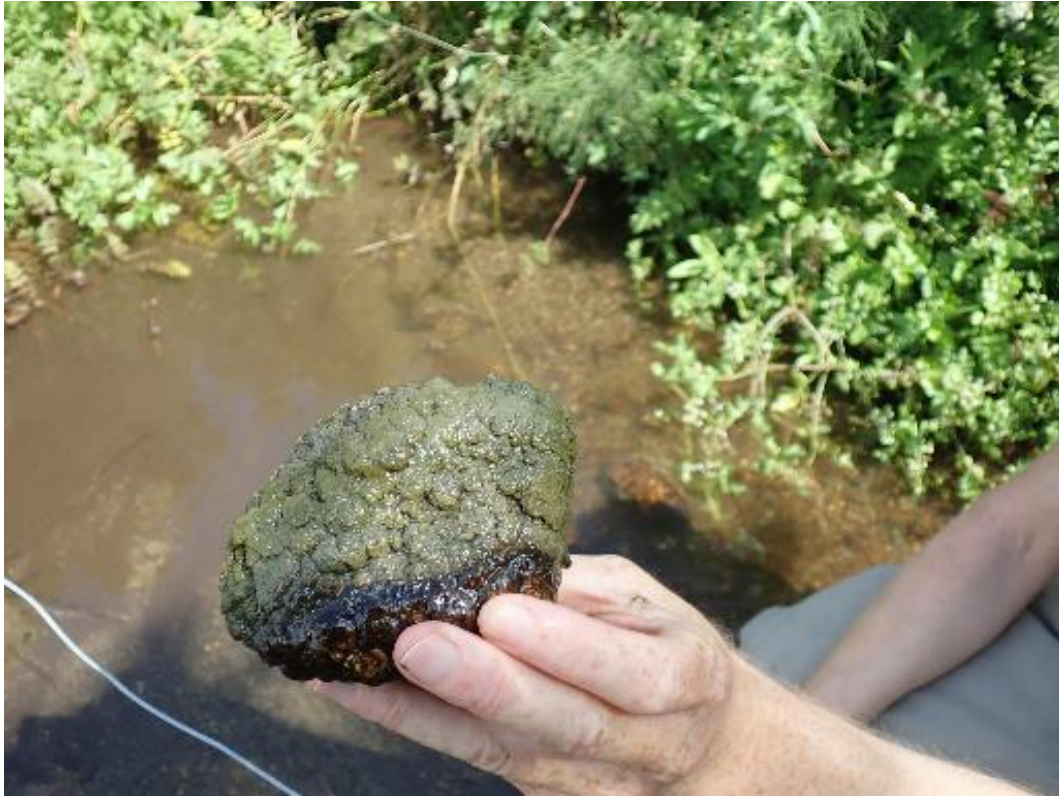
**Photo 140.** More evidence of the calcareous nature of these tributaries and the influence of local limestone geology was evident from tufa (calcium carbonate precipitation) on some of the gravels. This can be an issue for spawning success in certain scenarios where it occurs at a rapid rate and gravels can become naturally cemented, making redd cutting difficult. However, that is only evident in a small number of locations globally and mitigation is unlikely to be required in this case; it is simply a useful indication of elevated alkalinity.

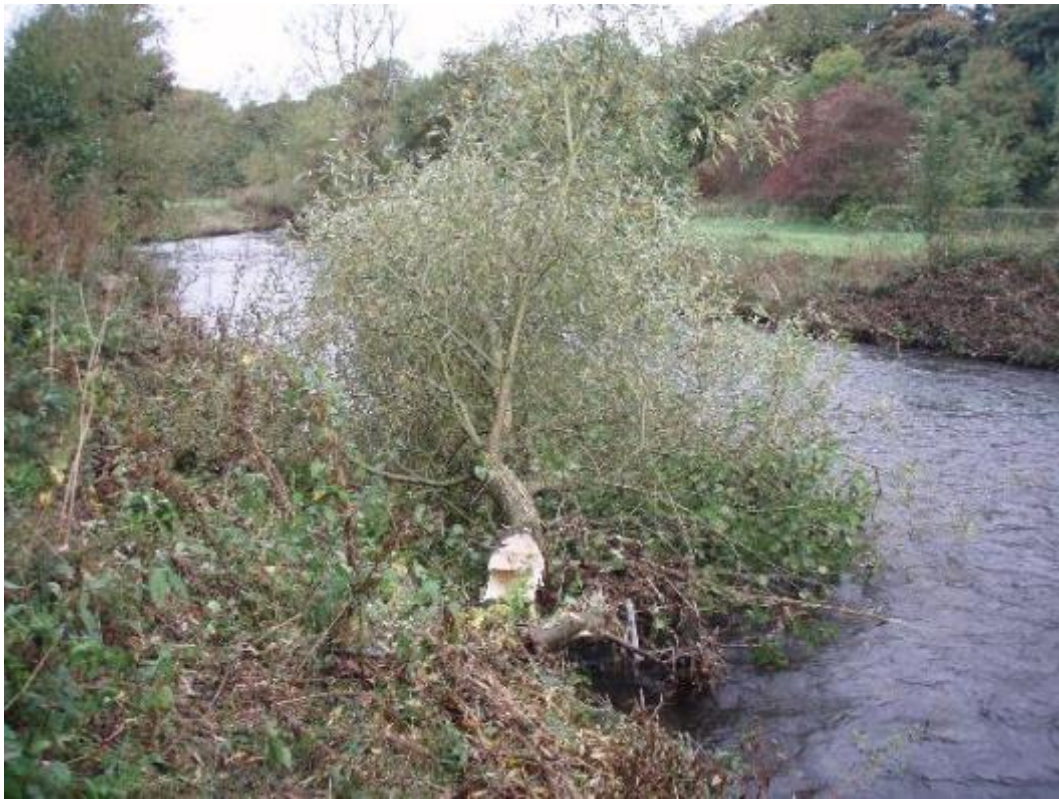
**Photo 141.** Example of a live willow hinged into the channel which will promote diverse changes in the bed shape of the river and provide cover for fish.

Laying the occasional suitable tree species down into the channel, as described for the willow in Photo 141, would be beneficial. This technique can be applied to trees and shrubs elsewhere on the river too.

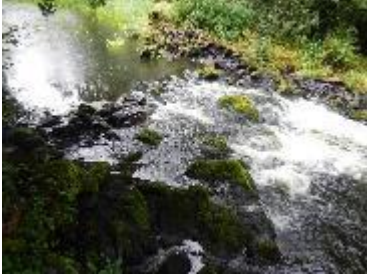
Observation	Photo (If required)	Priority (1-3)	Location	Proposed action
Weir – attempts to rebuild the structure

Photo 1	1/2	54.059055, -6.647277	Ensure that the obstruction is not rebuilt.
Straight, uniform channel

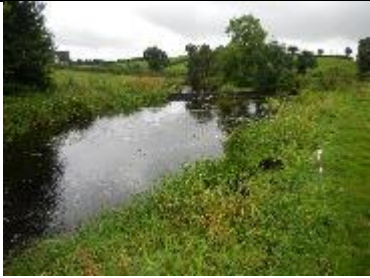
Large, partially-breached weir

**Photo 39.** Another weir creates a small obstacle but is already breached, reducing the issue (54.01271, -6.595992). However, creating a notch to bed-depth in a section of the weir would still be beneficial.

<p><b>Photo 39</b></p>	2	54.01271, -6.595992	Notch at least a section of the weir to bed level.
Small weir

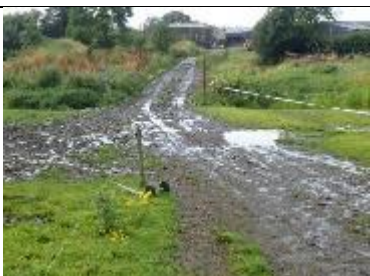
**Photo 56.** The top of the track leading to the slatted bridge (depicted in photo 55) at Fane Farm in the background. Track and field drainage (and associated sediments) could be intercepted and diverted into the ditch system in the foreground.

<b>Photo 56</b>	2	53.986179, -6.553918	Divert surface run-off into ditch and rough ground.

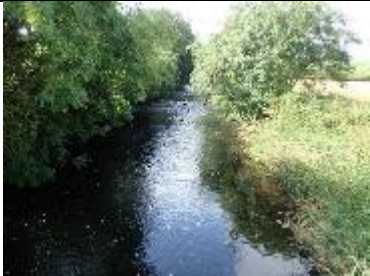
Straightened channel

**Photo 60.** A long, straight section of channel (53.983335, -6551503) lacking any significant pool habitat. Previous channel straightening, fallen tree removal and bank protection are usually the reasons why pool habitats fail to develop. Opportunities exist for tree hinging to promote a meandering thalweg at the very least.

<b>Photo 60</b>	2	53.983335, -6551503	Undertake selective tree-hinging or lodged woody material installation.
Inadequately buffered maize field

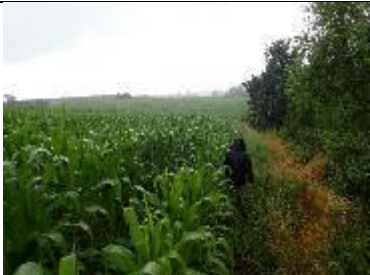
**Photo 69.** A large maize field located on a sloping meadow with a wholly inadequate buffer strip adjacent to RB just upstream of Castlering bridge (53.974340, -6.629830). Unless a cover crop is quickly planted post-harvest, this meadow will lose significant quantities of nutrient rich soil to the river over the winter period.

<b>Photo 69</b>	1/2	53.974427, -6.530000	Initiate dialogue with farmer.  Monitor and report if/when the suspected fine sediment pollution occurs.
Weir – impoundment to flow and sediment transport

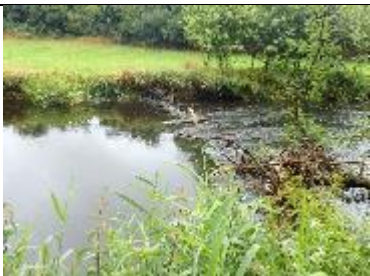
**Photo 72.** One of several low stone weirs in the Castlering to Knockbridge reach. Notching out a 2m wide gap to bed level would reinstate sediment transport and create an attractive flume for fish holding. Ideally, the gap should be on the side of the river where the flow velocities are potentially the fastest (outside of any sweeping bend).

<b>Photo 72</b>	1	Several low weirs	Notch out a 2m wide gap to bed level into all low stone weirs. Select areas where flow velocities would naturally be at their highest.
Over-shading

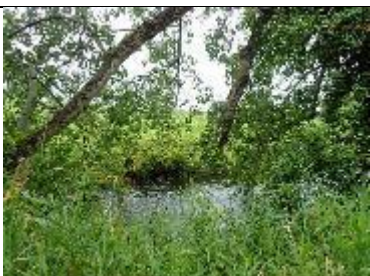
**Photo 73.** Habitat quality in the reach between Castlering and Knockbridge was generally very good. However, there were numerous opportunities to undertake some valuable tree hinging to create more in-channel habitat diversity and to open up one or two areas for increased light penetration.

<b>Photo 73</b>	2	Numerous locations	Undertake tree hinging to increase light penetration.

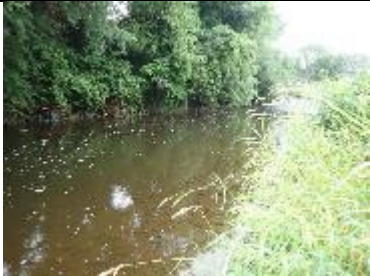
Stone bank revetment

**Photo 79.** The far margin is defended with pitched stone. These should be removed to encourage bank and bed scour so that deeper pools can develop.

<b>Photo 79</b>	1/2	Numerous locations	These should be removed to encourage bank and bed scour so that deeper pools can develop.
Poor land management and inappropriate bank work

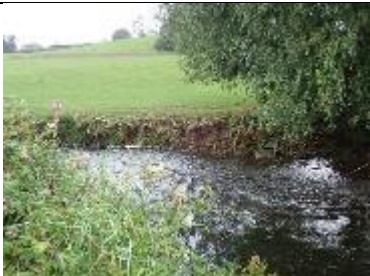
**Photo 82.** The next 250m of RB appears to be in single ownership and is blighted by poor management of the riparian zone (grazing and bank poaching pressures) with areas of the bank inappropriately defended with imported waste. The whole reach between 53.964985, -6.490593 and 53.963552, -6.485808 has examples of poor riparian management.

<b>Photo 82</b>	1	53.964985, -6.490593 to 53.963552, -6.485808	Enter discussions with the landowner to seek buffer fencing and cessation of bank work with waste material.  If no improvement is achieved, report to the relevant authority (e.g. EPA in RoI).
Extensive horse chestnut growth and shading along the riverbank

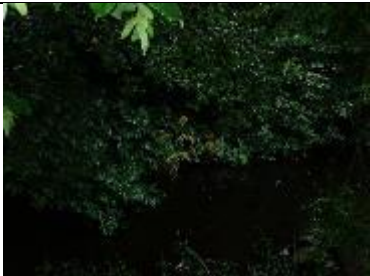
**Photo 100.** A dark avenue of dense shading around 53.958713, -6473519 is thought to be associated with ornamental planting in the grounds of the old derelict house, which sits back on the northern ridge. These horse chestnuts are an inappropriate riverside tree. The conkers themselves if crushed produce saponin, which is a highly toxic piscicide. Any horse chestnut that drops fruit on a farm access track for instance, where conkers might be prone to crushing, should be carefully assessed to ensure any run-off does not enter any nearby stream or river.

<b>Photo 100</b>	1/2	53.958713, -6.473519	It would be beneficial to thin-out the trees and replace with alternative species.
Bamboo – non- native and invasive species

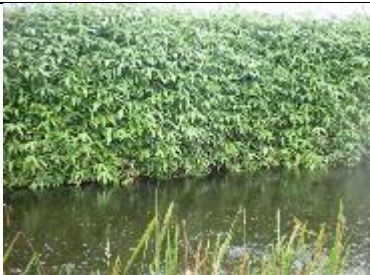
**Photo 101.** Another non-native legacy from the old estate, although not usually categorised as an "Invasive Non-Native Species": bamboo is nevertheless not native, highly invasive and undesirable as a riverside plant (53.957863.-6.470611).

<b>Photo 101</b>	1	53.957863, -6.470611	Eradicate the plant from the wild (e.g. riverbank).

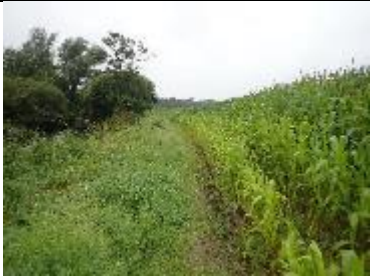
Inappropriate land use/lack of buffer

**Photo 103.** Again, in some areas, essential buffer zones between sloping arable fields and the river were completely missing (53.958030, -6.470700). In this case, a large field running down below the derelict manor house.

<b>Photo 103</b>	1/2	53.958030, -6.470700	Initiate dialogue with farmer.  Monitor and report if/when the suspected fine sediment pollution occurs.
Weir – impoundment

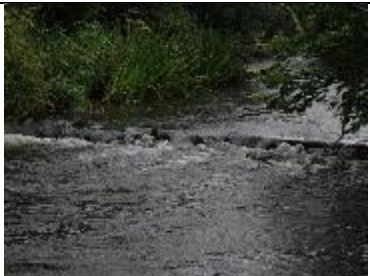
**Photo 104.** Yet another low stone weir is present on this reach (53.957936, -6.467749). Creating a 2m wide notch to be level is recommended.

<b>Photo 104</b>	1	53.957936, -6.467749	Create a 2m wide notch to be level.
Public water supply abstraction point - lack of screening

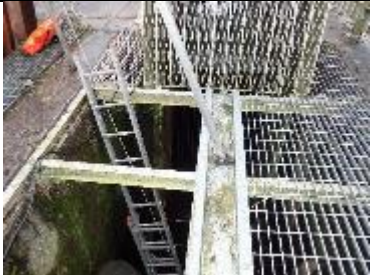
**Photo 106.** The chamber to the public water supply abstraction near the bottom of the beat (53.954030, -6.460303). The author was surprised to find that there were only trash screens and appeared to be no fish barriers or behavioural screens installed. It is highly likely that this intake will be entraining smolts and eels on migration. Dialogue is required to establish if screens are fitted and if not, lobby for urgent mitigation.

impact on this sensitive stretch of the river. The provision of secondary screening of the structure, in addition to simple trash screens, is essential and likely to be required by law. There is a chance that these screens are in place, or are planned; however, they were not evident during this walk-over survey. Rotating drum-style wedge-wire screens are the industry standard for abstraction points on rivers that support migratory salmonids and eels. It is therefore recommended that all angling clubs call for urgent improvements to screening.

<b>Photo 106</b>	1	53.954030, -6.460303	Dialogue is required to establish if screens are fitted and if not, lobby for urgent mitigation.
Long concrete channel – poor habitat quality

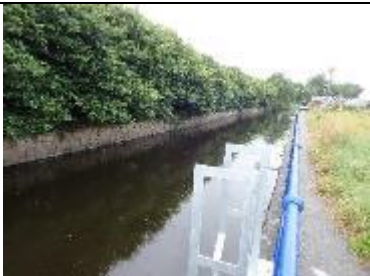
**Photo 107.** The long concrete channel constructed at the downstream end of the abstraction appears set up for flow gauging. It would be worthwhile ascertaining whether the data are available to the club. Dialogue with the regulators and water company might also identify if the long section of sterile channel could be improved via box planters to provide shade and cover without interfering with the laminar flows within the gauging box.

<b>Photo 107</b>	2	U/s of 53.954030, -6.460303	Contact the water company and regulator to ascertain whether in-channel improvements could be achieved with planters, without compromising monitoring at the site.

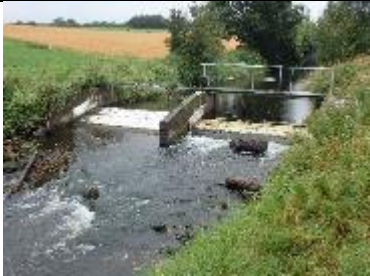
Weir – obstruction to fish passage

**Photo 109.** The crump weir/fish counter located a short distance downstream of the abstraction point (53.9536604, -6.4580669) raises a number of questions:

Good quality data gathered from fish counters can be of enormous value to regulators and clubs. On the Fane, it is not apparent if such data are available and shared or, indeed, if the counter is fully functional. It is recommended that the clubs open a dialogue with the regulators to explore options for gathering fish population data and improving information sharing. Furthermore, the weir at the counter is a significant barrier to free fish migration and will significantly impact downstream sediment transport, over time creating siltation problems for the u/s reach. We suggest that the regulators be encouraged to consider alternative fish population monitoring options that do not require a significant step in the bed height and obstruction of the river.

<b>Photo 109</b>	1	53.953660, -6.458066	Ideally, options should be explored to monitor fish populations without the requirement for a weir and certainly without the current obstruction to fish passage and sediment transport.
--	--	---	----------------------	--

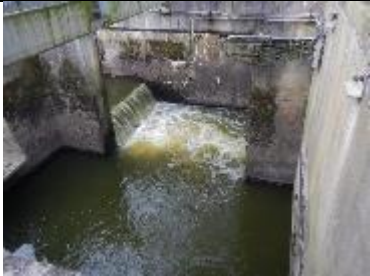
**Photo 113.** Looking at the d/s side of the structure: it appears some flow is also passing under the weir. This may provide some potential for fish passage, at certain times, but undershot structures are notoriously poor at facilitating d/s fish passage. Note the high turbidity of the water. Much of this is suspected to be algal/diatom growth, potentially indicating the enrichment/eutrophication recognised in the river system.

<b>Photo 113</b>	1	54.099668, -6.67637	Without details of how this structure is operated, it is difficult to advise but improvements to both u/s and d/s passage are likely to be required.
Artificially uniform channel - poor habitat quality

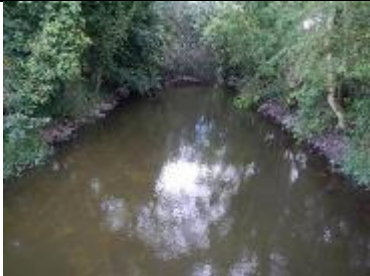
**Photo 114.** D/s of the weir, the artificial, straightened, uniform width and heavily incised channel offers poor habitat for flow-loving salmonids. Occasional overhanging trees provide some cover and refuge but the area is better suited to coarse fish. Introducing more structure into the channel here could improve the flow characteristics and fish-holding potential.

<b>Photo 114</b>	2	D/s of 54.099668, -6.67637	Install tree kickers or other large, lodged woody material to provide in-channel structure and diversify flow.

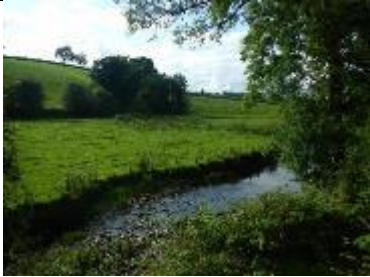
**Photo 119.** An old meander in the river course (blue arrow) was observed in the field but is now disconnected from the watercourse and is highly suggestive that the channel has been straightened (54.1400448, -6.6409435). This kind of feature can be reinstated as part of a river restoration scheme, but that requires landowner buy-in to the scheme.

<p><b>Photo 119</b></p>	2	54.1400448, -6.6409435	Potential for channel restoration/re-meandering.
Cattle poaching/bank erosion

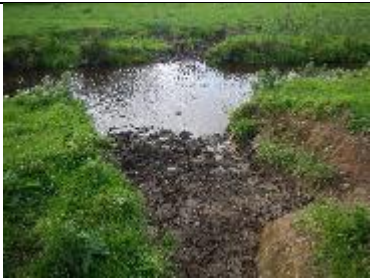
**Photo 121.** Un-natural bank erosion created by livestock access is not beneficial and is contributing to greatly increased fine sediment input that can clearly be seen smothering the bed (54.139115, -6.640402).

<p><b>Photo 121</b></p>	1/2	54.139115, -6.640402	Buffer fence the field and provide alternative watering system (pasture pump, solar pump ram pump etc.).
Failed bank protection

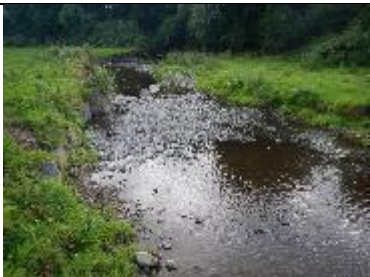
**Photo 123.** Around 54.139052, -6.640593, what appears to be a weir is actually the remains of failed bank protection, where the river has broken through from its previous course (blue arrow). Flow is now being directed into the bank by the failed revetment which acts as a flow deflector, which will be a particular issue at high flows. Consequently, the bank d/s is eroding at an accelerated rate.

<p><b>Photo 123</b></p>	2/3	54.139052, -6.640593	Remove the block stone and buffer fence the field to reduce erosion to a naturally low level.

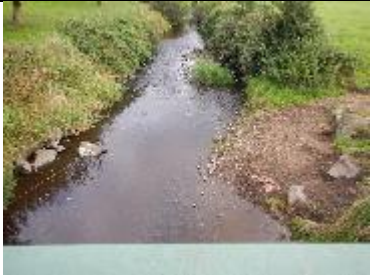
**Photo 124.** D/s of the road bridge (54.13813, -6.639995), a drinking bay creates typical bank erosion issues. Interestingly, the erosion and widening at that point has subsequently led to deposition of fine material supplied from u/s (red circle), highlighting the over-supply of fine material resulting from erosion from u/s too. Note the very silty bed and smothered gravel.

Erosion at drinking bay

<b>Photo 124</b>	2	54.13813, -6.639995	Provide alternative watering system (pasture pump, solar pump ram pump etc.).
-------------------------	--	---	---------------------	---

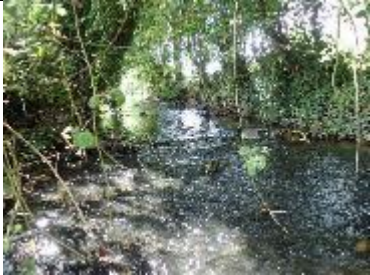
**Photo 131.** The confluence of the Ballykelly with the Fane: the bed of the stream here is considerably higher than the bed of the main river. All three of the tributaries inspected that join the Fane in the Castlering to Knockbridge reach were similar, suggesting that sediment transport is arrested when the main river is in flood, resulting in disposition of coarse bed sediments in the straightened, lower tributary reaches.

**Photo 131.** These small side streams and tributaries are critical to the overall productivity of the Fane system. Opportunities to restore them should be explored, with priority given to this stream, which appears to have the most reliable flow. In this case, any project to restore more natural morphology and river processes should begin at the d/s end to provide enhanced spawning and nursery opportunities for fish migrating into the system.

<b>Photo 131</b>	2	Throughout tributary, particularly the lower reaches, towards the Fane confluence.	The creation of a series of sinuous pool and run features will provide improved holding opportunities for pre and post spawning adult fish. The WTT can help with simple enhancement designs. Prioritise the reach in the lower two meadows.

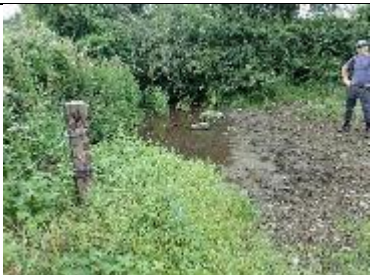
**Photo 138.** Another example where cattle have access to the stream, a short distance from the Fane confluence. Large densities of shrimp *Gammarus pulex* were found here, which often indicates enrichment, potentially even significant eutrophication.

<p><b>Photo 138</b></p>	1/2	Throughout the Halftate tributary.	Undertake further investigation of the potential pollution sources (e.g. septic tank discharges and farm run-off).
Heavily modified channel
